A Study on the Crash of Boeing 737 MAX

Vijay Kumar Shrivastava

Abstract: Air travel is one of the safest (0.18 fatal accidents per million flights) and fastest mode of transportation out of all the other modes of transportation. The aviation industry has generated over 838 billion USD in revenue globally (2019, Statistica). Despite its huge contribution to the global economy, the aviation industry is majorly dominated by two key aircraft manufacturers, Boeing (American) with its 7-series of jets and Airbus (European) with its A-series of jets. To compete in the market, Boeing launched 737 MAX series in 2011, which promises to be more fuel-efficient compared to its previous model (737 NG) and competitors (A320). However, within a few years of its operation, two 737 MAX fatal crashes occurred in October, 2018 and March, 2019, respectively, killing all passengers and crew onboard (Total = 346). This raised a serious question as to how safe is 737 MAX for further operation. This research paper aims to review the facts, analyze critical decisions, study their impact on the results and to discuss the best practices on the subject under review.

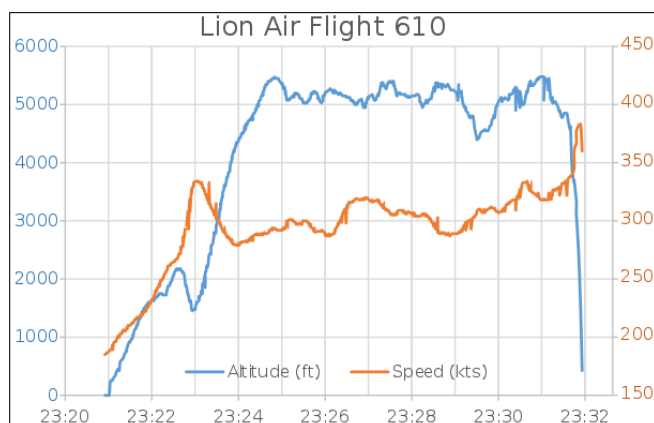
flight control software that adjusts the horizontal stabilizer trim to push the nose downwards, when the aircraft is operating in manual flight, with flaps up (Boeing Statement on Lion Air Flight 610 Preliminary Report, Nov, 2018). MCAS takes input from one of the two angle of attack (AOA) sensors, making it susceptible to single point of failure. The MCAS got automatically activated for 10 seconds ON and 5 seconds OFF, which made it difficult for pilots to figure out as to why the plane's nose was pitching downwards automatically. The plane was losing 600 feet of altitude within seconds. The captain asked the ATC (Air Traffic Controller) to return back to the airport as they could not figure out a solution to problem and was struggling to maintain a stable cruising altitude. While returning to the airport, the pilot asked for 3000 feet altitude to be locked, as they lost control of the actual altitude and wanted to refrain from causing a trouble to other aircrafts in the airspace. While returning, pilots mentioned that most of the systems and equipment were not working properly. MCAS got activated every 10 seconds and switched OFF for 5 seconds which resulted in loss of altitude with nose pitched downwards for 10 seconds and pilots tried to regain the altitude in the remaining 5 seconds. This cycle kept on repeating itself and as it was happening rapidly, without prior information to pilots about MCAS, pilots were not able to understand the reason behind sudden loss of altitude of the plane. The plane was experiencing a steep descent for 10 seconds (when MCAS is ON). A sudden shift in altitude and airspeed can be observed from the graph given below. Pilots had to adjust the pitch trim every few seconds. It was a nightmare in the cockpit as the pilots did not even had sufficient time to consult the Boeing checklist. At 11:32 UTC, the Lion Air Flight 610 crashed in the Jawa Ocean with 40-degree steep nose downwards with system repeatedly announcing "PULL UP TERRAIN PULL UP TERRAIN" killing all 189 crew and passengers onboard. (Indonesian National Transport Safety Committee)

Figure 1: Altitude and speed of Lion Air Flight 610

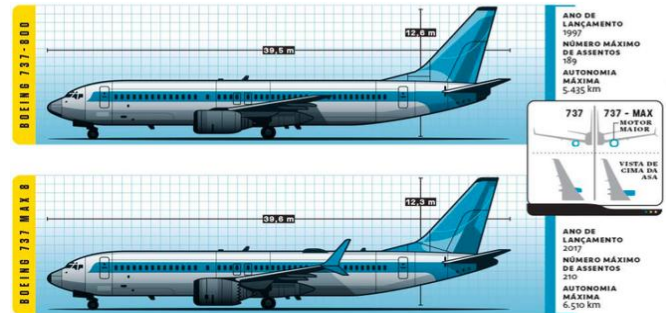
According to Carnot efficiency and Laws of Thermodynamics, larger the size of engines, better will be the efficiency. To deal with larger size of engines and to have better ground clearance, Boeing tried to change the mounting point of the engines, placing them forward and much higher on the wings. The engine's position on the wings forced the nose of the plane to go up, creating a stall possibility (if the angle of attack is too high). To prevent the plane from going into stall position, Boeing installed MCAS software, which automatically turns ON (for 10 seconds) and OFF (for 5 seconds). The purpose of MCAS is to bring the nose of the plane downwards as a counteract to the automatic lift in the nose of the plane in upward direction (due to placement of the engines) so as to nullify the whole effect and to prevent the plane from going into stall position.

Figure 2: Altitude and speed of Lion Air Flight 610
