Task Force SAFE

Inspection-Report_TFSAFE_F797V_12345_Team 101_19-12-25_1-3

Base Location	Erbil (Iraq)	Date:	2025-12-19
Base Code	F797V	Team #:	Team 101
Building #	12345	System Voltage	230/400
Building Type	Warehouse	Inspection Phase	Initial Inspection
Previous Report #:	N/A	Work Order:	TFS-F797V-2025-00001

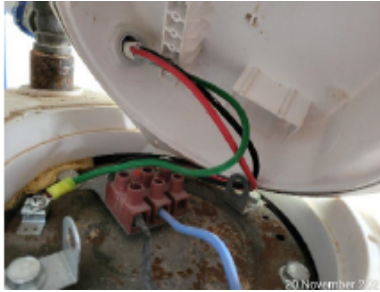
Deficiency #1**RAC 1****Occurrences: 1****Description:** Missing cover on junction box exposing live terminals

Location:	Panel room, main distribution board
Category:	Improper Use / Damaged
Equipment:	WLT
Imminent:	Yes
Action:	Circuit Isolated
Code:	BritishStandard 522: Selection and erection of wiring systems in relation to external influences
Status:	Open

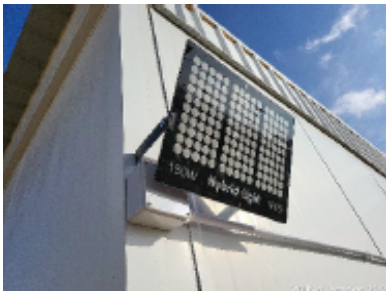
Deficiency #3**RAC 1****Occurrences: 3****Description:** Exposed wiring running along exterior wall without proper conduit protection

Location:	External wall, east side
Category:	Poor Workmanship
Equipment:	WLT
Imminent:	Yes
Action:	Circuit isolated and locked off until repair can be made
Code:	BritishStandard 522: Selection and erection of wiring systems in relation to external influences
Status:	Open
