Task Force SAFE

Inspection-Report_TFSAFE_CP2FL_ACCOM-1_128_24-12-25_1-1

Base Location	Tower 22 (Jordan)	Date:	2025-12-24
Base Code	CP2FL	Team #:	128
Building #	ACCOM-1	System Voltage	230/400
Building Type	Barracks	Inspection Phase	Initial Inspection
Previous Report #:	N/A	Work Order:	TFS-CP2FL-2025-00001

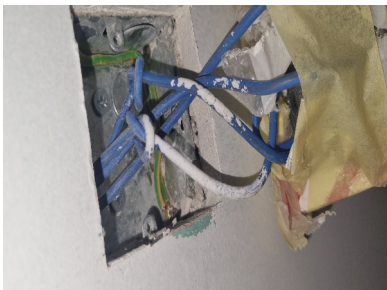
Deficiency #1

RAC 2

Description: Twisted conductor, compression on cable

Location:	At each light switch within billeting rooms.
Category:	Improper Terminations
Equipment:	WLT
Imminent:	No
Action:	N/A
Code:	BritishStandard 642: Inspection
Status:	Open

Accommodation 1 North Rooms were found to be at 40% completion upon inspection. All first fix wiring has been completed. No lighting has been installed yet as there is no ceiling present. Cables are still within copex. Partial 2nd fix on low level accessories within billeting rooms. Back boxes installed for sockets/AC has large gap between accessory and wall. Excess cable at connection of accessories. Compression when fixed into position.
