FLIGHT OPERATIONS TECHNICAL BULLETIN

NUMBER:	707-16-1	777-44
	B-717-16-01	787-17
	727-16-1	DC-8-16-01
	737-16-3	DC-9-16-01
	747-100/200/300/SP-21	DC-10-16-01
	747-400-69	MD-10-16-01
	747-8-9	MD-11-16-01
	757-89	MD-80-16-01
	767-92	MD-90-16-01

SUBJECT: Lithium Battery Fires on the Flight Deck

APPLIES TO: All 707, 717, 727, 737, 747, 757, 767, 777, 787, DC-8, DC-9, DC-10, MD-10, MD-11, MD-80, and MD-90 Airplanes

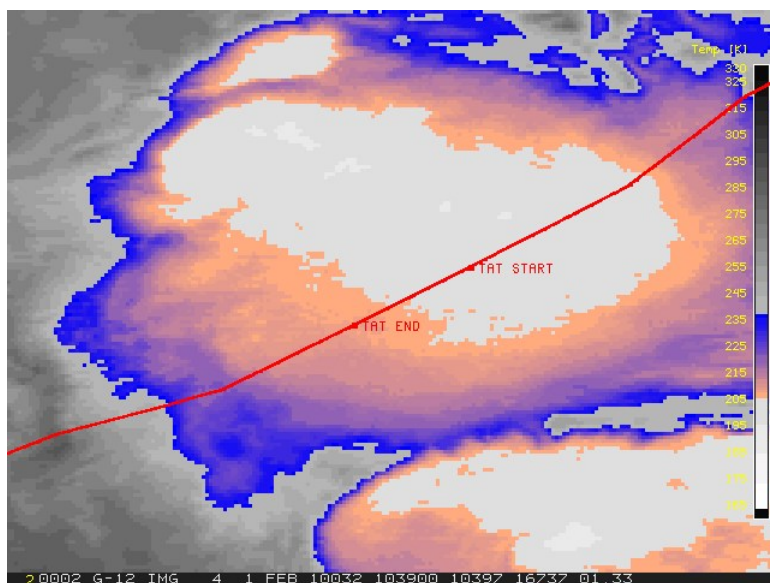
Figure A: Enhanced infra-red satellite image showing clouds at or above the tropopause in grey and white colors. The airplane track is shown in red. An engine damage event occurred during a TAT anomaly, noted by TAT start and TAT end notations. In the flight deck, the flight crew observed an auto-throttle disconnect associated with the TAT anomaly.

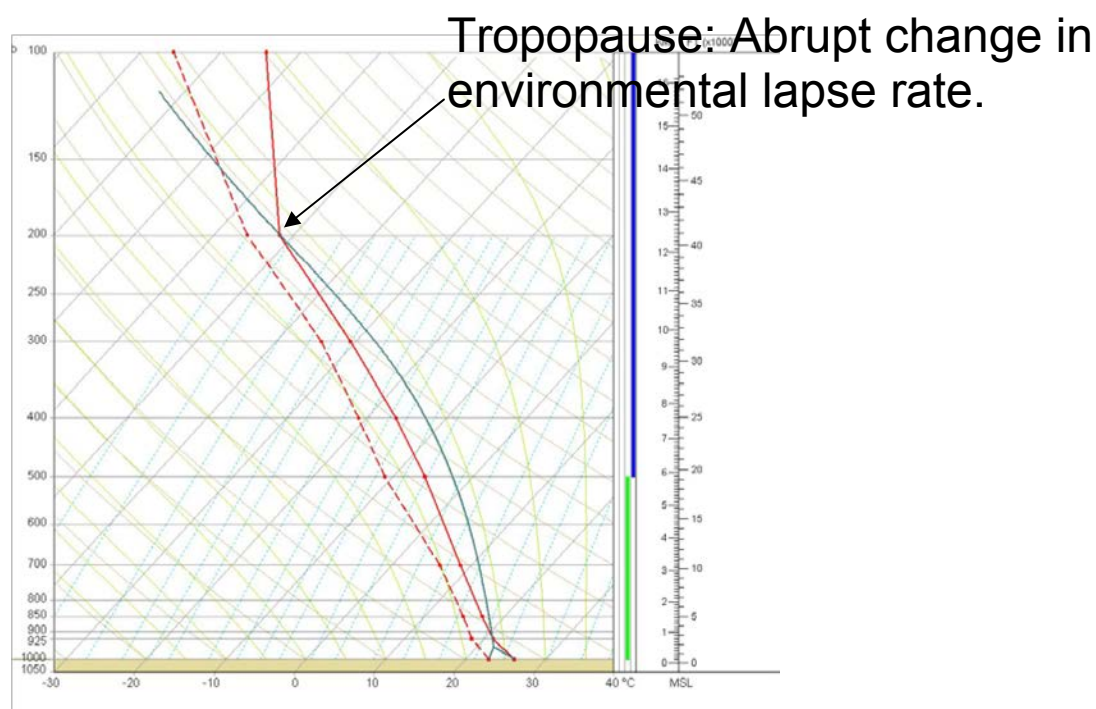
Figure B: An average sounding compiled from engine power loss and damage events up through 2009
