ERRATA NOTES

CC1101

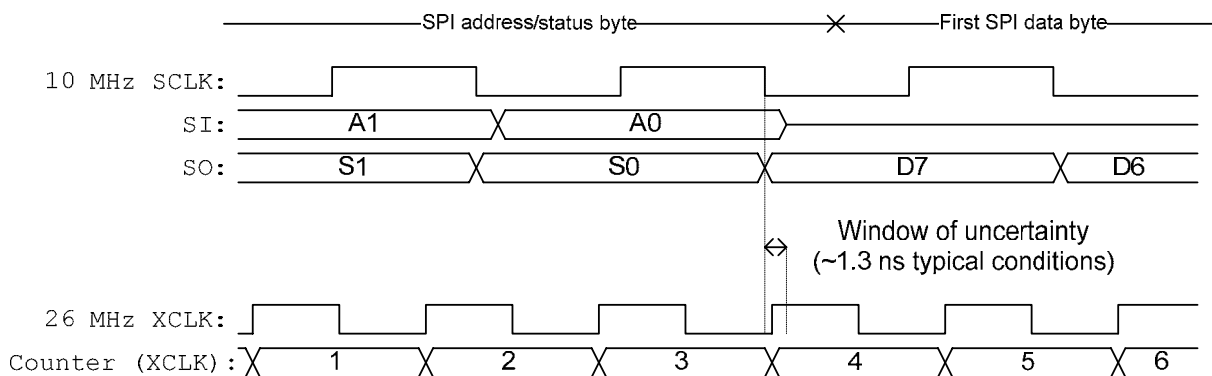
Figure 1: Window of Uncertainty (drawing not to scale)

Due to this synchronization issue, if the register being read changes value (synchronously with XCLK) during a certain period of time after this falling edge of SCLK then some of the bits in the read value will come from the **previous** value and some from the **next** value. This so-called window of uncertainty is about 1.3 ns for typical conditions and increases to about 2.0 ns for worst-case conditions (1.8 V VDD, 85 °C).

Figure 1 shows a timing diagram of an SPI read that fails when reading a fictitious counter being updated internally each **XCLK**. Since the counter update from value **3** (**011b**) to **4** (**100b**) within the window of uncertainty, the read value could be any one of 0-7 (**000b**, **001b**, **010b**, **011b**, **100b**, **101b**, **110b**, **111b**) depending on exactly when the positive edge of **XCLK** falls within the window of uncertainty.

If it is important to **ensure** that read values are not corrupted, reading of one of the affected registers should be done repeatedly until the same value is read twice in succession. If the rate at which the register is read is specified to be at least twice as fast as the expected register update rate, then an upper bound on the number of required reads is four and the average number of reads slightly more than two.
