Crossed Dipole antenna Evaluation

Preliminary Report

Politechnika Gdańska
2019-12-11

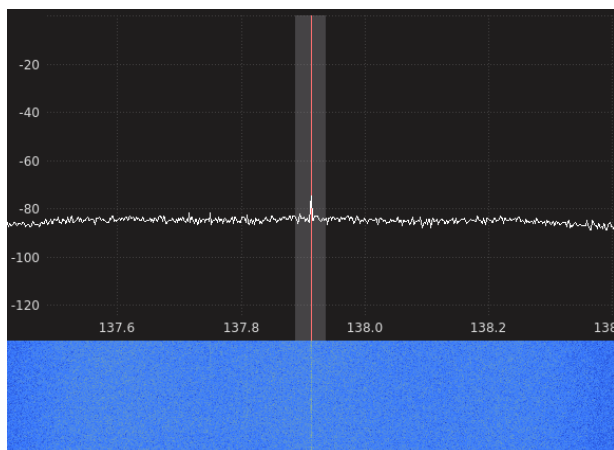
During the test time the best pass parameters had NOAA 18 satellite. We adjusted the SDR to frequency 137.9125 MHz and started observations. We noticed that the noise level was -82dB. However, the downlink signal had very poor quality. It was at level -78 dB. It had very narrow width, without any side bands. Such signal was deemed unusable and it was not possible to extract any imagery from this signal.

Figure 1: New antenna - very low quality signal. Only on main frequency exists little peak, but its level is greater by 4dB then noise. This peak is visible even when satellite doesn't pass. None side band occurs.

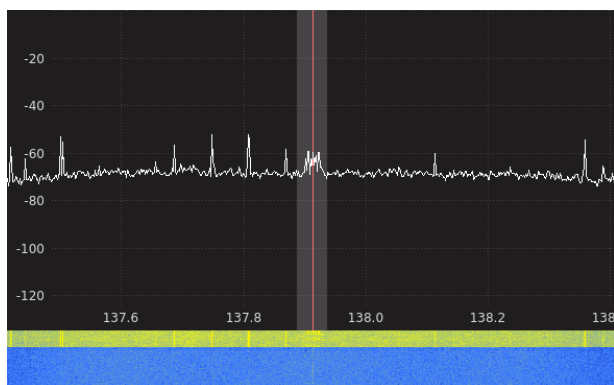
So far we used a simply turnstile antenna attached to SDR. It is low quality and small length. Nevertheless, we managed to receive and decode correctly a few images from NOAA satellites. It was replaced it with new antenna during NOAA 18 pass. The parameters of the signal changed. The noise level increased to -75 dB. The downlink signal increased to -60 dB. At specified frequency we had noticeable, wide beam. We noticed also a lot of side bands. Probably it is possible to extract imagery from recorded data, but we change the antenna in record time and our current algorithm wasn't prepare to handle it. Based on previous experienced the output picture will be strongly noised but on part recorded above antenna the details would be noticeable.

Figure 2: Old antenna - medium quality signal. We noticed data beam. We had 15 dB difference between useful signal and noise. Some side bands.

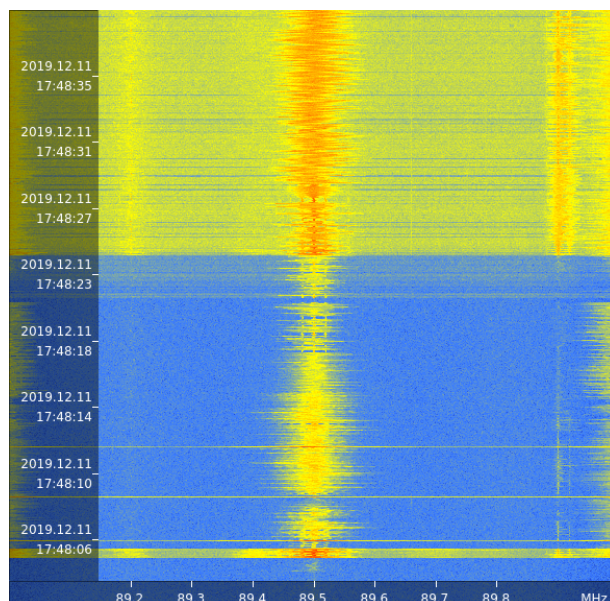
Figure 3: Waterfall of signal. At the bottom is signal on new antenna. The noise level is low (blue), but the signal is faint (center yellow). At the top is signal on old antenna. The noise level is high (yellow on sides). The useful signal is relative clear (center orange). At 17:48:30 the center line becomes zigzag. It is moment when satellite has passed the roof.
