PROPERTY INSPECTION REPORT

KLM ENTERPRISES, LLC
GOLDEN HOME INSPECTION SERVICES

Summary of Home Inspection Findings

RE: 17908 8th Ave NE
Shoreline, WA 98155

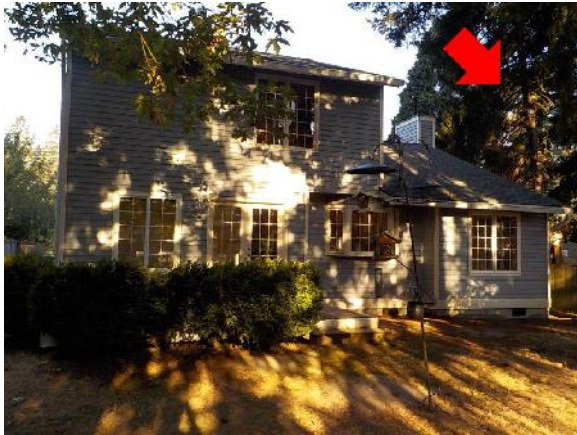
5.2 Trees:

There are tall trees present around the house. Determining if trees are a potential hazard to the structure is outside the scope of inspection unless the hazard seems obvious. When there are tall trees or potentially damaging trees around the structure it would be prudent to have further evaluation of any possible risk by a licensed, insured tree specialist or arborist. Left and back side.

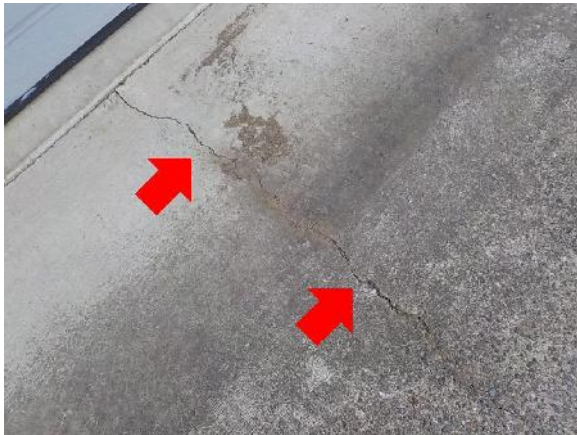
5.4 Cracks:

Typical driveway cracking is seen. Small cracks are typical and expected and it is part of normal maintenance to keep them filled and sealed to prevent worsening from freeze thaw action.

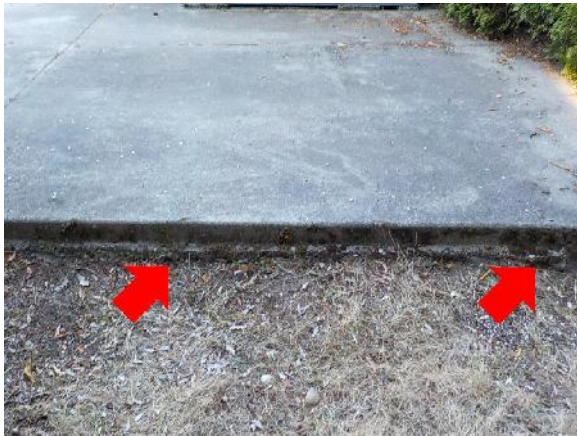
5.6 Undermining:

Walkway is starting to undermine: This condition may cause eventual deflection and damage to the walkway. A landscape contractor may be able to suggest remedies to stabilize the soil and fill in any voids under the concrete. A licensed concrete contractor may also be helpful in evaluating and correcting the condition. Seen on the left side. Use caution not to trip.

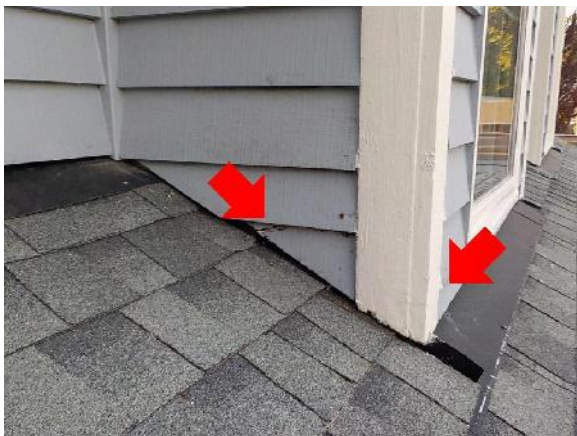
5.9 Other:

Other siding and trim condition issues are seen: Some minor damage is seen at the lower left corner of the left side dormer. Maintenance repair is indicated.

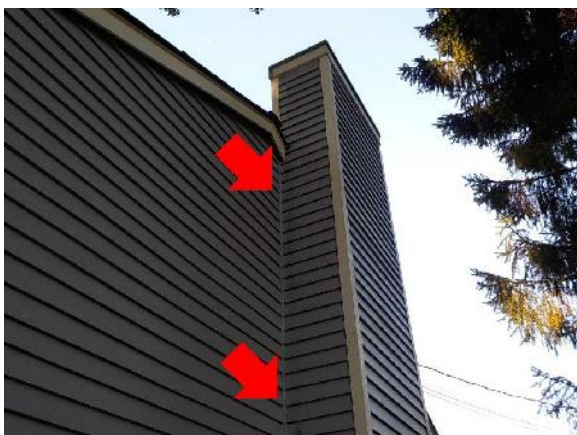
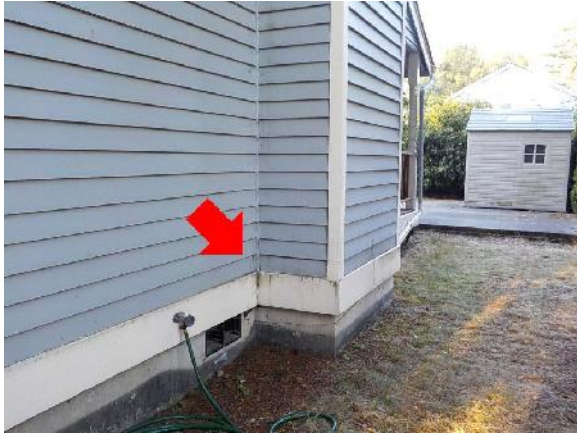
5.11 Mildew-Like Staining:

There is a mold/mildew-like material on the siding/eaves. This is a common finding, especially in eaves and on the North side of the house. Keeping the siding clean of molds and mildews is a typical maintenance issue and is important to maintain the integrity of wood or composite wood sidings. Minor Seen on the side of the wood chase.

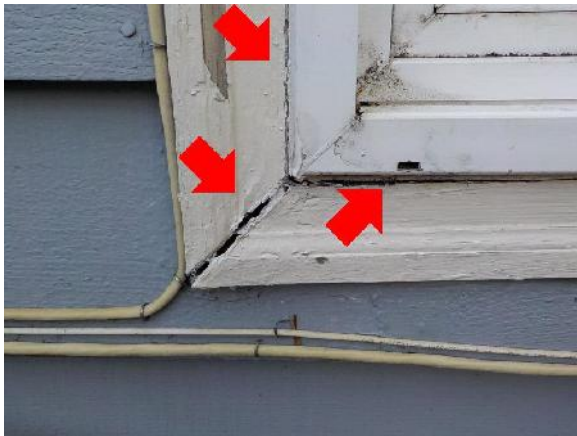
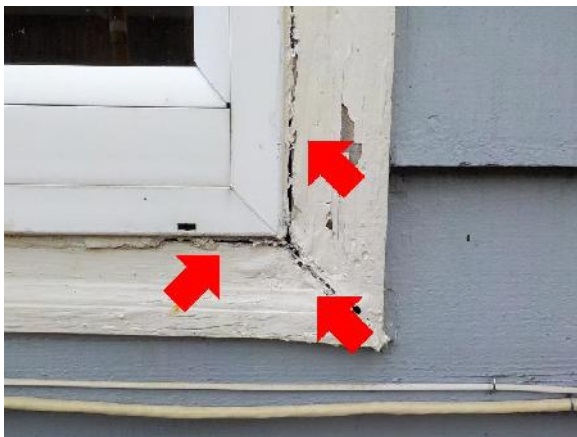
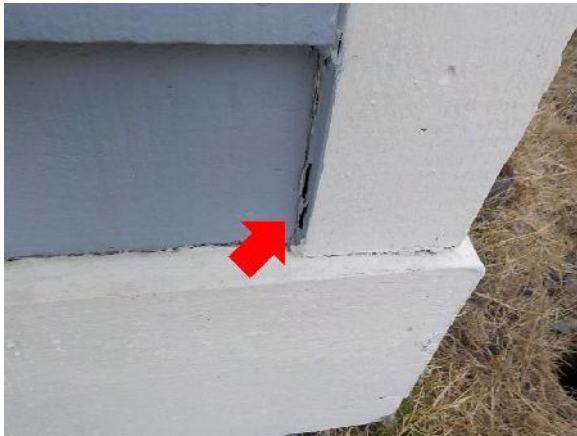
5.12 Caulking:

There is some failure of the exterior caulking: Caulking around exposed penetrations such as doors, windows, nail heads, butt joints of lap siding, etc., is a normal and extremely important maintenance task which needs to be performed on a regular basis. It is also extremely important to maintain caulking along the top edge of any horizontal trim boards, or belly boards. Failure to maintain caulking may result in rapid deterioration of composite wood sidings and trim. Always use a high quality paint-able caulk such as OSI Quad. Seen at all the windows on the South side and scatters in other areas.

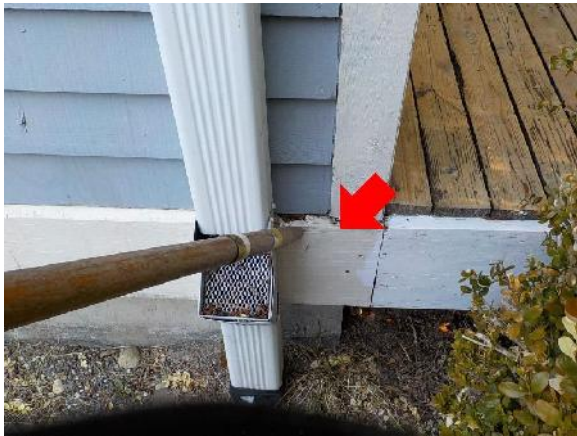
Siding and/or trim damage is seen. Recommend a licensed contractor evaluate and repair as needed. Be aware that depending on location, hidden conditions may exist that may not be discovered without destructive discovery. Damage was seen in the following area(s): Belly band board: West side at corner.

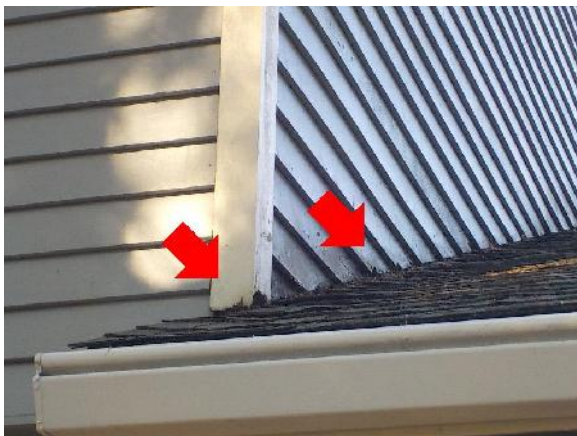
Exterior trim and lower roof to wall siding: Seen on the back side.

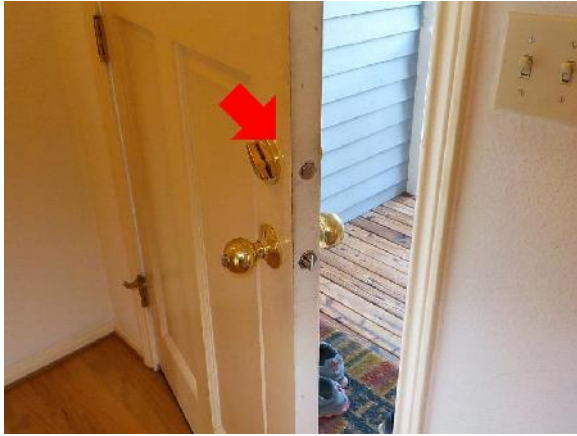
5.18 Door Hardware:

Exterior door has damaged hardware. Maintenance repair indicated. The front door deadbolt will not lock.

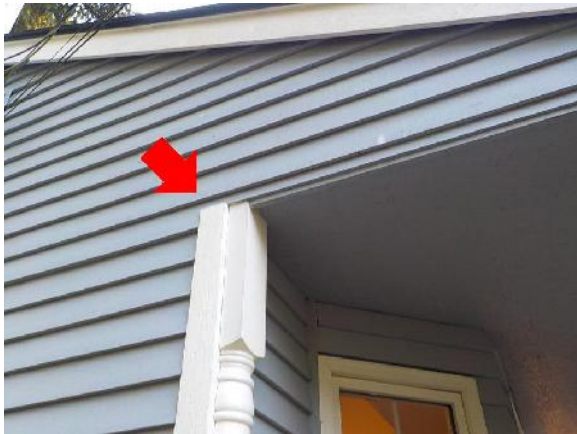
5.27 Missing Flashings:

Exterior trim has exposed end cuts present: Since the exposed end cut is susceptible to damage over time from water penetration, it will be important to keep it caulked and sealed with a high quality sealant such as OSI Quad. This was noted in the following area: Left next to porch.

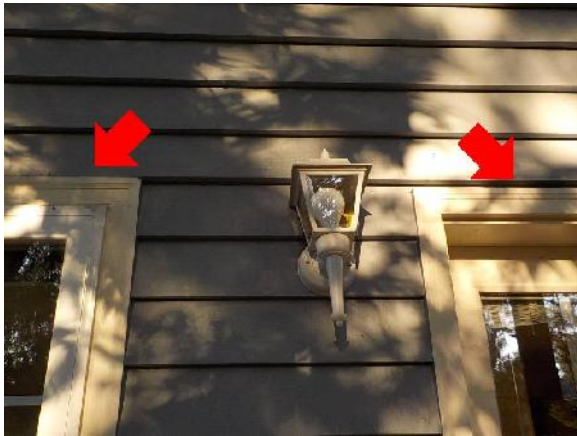
Head flashing details not seen: Exposed penetrations such as entry doors, vehicle doors, window trim, foundation vents and wood mounting blocks for exterior lights, house numbers and faucets can be susceptible to water penetration. With no head flashing detail present and no reasonable way to install one on a retrofit basis, it will be important to keep these areas caulked with a high quality sealant such as OSI Quad. This was noted in the following area: Exposed window(s), Garage door. Only seen on South side windows and doors.

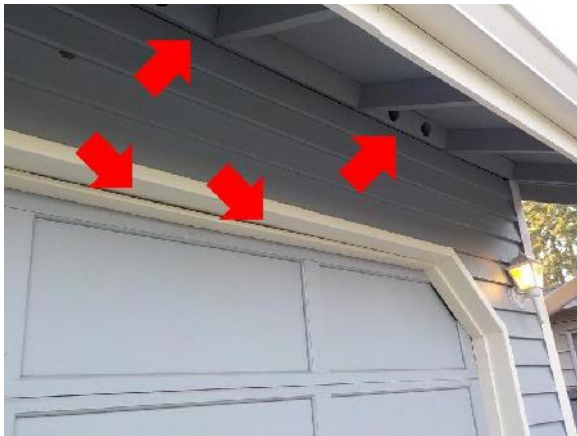
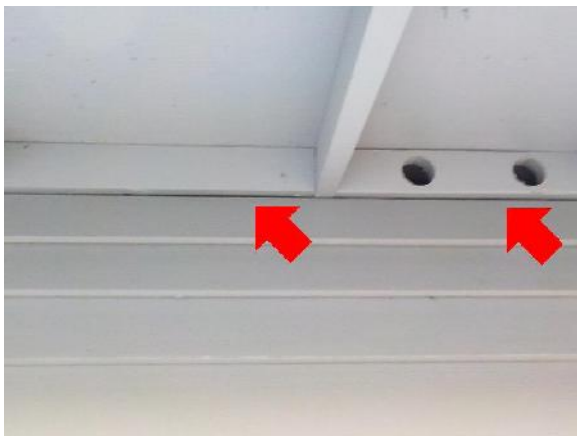
5.28 Siding Gaps or Voids:

Gaps or openings seen in the siding/trim: These may offer pathways for insects, vermin and birds to enter and depending on location, could also allow water penetration. Repair is suggested. Gaps or voids were seen in the following area: The eaves in front of the garage doors and a piece of trim on the garage framing.

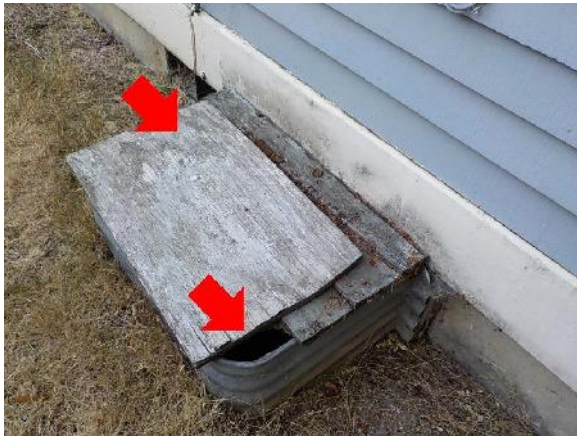
5.29 Crawl Space Access::

The crawl space access lid is inadequate or does not fit properly: The lid should be repaired or a proper lid should be constructed and installed suitable to keep animals, vermin and weather out of the crawl space. There is also missing framing and decay seen on some of the wood covering.

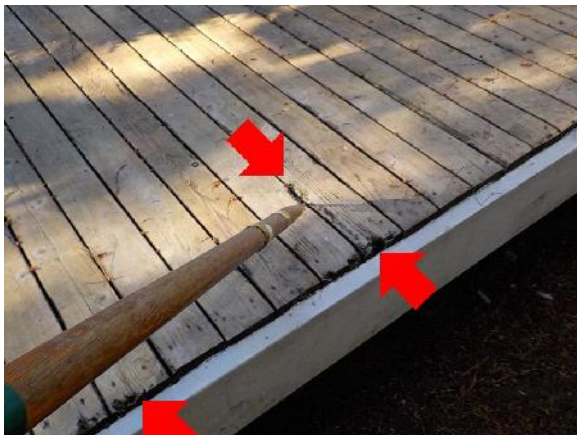
6.3 Deck Decay:

Deck has rot damage present. Recommend a contractor evaluate and repair. Be aware that depending on location, further hidden damages may be discovered. Deck boards. scattered, minor.

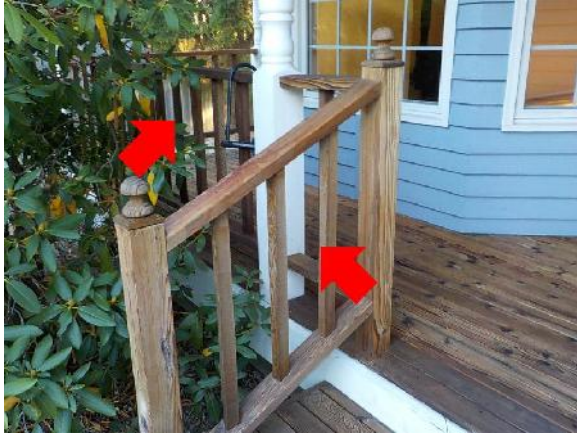
Conditions related to the deck guard rail balusters are seen: Some or all balusters are >4 inches apart. Be aware that more widely gapped stair or handrail spindles may represent some risk to small children who could become stuck or fall through. Caution is advised. On taller decks where the risk of injury is greater, correction or

modification is advised. Front entry.

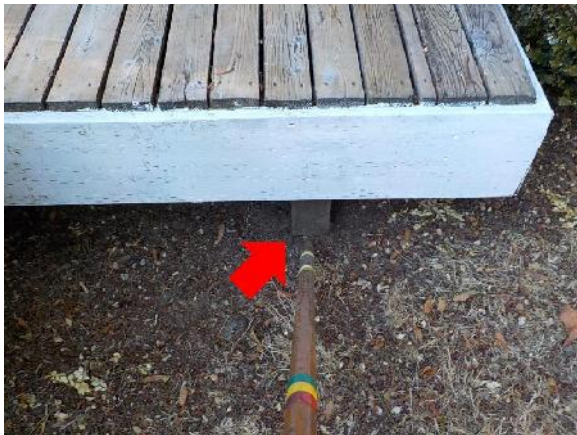
Earth to wood contact is seen: This includes, but is not limited to soil, decorative bark, gravel, rock, or other landscape materials. Where possible, provide for a minimum 4 - 6 inch clearance between all siding materials, structural members and the earth. Framing members such as stair risers or supports should land on concrete piers or pads to protect them from damage. Hidden conditions such as damage or infestation may exist and should be reported to the inspecting firm. Earth wood contact was noted with the following: Deck framing.

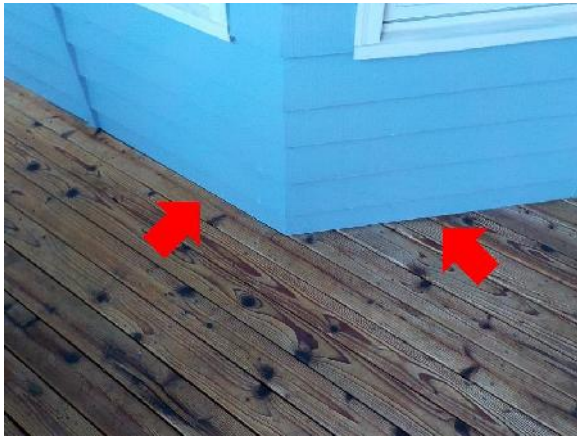
6.11 Deck Flashings:

The wood deck lacks a flashing detail where it attaches to the structure. Where a deck is exposed to the weather, a flashing detail should be installed as an upgrade to protect the deck ledger board and siding behind it. Be aware that on older structures, hidden conditions may exist. Front and back decks.

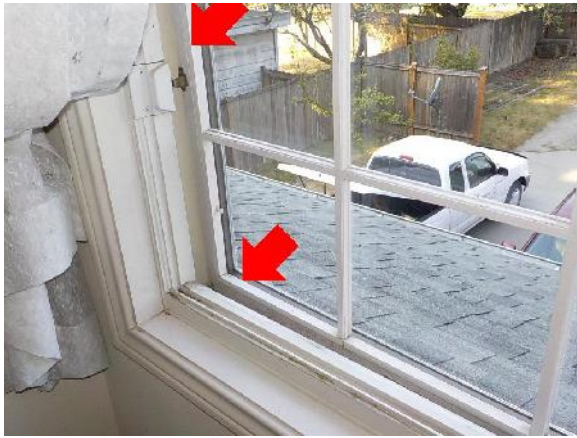
Other window operation conditions exist: The upper left side bedroom dormer window will not close. Further evaluation and repair is indicated.

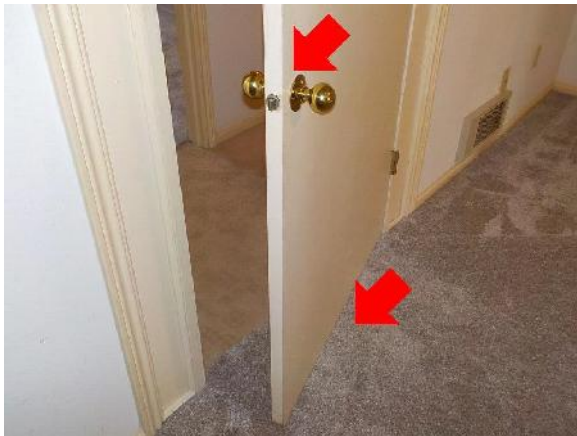
Other interior door operation conditions exist: The master bedroom door binds. Both the master bedroom door and adjacent bedroom and closet doors rub on the new carpet installed. Maintenance repair is indicated.

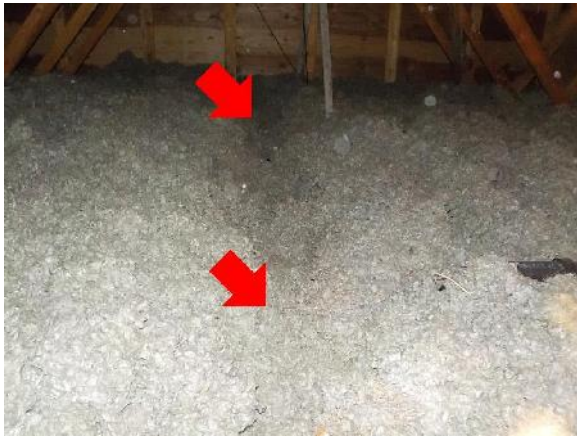
Attic insulation is uneven or compressed: This often occurs over time from settling or from people accessing the attic space for various reasons. This may promote heat loss in the areas where the insulation has been compromised. Recommend repair for energy conservation.

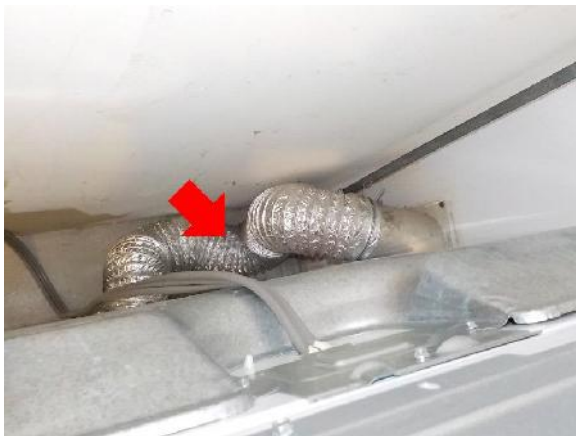
The clothes dryer duct is older flexible type: Newer standards require clothes dryer ducts to be smooth wall pipe as the flexible type tends to trap lint and debris which can cause blockage. Suggest changing to smooth wall pipe as a future safety upgrade. Regular duct cleaning is also advised as trapped lint may constitute a fire hazard.

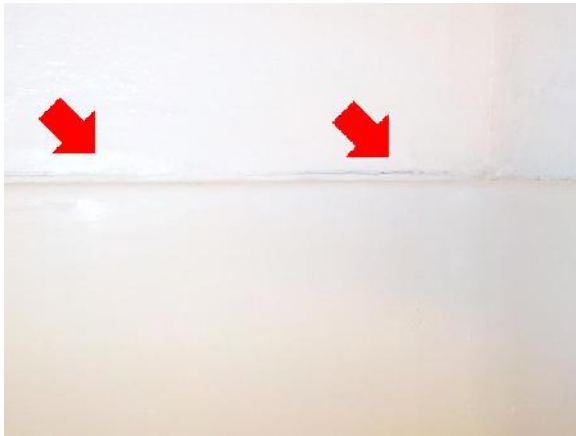
The caulking or grout on the tub or shower surround is failing. Maintenance repair indicated. Upper portion of the shower surround. Master bathroom.

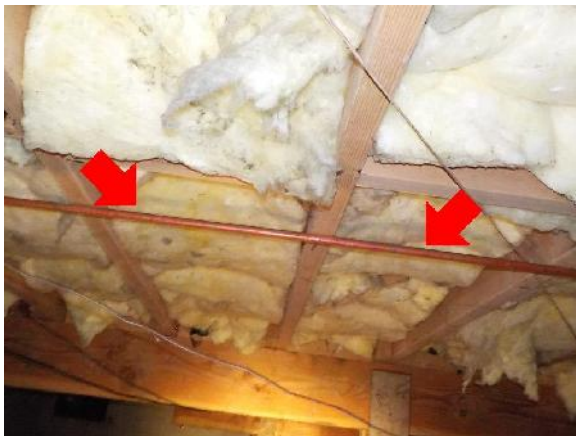
The main plumbing line and/or supply lines are not insulated: Recommend wrapping all pipes for efficiency and to prevent possible freeze damage. Seen in crawl and garage.

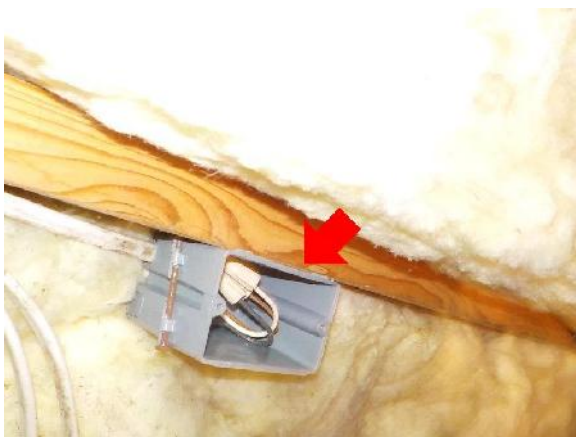
Missing electric junction box covers are noted: Junction boxes should always have covers in place. Correction indicated. This was noted in the following area: Seen in crawl space.

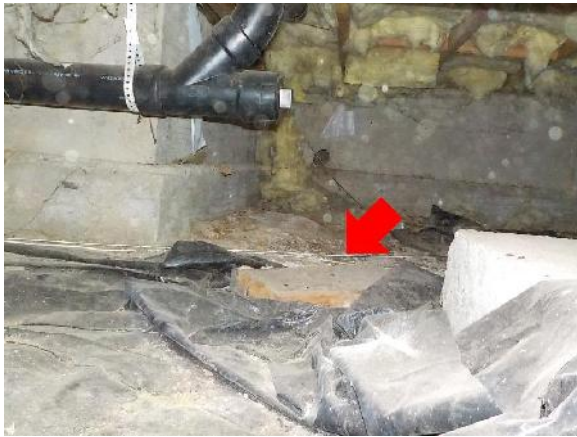
Conductive debris is present in the crawl space: All rake-able sized conductive debris should be removed from the crawl space. Fallen/damaged insulation should be re-installed or replaced. If present, cardboard footing forms should be removed as best as able. Debris present included: Wood scraps.

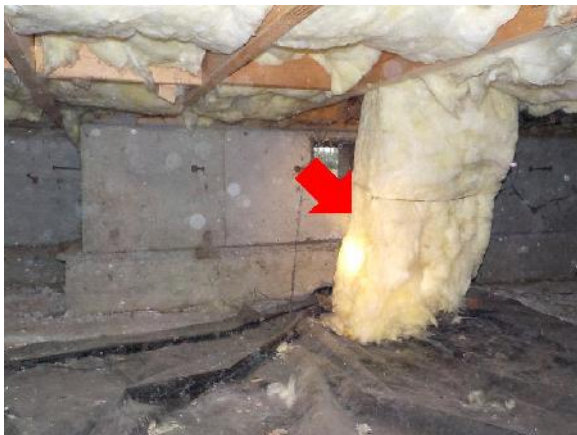
17.12 Insulation:

There is fallen or damaged insulation in the crawl space. This is also considered to be debris which is conducive to the infestation of wood destroying insects. Damaged or fallen insulation should be removed or restored as needed. Minimal.

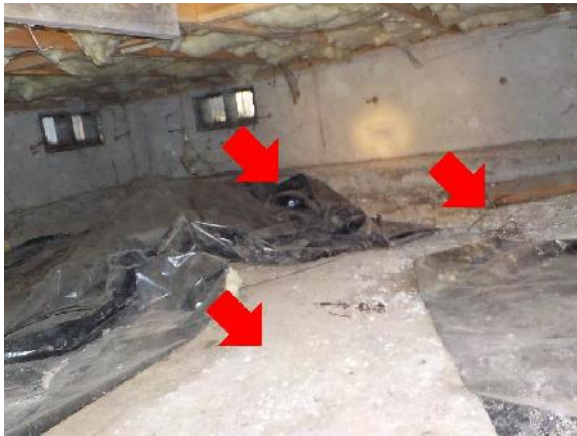
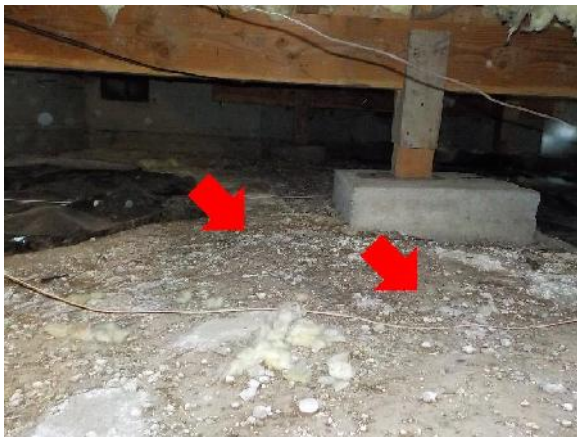
17.13 Vapor Barrier:

Crawl space has inadequate and/or damaged vapor barrier. Re-spread existing crawl space vapor barrier as able and install additional 6 mil black plastic vapor barrier as needed to meet current building requirements with provision for appropriate overlap at seams, (12 inches). Seen scattered in the crawl, may have been cause by people in crawl running cables. Re-spreading where required is indicated.

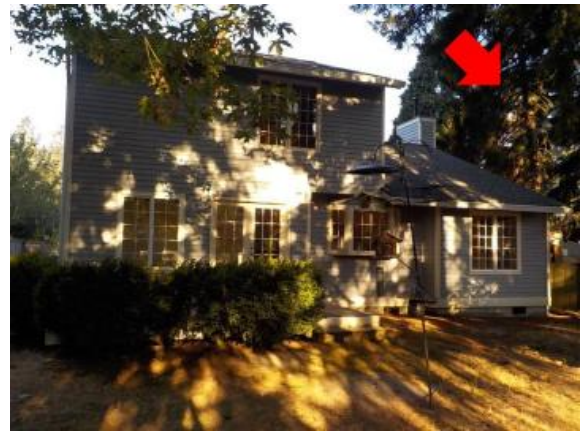
There are tall trees present around the house. Determining if trees are a potential hazard to the structure is outside the scope of inspection unless the hazard seems obvious. When there are tall trees or potentially damaging trees around the structure it would be prudent to have further evaluation of any possible risk by a licensed, insured tree specialist or arborist. Left and back side.

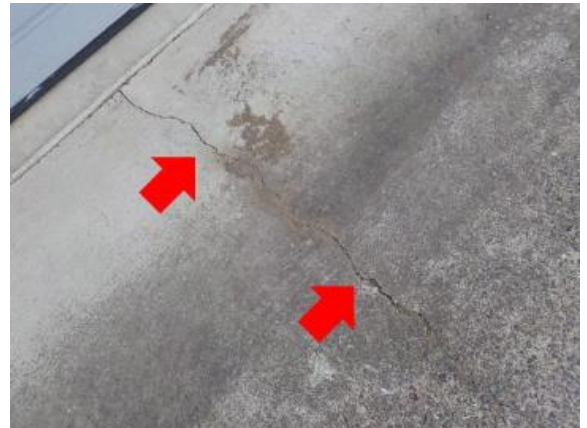
Typical driveway cracking is seen. Small cracks are typical and expected and it is part of normal maintenance to keep them filled and sealed to prevent worsening from freeze thaw action.

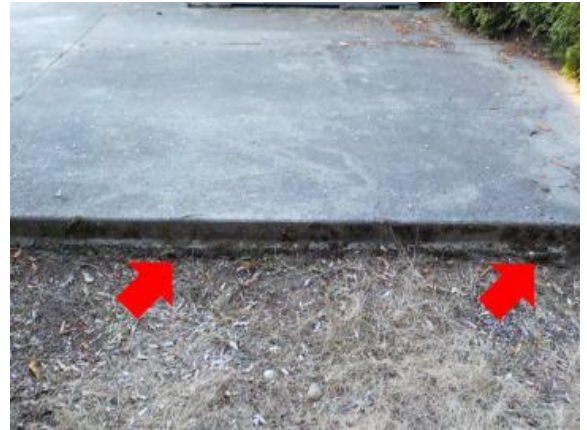
Walkway is starting to undermine: This condition may cause eventual deflection and damage to the walkway. A landscape contractor may be able to suggest remedies to stabilize the soil and fill in any voids under the concrete. A licensed concrete contractor may also be helpful in evaluating and correcting the condition. Seen on the left side. Use caution not to trip.

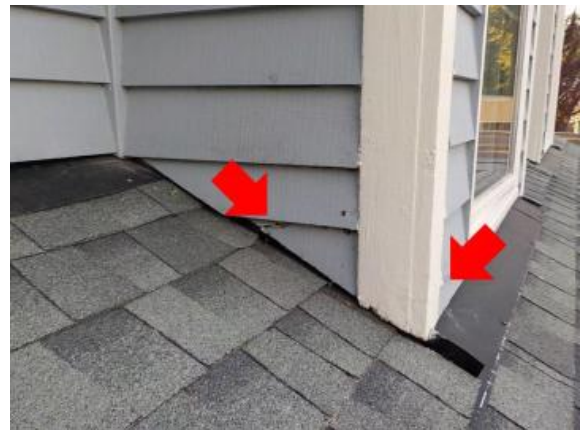
Other siding and trim condition issues are seen: Some minor damage is seen at the lower left corner of the left side dormer. Maintenance repair is indicated.

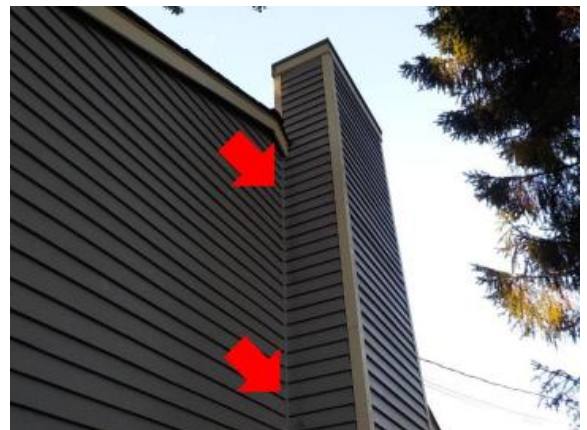
There is a mold/mildew-like material on the siding/eaves. This is a common finding, especially in eaves and on the North side of the house. Keeping the siding clean of molds and mildews is a typical maintenance issue and is important to maintain the integrity of wood or composite wood sidings. Minor Seen on the side of the wood chase.

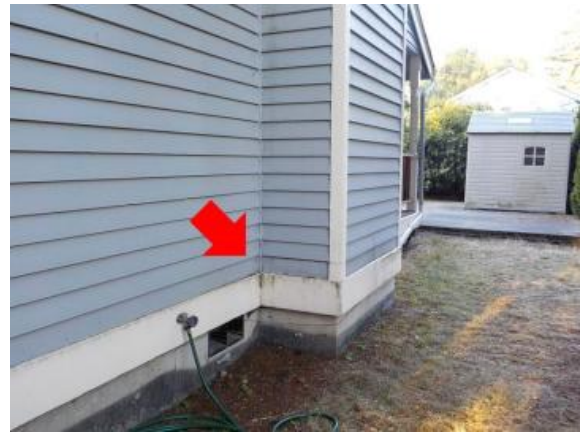
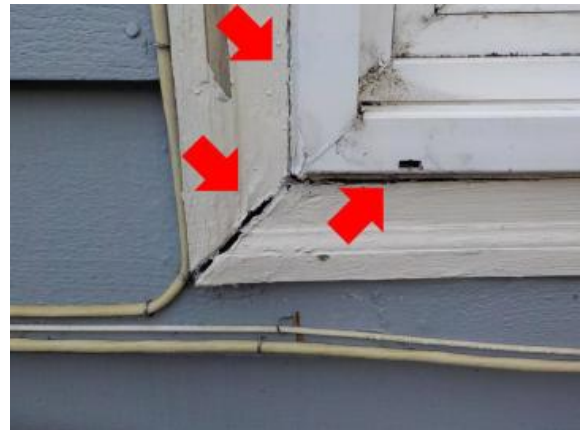
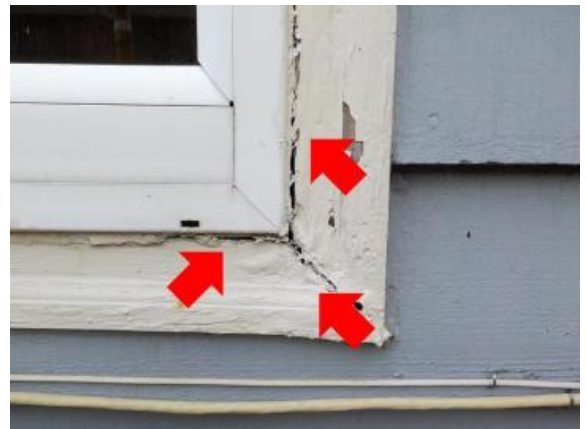
5.12 Caulking:

There is some failure of the exterior caulking: Caulking around exposed penetrations such as doors, windows, nail heads, butt joints of lap siding, etc., is a normal and extremely important maintenance task which needs to be performed on a regular basis. It is also extremely important to maintain caulking along the top edge of any horizontal trim boards, or belly boards. Failure to maintain caulking may result in rapid deterioration of composite wood sidings and trim. Always use a high quality paint-able caulk such as OSI Quad. Seen at all the windows on the South side and scatters in other areas.

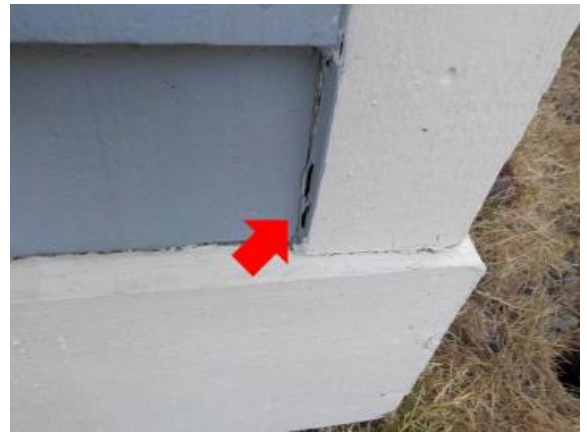
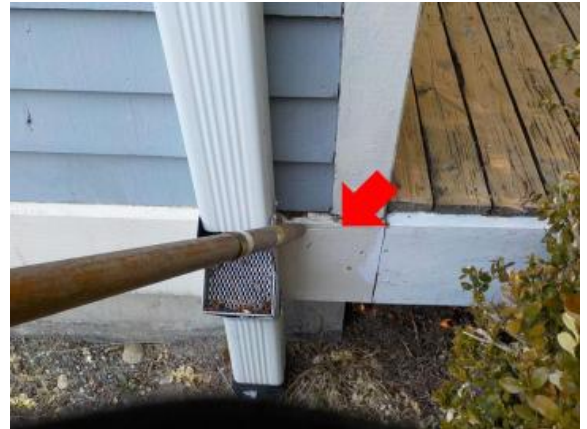
Siding and/or trim damage is seen. Recommend a licensed contractor evaluate and repair as needed. Be aware that depending on location, hidden conditions may exist that may not be discovered without destructive discovery. Damage was seen in the following area(s): Belly band board: West side at corner.

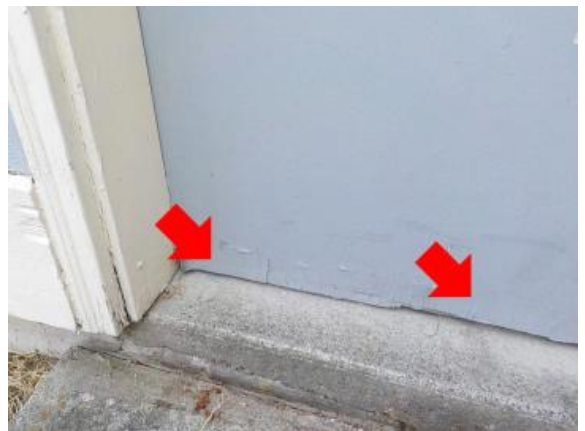
Exterior door has cosmetic damage or deterioration: Maintenance attention indicated. The side garage door, is delaminating and binds when used. Repair is indicated.

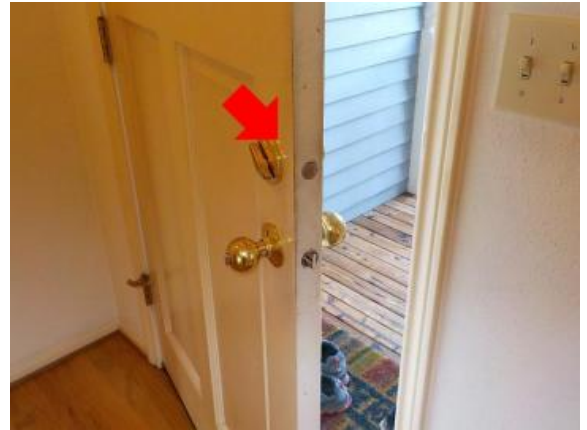
5.18 Door Hardware:

Exterior door has damaged hardware. Maintenance repair indicated. The front door deadbolt will not lock.

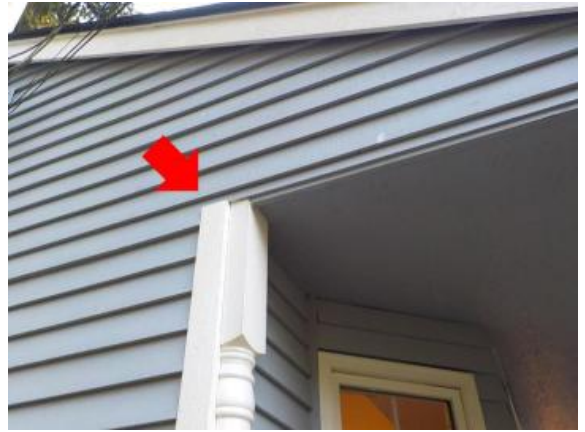
Exterior trim has exposed end cuts present: Since the exposed end cut is susceptible to damage over time from water penetration, it will be important to keep it caulked and sealed with a high quality sealant such as OSI Quad. This was noted in the following area: Left next to porch.

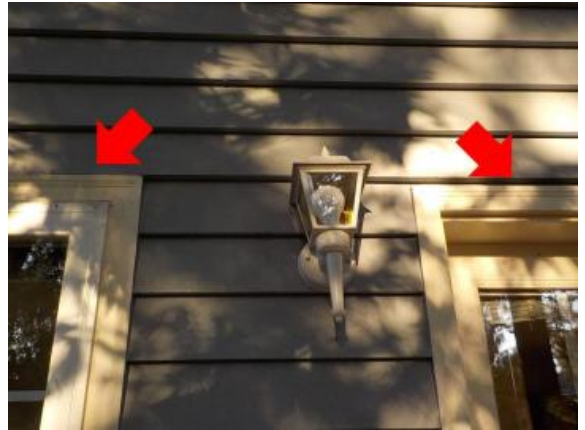
Head flashing details not seen: Exposed penetrations such as entry doors, vehicle doors, window trim, foundation vents and wood mounting blocks for exterior lights, house numbers and faucets can be susceptible to water penetration. With no head flashing detail present and no reasonable way to install one on a retrofit basis, it will be important to keep these areas caulked with a high quality sealant such as OSI Quad. This was noted in the following area: Exposed window(s), Garage door. Only seen on South side windows and doors.

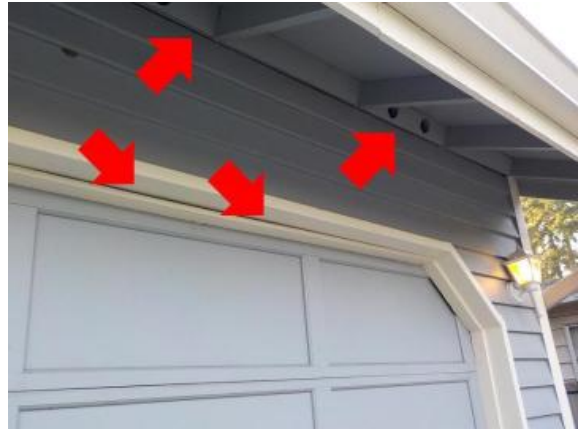
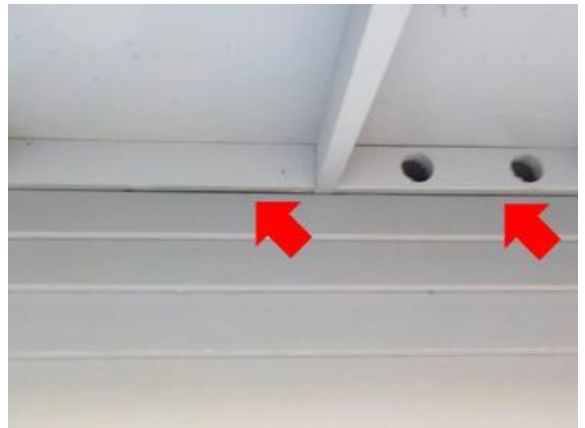
5.28 Siding Gaps or Voids:

Gaps or openings seen in the siding/trim: These may offer pathways for insects, vermin and birds to enter and depending on location, could also allow water penetration. Repair is suggested. Gaps or voids were seen in the following area: The eaves in front of the garage doors and a piece of trim on the garage framing.

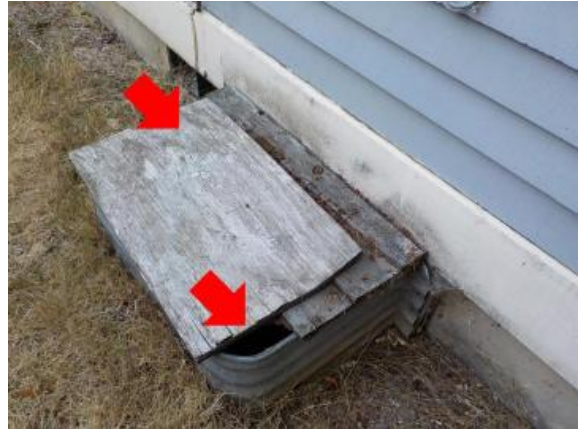
5.29 Crawl Space Access::

The crawl space access lid is inadequate or does not fit properly: The lid should be repaired or a proper lid should be constructed and installed suitable to keep animals, vermin and weather out of the crawl space. There is also missing framing and decay seen on some of the wood covering.

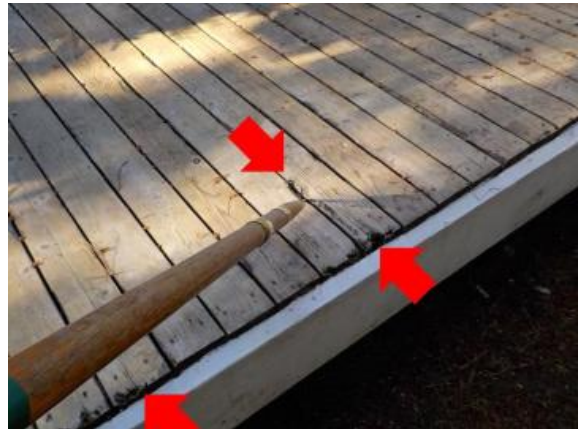
Recommend a contractor evaluate and repair. Be aware that depending on location, further hidden damages may be discovered. Deck boards. scattered, minor.

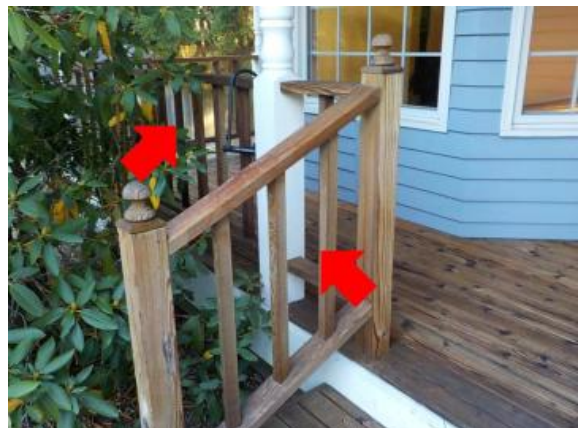
Some or all balusters are >4 inches apart. Be aware that more widely gapped stair or handrail spindles may represent some risk to small children who could become stuck or fall through. Caution is advised. On taller decks where the risk of injury is greater, correction or modification is advised. Front entry.

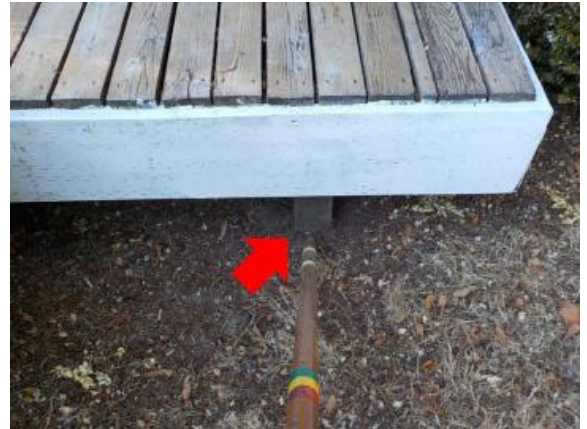
This includes, but is not limited to soil, decorative bark, gravel, rock, or other landscape materials. Where possible, provide for a minimum 4 - 6 inch clearance between all siding materials, structural members and the earth. Framing members such as stair risers or supports should land on concrete piers or pads to protect them from damage. Hidden conditions such as damage or infestation may exist and should be reported to the inspecting firm. Earth wood contact was noted with the following: Deck framing.

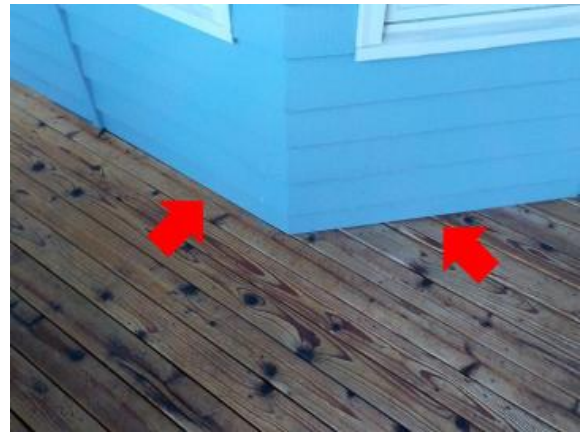
6.11 Deck Flashings:

The wood deck lacks a flashing detail where it attaches to the structure. Where a deck is exposed to the weather, a flashing detail should be installed as an upgrade to protect the deck ledger board and siding behind it. Be aware that on older structures, hidden conditions may exist. Front and back decks.

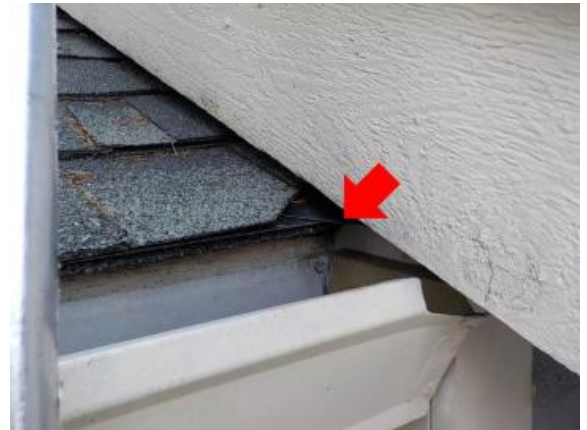
Roof kick out flashing is missing or inadequate. Where the gutter edge of a roof meets a wall, the last sidewall flashing above the gutter end should be installed in a special manner so that water from the roof is directed into the gutter instead of over, or behind, the siding. This is called a kick out flashing. Be aware hidden conditions may exist. Caulking alone is not an acceptable substitute as it will fail over time. Correction is recommended. This was noted in the following area: Seen at front over entry.

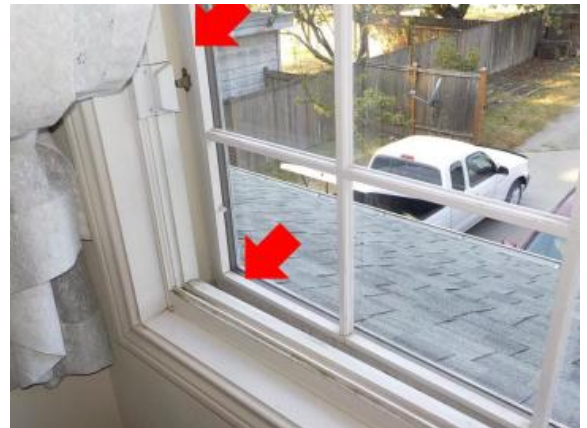
Other window operation conditions exist: The upper left side bedroom dormer window will not close. Further evaluation and repair is indicated.

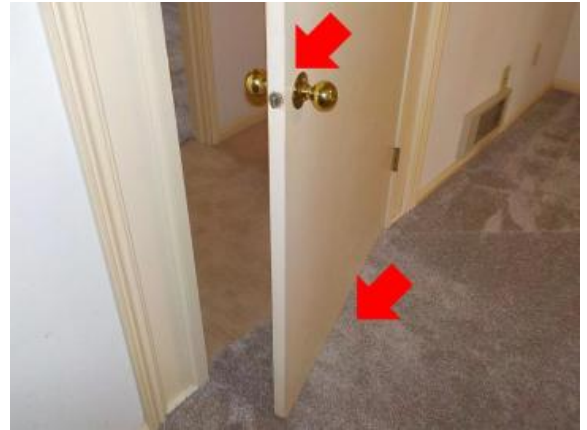
Other interior door operation conditions exist: The master bedroom door binds. Both the master bedroom door and adjacent bedroom and closet doors rub on the new carpet installed. Maintenance repair is indicated.

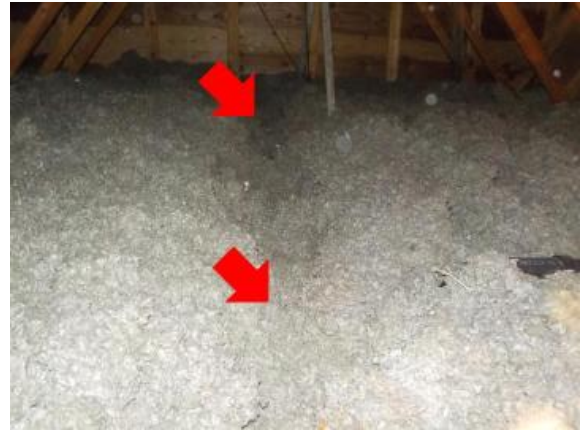
Attic insulation is uneven or compressed: This often occurs over time from settling or from people accessing the attic space for various reasons. This may promote heat loss in the areas where the insulation has been compromised. Recommend repair for energy conservation.
