MOLD INSPECTION AND TESTING REPORT

CLIENT	Alefiyah Rajabali
PROPERTY ADDRESS	12177 NW Fernleaf Ln ~ Portland, Oregon 97229
DATE OF INSPECTION	Wednesday, August 4, 2021

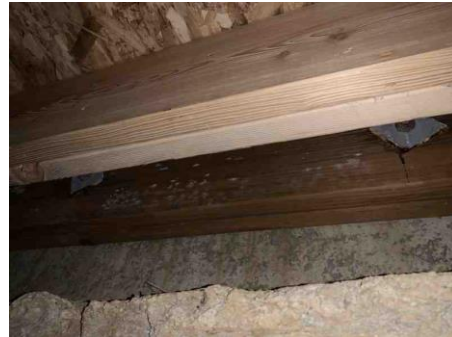
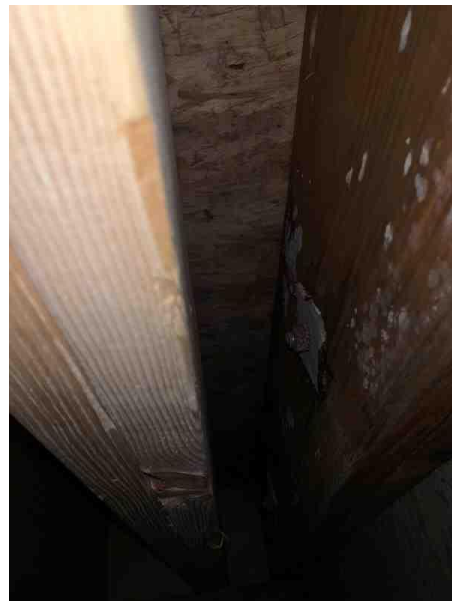
FRONT CRAWLSPACE (FLOOR JOISTS) [SOUTH]

Evidence of mold-like growth was observed.

Mold like growth was observed at floor joists and subfloor materials in the front Crawlspace Area Below the garage.

Moisture Content: **Wet**

Humidity this area: **70%**
Humidity Outdoor: **61%**

Area Affected: **Subfloor and floor Framing below the Garage**

Suspected source(s)/cause(s):
Humidity / condensation due to indadequate ventilation

*** Humidity level for this area is above the ASHRAE recommended level for habitable spaces. Preferable level is between 30% and 60%.**

Room/Area	Location within Room/Area and/or Affected Materials
Front Crawlspace	Mold Impacted and Water Damaged Materials. Mold growth was confirmed at the Floor Joists and Subfloor, and additional hidden mold growth is possible. Work area should be isolated with use of containment barriers. Negative air should be established with use of HEPA filtered negative air machines. All insulation should be removed. The existing vapor barrier should be removed. All loose building materials / debris should be removed. Any water damaged and/or mold impacted structural materials should be properly HEPA vacuumed, scrubbed/cleaned, and then HEPA vacuumed again. A sealed vapor should be installed. Entire work area should be HEPA vacuumed and wet wiped. HEPA air filtration should run for a minimum of 24 hours after the work is complete. If during removal additional mold sources/water damage is noted, remediation/removal should continue until 12” past the last impacted area wherever feasible.

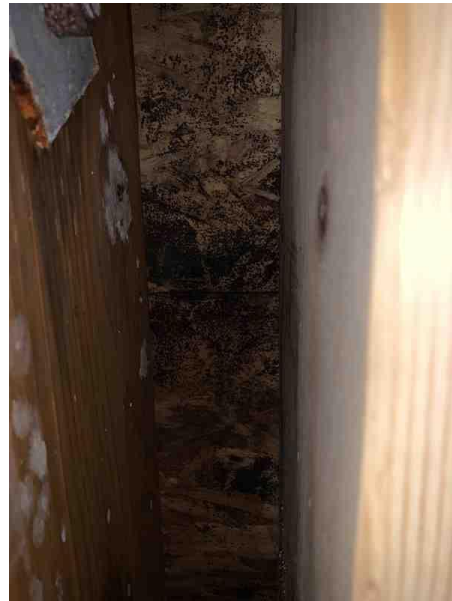
**FRONT CRAWLSPACE (SUBFLOOR)
[SOUTH]**

Evidence of mold-like growth was observed.

Moisture Content: **Wet**

Humidity this area: **70%**

Humidity Outdoor: **61%**

Area Affected: **Subfloor materials in several areas.**

Suspected source(s)/cause(s):
Humidity / condensation due to inadequate ventilation

*** Humidity level for this area is above the ASHRAE recommended level for habitable spaces. Preferable level is between 30% and 60%.**

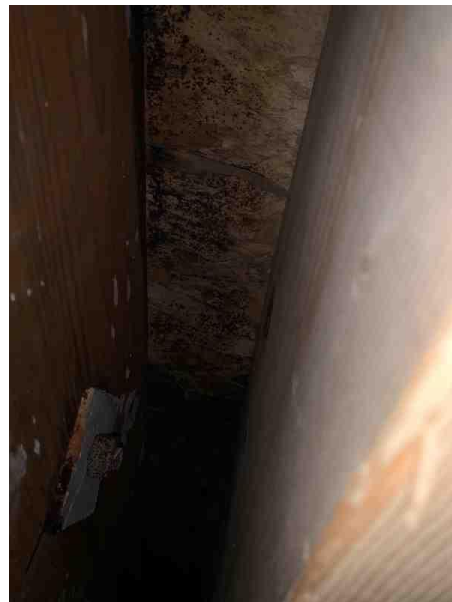
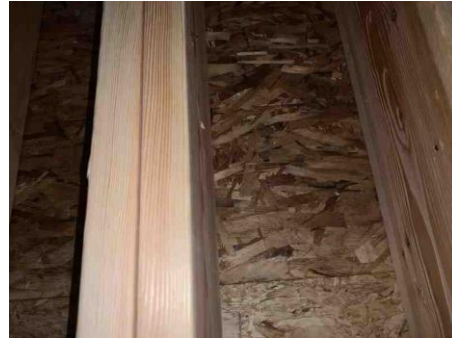
Mold like growth observed at sub floor materials.

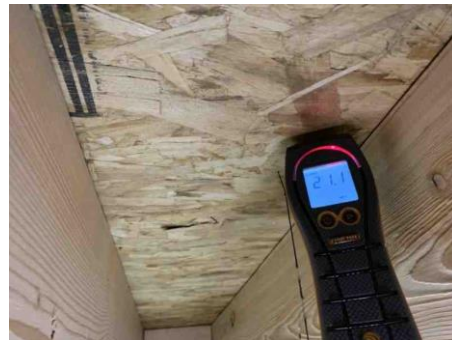
FRONT CRAWLSPACE [SOUTH]

Wet Building materials noted

Moisture Content: **Wet**

Suspected source(s)/cause(s):
Humidity / condensation due to inadequate ventilation and/or previous exterior water intrusion.

*** Humidity level for this area is above the ASHRAE recommended level for habitable spaces. Preferable level is between 30% and 60%.**

- FRONT CRAWLSPACE (FLOOR JOISTS BELOW GARAGE)

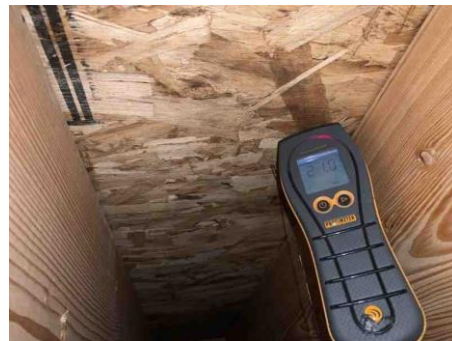
The subfloor below the garage is actively wet and retaining moisture

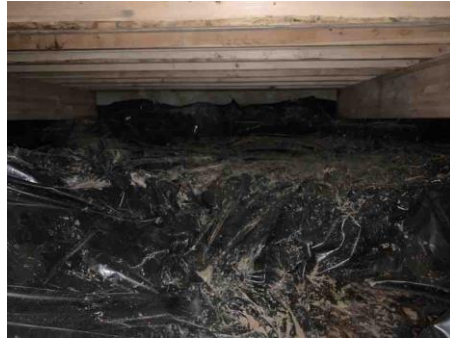
FRONT CRAWLSPACE [SOUTH]

Water damage - Moisture damage or staining observed in this area.

Humidity this area: 70%
Humidity Outdoor: 61%

Suspected source(s)/cause(s):
Previous exterior moisture intrusion

*** Humidity level for this area is above the ASHRAE recommended level for habitable spaces. Preferable level is between 30% and 60%.**

Dry moisture stains were observed on the vapor barrier below the garage indicating previous water intrusion.

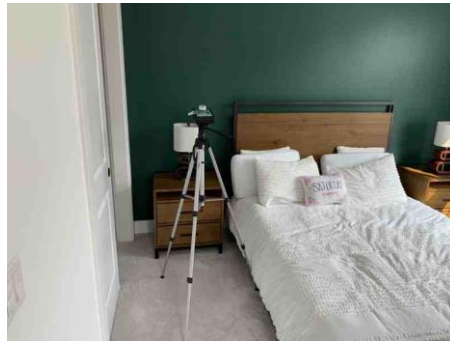
MAIN LEVEL GUEST BEDROOM [SOUTH]

Possible cross contamination from the affected Crawlspace.

Moisture Content: **Dry**

Humidity this area: 42%
Humidity Outdoor: 61%

A cross contamination air sample was collected in the main level bedroom or the access to the front Crawlspace is located.

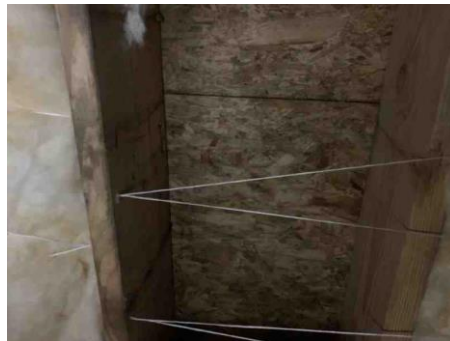
REAR CRAWLSPACE (SUBFLOOR-WEST)

Evidence of mold-like growth was observed.

Moisture Content: **Dry**

Humidity this area: 72%
Humidity Outdoor: 61%
Area Affected: **Subfloor in multiple areas**

Suspected source(s)/cause(s):
Humidity / condensation

*** Humidity level for this area is above the ASHRAE recommended level for habitable spaces. Preferable level is between 30% and 60%.**

Rear Crawlspace	Mold Impacted and Water Damaged Materials. Mold growth was confirmed at the Subfloor-West and Subfloor-East, and additional hidden mold growth is possible. Work area should be isolated with use of containment barriers. Negative air should be established with use of HEPA filtered negative air machines. All insulation should be removed. The existing vapor barrier should be removed. All loose building materials / debris should be removed. Any water damaged and/or mold impacted structural materials should be properly HEPA vacuumed, scrubbed/cleaned, and then HEPA vacuumed again. A sealed vapor should be installed. Entire work area should be HEPA vacuumed and wet wiped. HEPA air filtration should run for a minimum of 24 hours after the work is complete. If during removal additional mold sources/water damage is noted,

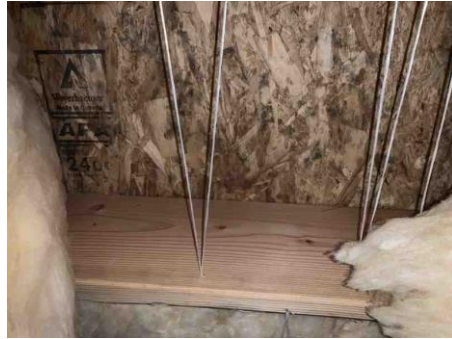
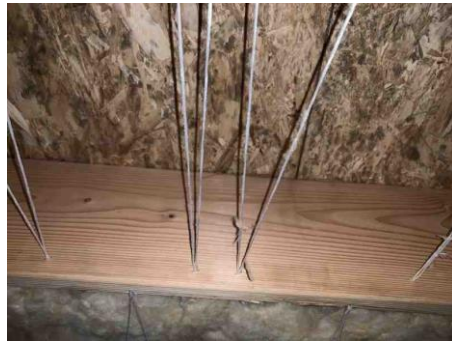
Mold like growth observed at subfloor materials.

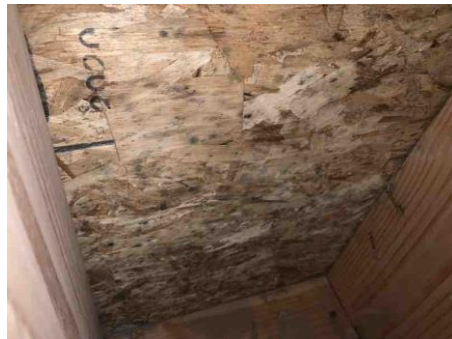
REAR CRAWLSPACE (SUBFLOOR-EAST)

Evidence of mold-like growth was observed.

Moisture Content: **Dry**

Humidity this area: **72%**
Humidity Outdoor: **61%**

Suspected source(s)/cause(s):
Humidity / condensation

*** Humidity level for this area is above the ASHRAE recommended level for habitable spaces. Preferable level is between 30% and 60%.**

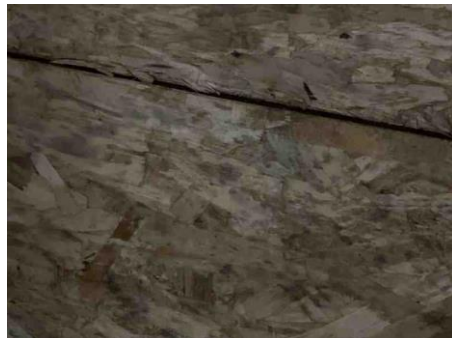
Mold-like growth observed at subfloor materials.

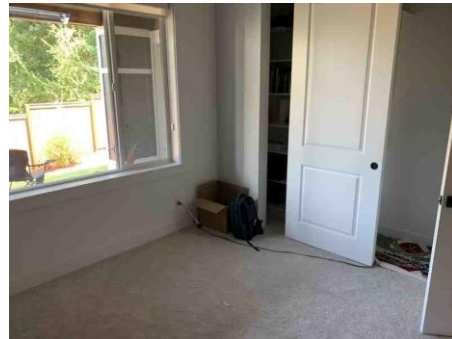
**LOWER LEVEL BEDROOM
[NORTHWEST]**

Possible cross contamination from the affected Crawlspace.

Moisture Content: **Dry**

Humidity this area: **52%**

A cross-contamination air sample was collected in the Lower-Level Bedroom due to mold- like growth conditions observed in the Crawlspace.

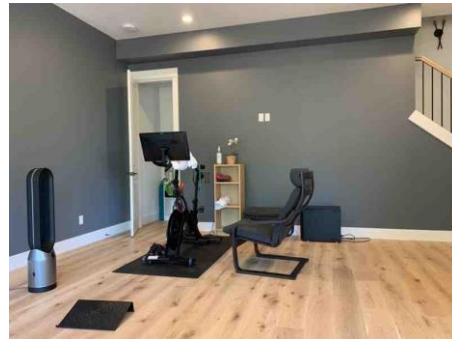
**LOWER LEVEL FAMILY ROOM
[NORTH]**

Possible cross contamination from the affected Crawlspace.

Moisture Content: **Dry**

Humidity this area: **53%**

A cross-contamination air sample was collected in the Lower Level Family Room.

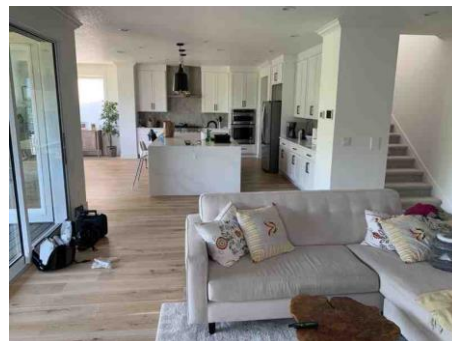
MAIN LEVEL LIVING ROOM

Possible cross contamination from the affected Crawlspaces.

Moisture Content: **Dry**

Humidity this area: **53%**

A cross contamination air sample was collected in the Main Level Living Room.

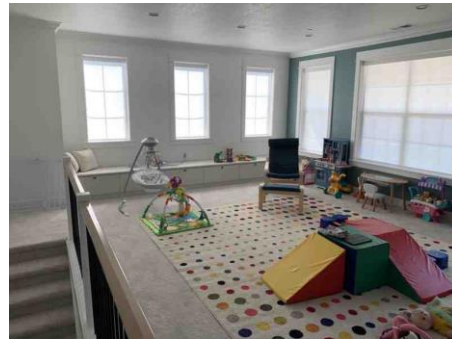
**UPPER LEVEL BONUS ROOM
[SOUTHEAST]**

Possible cross contamination from the affected Crawlspace.

Moisture Content: **Dry**

Humidity this area: **53%**

A cross contamination air sample was collected in the Upper Level Bonus Room.

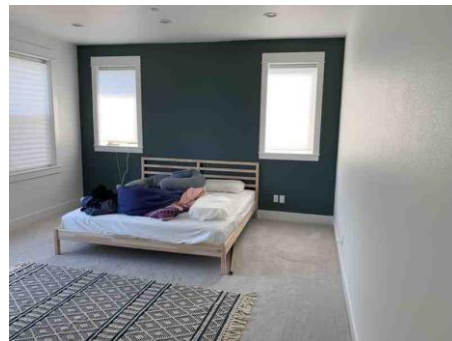
PRIMARY BEDROOM [NORTHEAST]

Possible cross contamination from the affected Crawlspace.

Moisture Content: **Dry**

Humidity this area: **52%**

A cross contamination air sample was collected in the Primary Bedroom.
