Corrosion Inspection Report

Image: img12_jpg.rf.dc930f9232a7310521fc6c7648c219a0.jpg

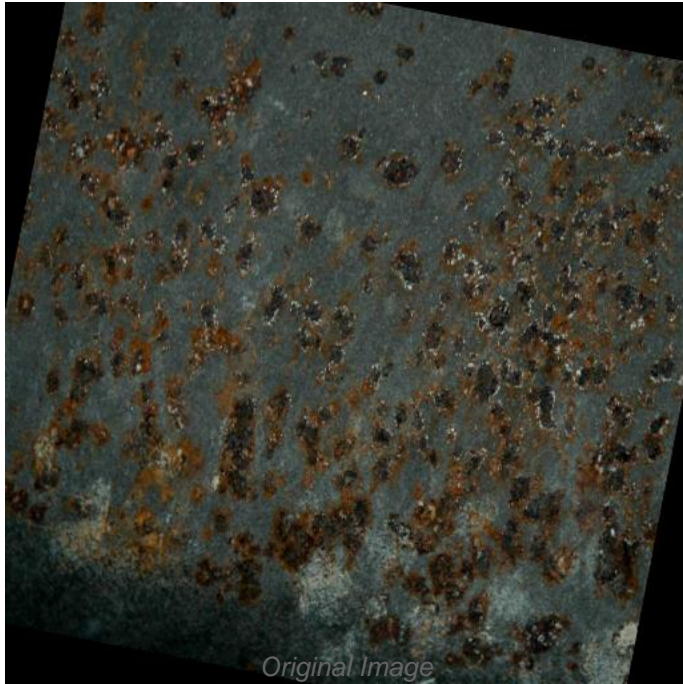
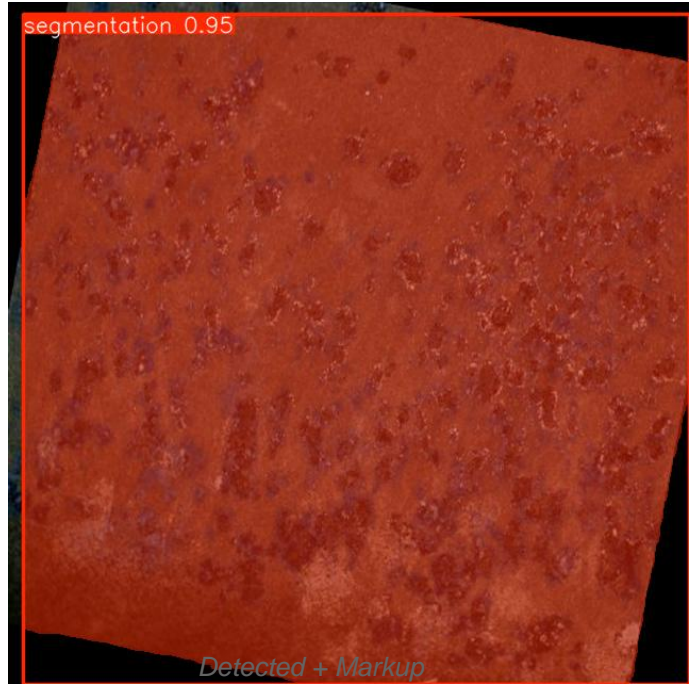
Detection Result:

(1 spot(s))

High=1, Medium=0, Low=0
