Corrosion Inspection Report

Report: bolt inspection 24.08.2025

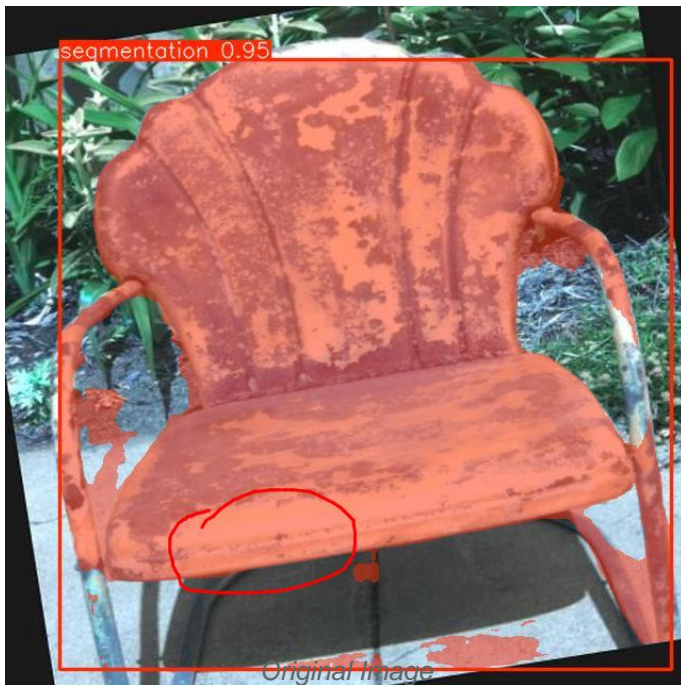
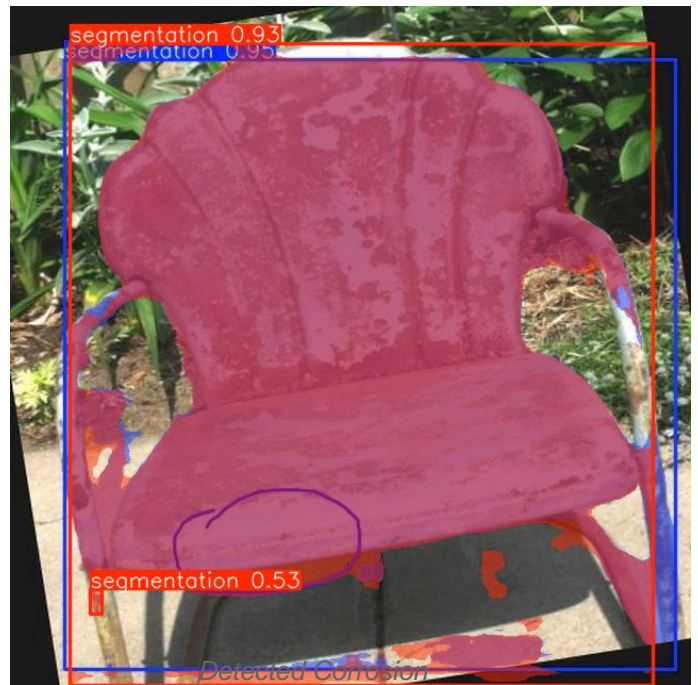
Image: marked_result_251e6916.jpg

Corrosion Detected: PASS (2 spot(s))

Severity: High=1, Medium=1, Low=0

pipe
