Corrosion Inspection Report

Image: img12_jpg.rf.d66cb1ddd828dc75d6e7119890ac9186.jpg

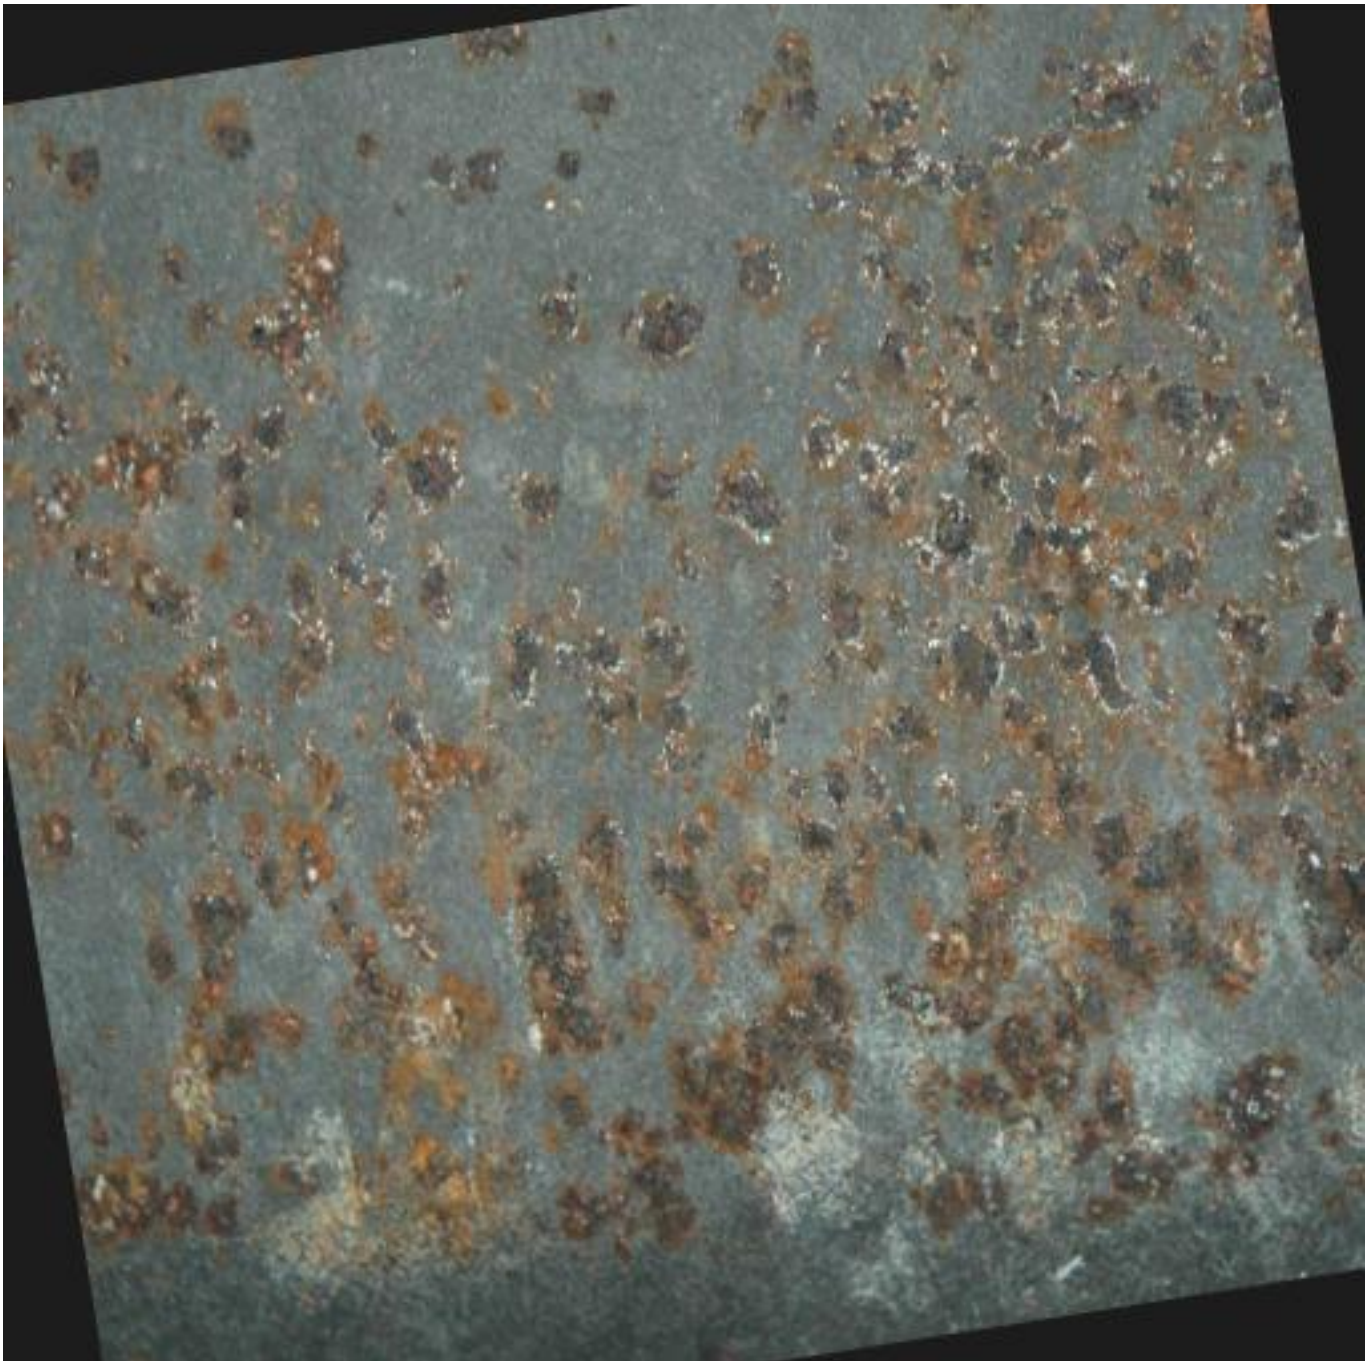
Original Image

Corrosion Detected: PASS (1 spot(s))

Severity: High=0, Medium=0, Low=1
