# CorrosionGuard AI

## Corrosion Inspection Report

Image: img61\_jpg.rf.3667f0e26a65e2eea99049744b6601aa.jpg

Time: 2025-08-23 09:56:20 (MYT)

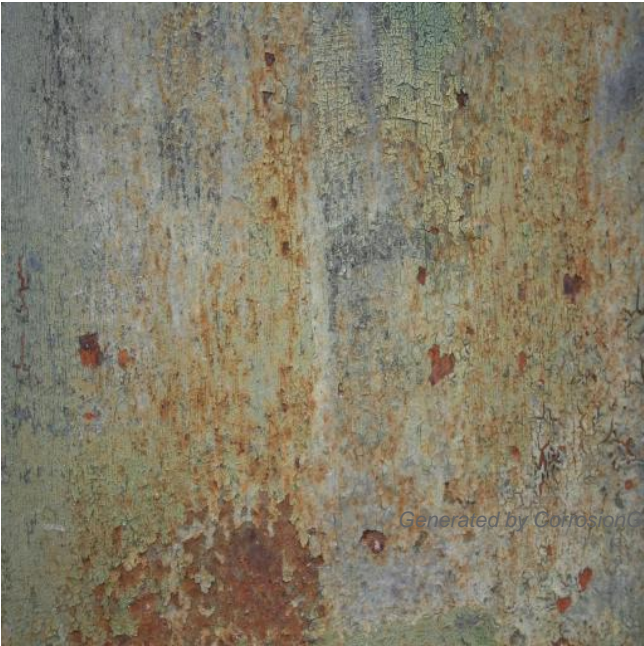
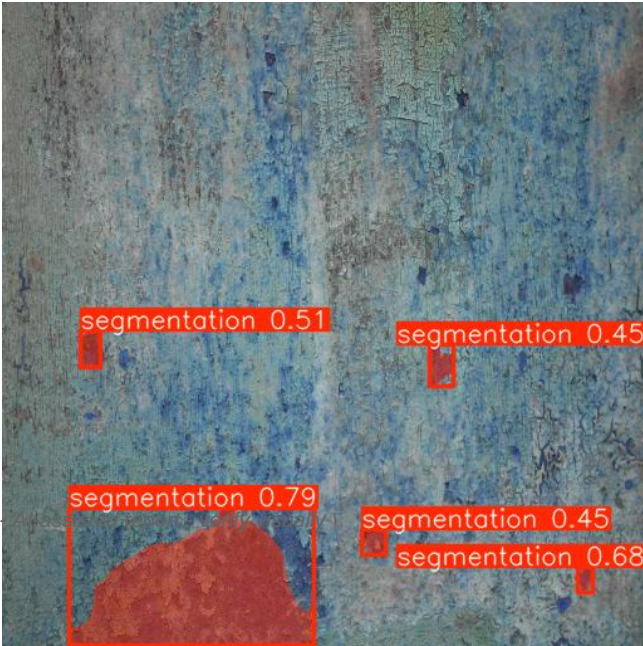
Corrosion Detected: PASS (5 spot(s))

Severity: High=1, Medium=0, Low=4
