Corrosion Inspection Report

Image: img0_jpg.rf.b5bc55cb84018cc1e4bb86eb71e00284.jpg

Generated on: report_17.pdf

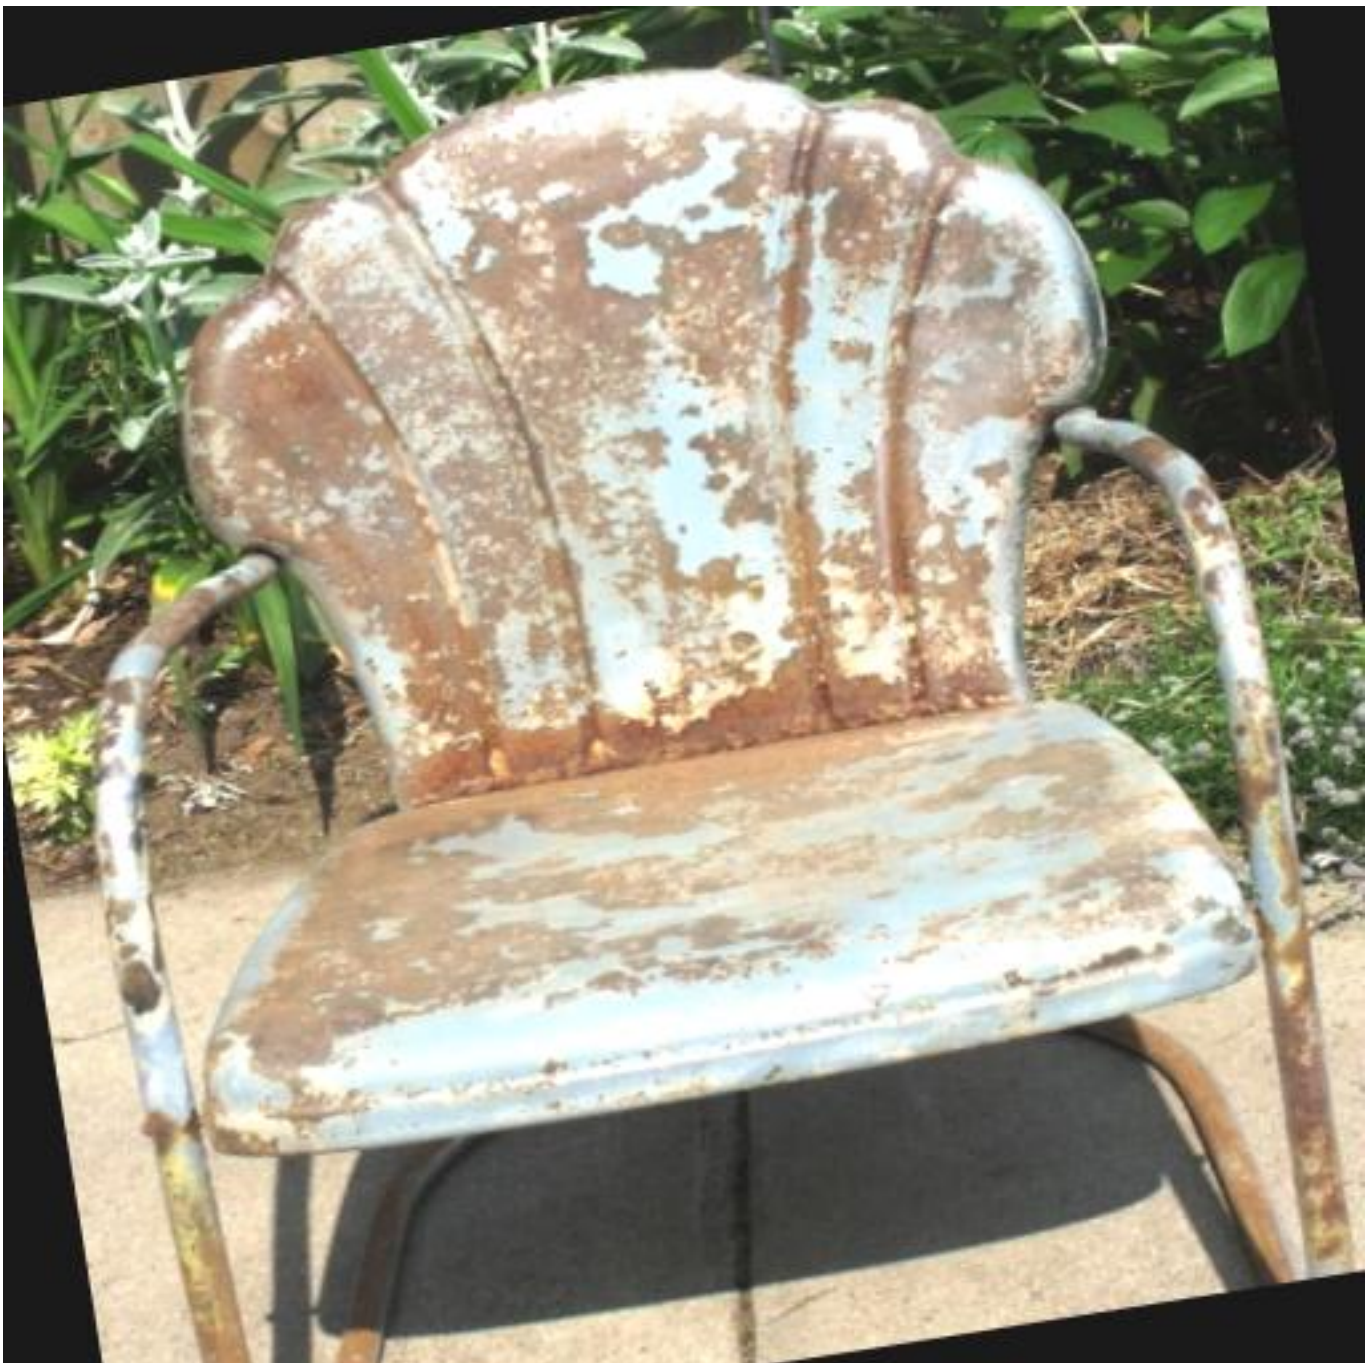
Original Image

Corrosion Detected: PASS (5 spot(s))

Severity: High=1, Medium=1, Low=3
