Corrosion Inspection Report

Image: pipes-metal-2022-12-15-22-16-59-utc.jpg

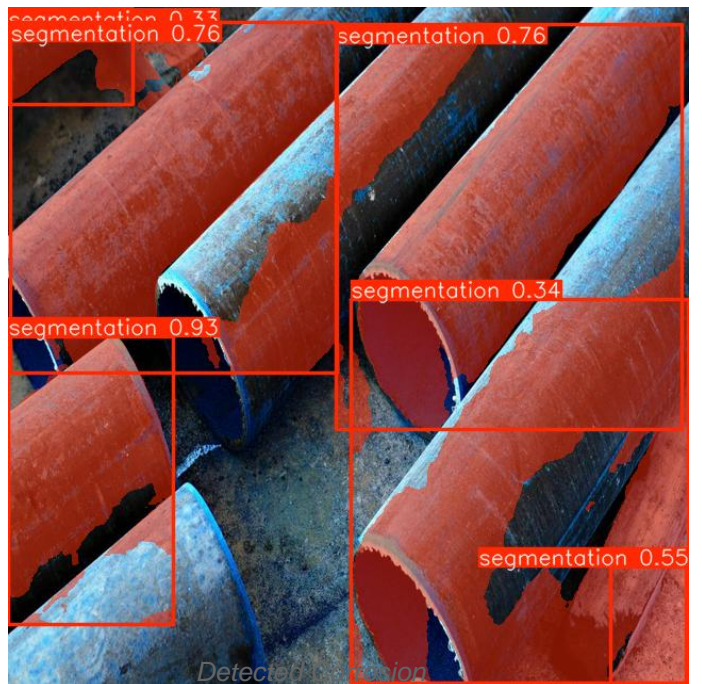
Detected Corrosion

Detection Result:

(10 spot(s))

High=4, Medium=0, Low=6
