Corrosion Inspection Report

Report: dfgffgh

Image: pipes-metal-2022-12-15-22-16-59-utc.jpg

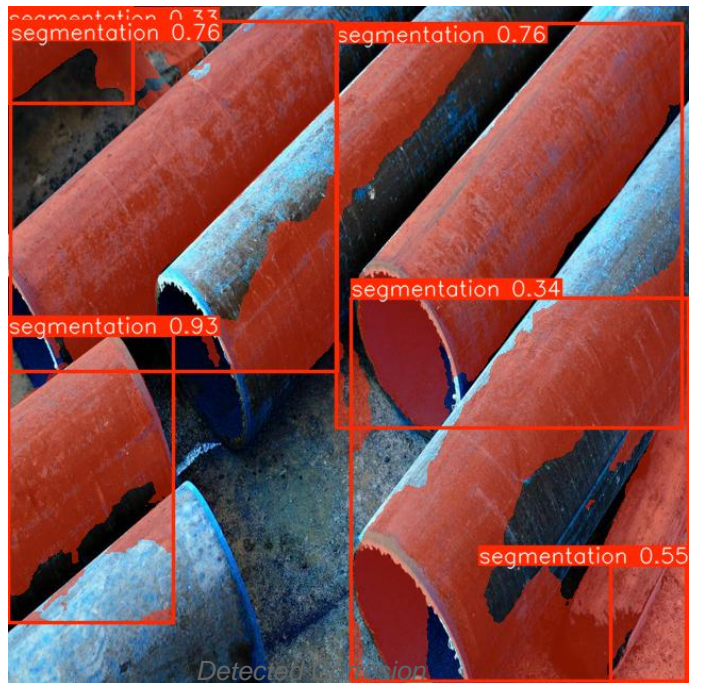
Detected Corrosion

Corrosion Detected: PASS (10 spot(s))

Severity: High=4, Medium=0, Low=6
