Corrosion Inspection Report

Image: img95_jpg.rf.b1930314743fd9c9592ba09bbb83541c.jpg

Generated on: test1_87.pdf

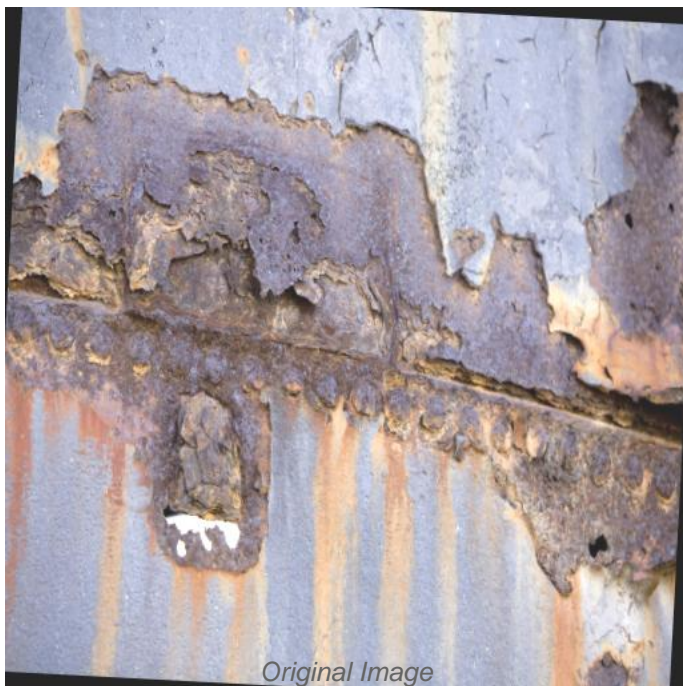
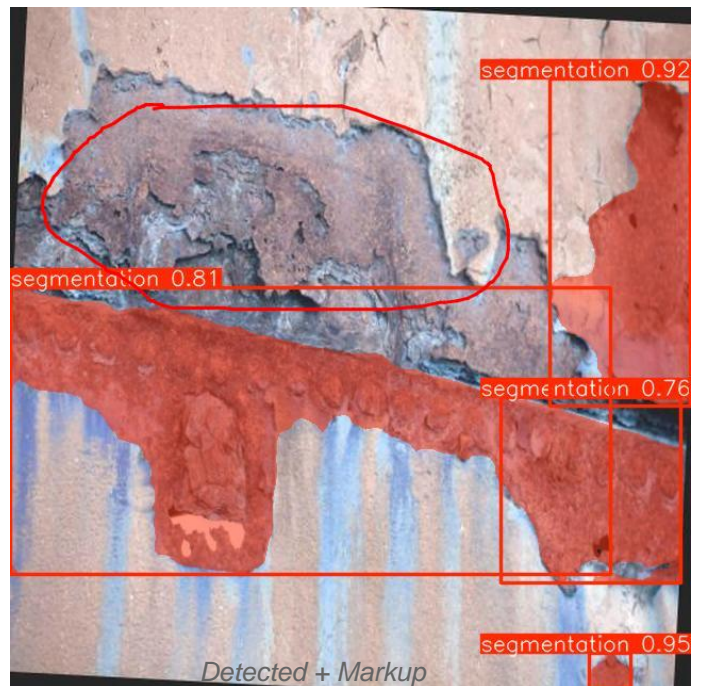
Detection Result:

(5 spot(s))

High=2, Medium=0, Low=3
