# Corrosion Inspection Report

Image: img187\_jpg.rf.8270fdbd03cbb3bb6941d20883d4f17d.jpg

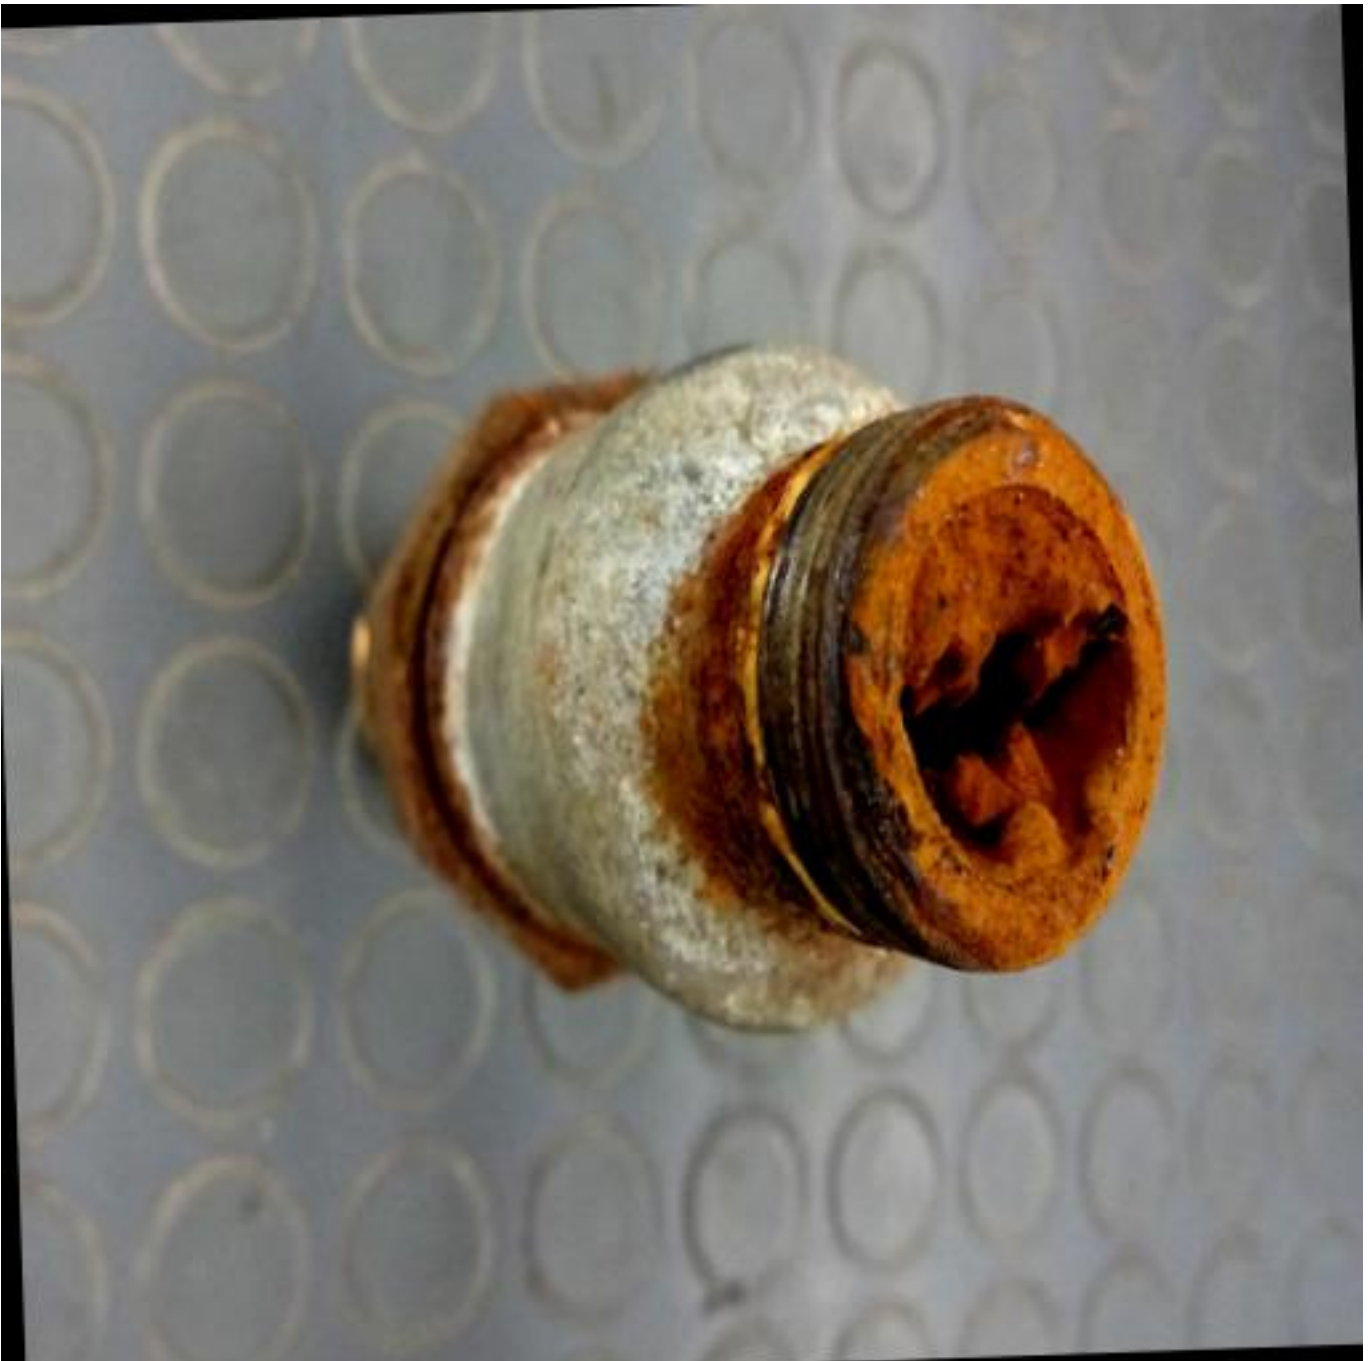
## Original Image

Corrosion Detected: PASS (1 spot(s))

Severity: High=1, Medium=0, Low=0
