Corrosion Inspection Report

Report: pipes-metal-2022-12-15-22-16-59-utc.jpg

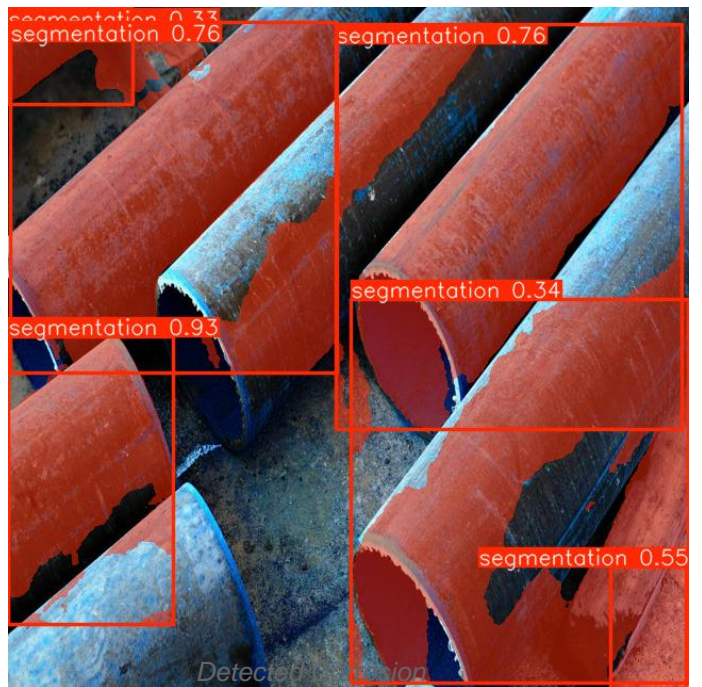
Detected Corrosion

Corrosion Detected: PASS (10 spot(s))

Severity: High=4, Medium=0, Low=6
