Corrosion Inspection Report

Generated on: report_85.pdf

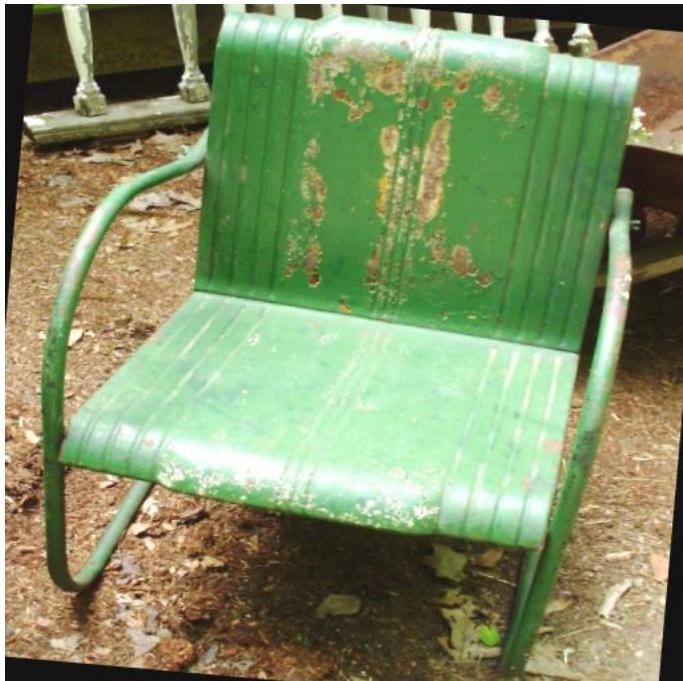
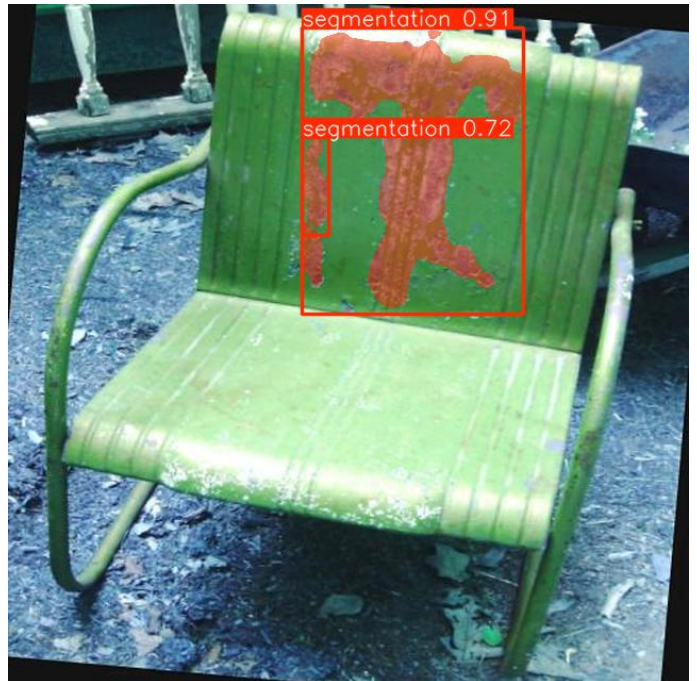
Marked-up Image

(4 spot(s))

High=1, Medium=0, Low=3

severely
