# Corrosion Inspection Report

Image: img61\_jpg.rf.ef7876eb87333d022bbbcf22ae5bc4e6.jpg

Generated on: report\_16.pdf

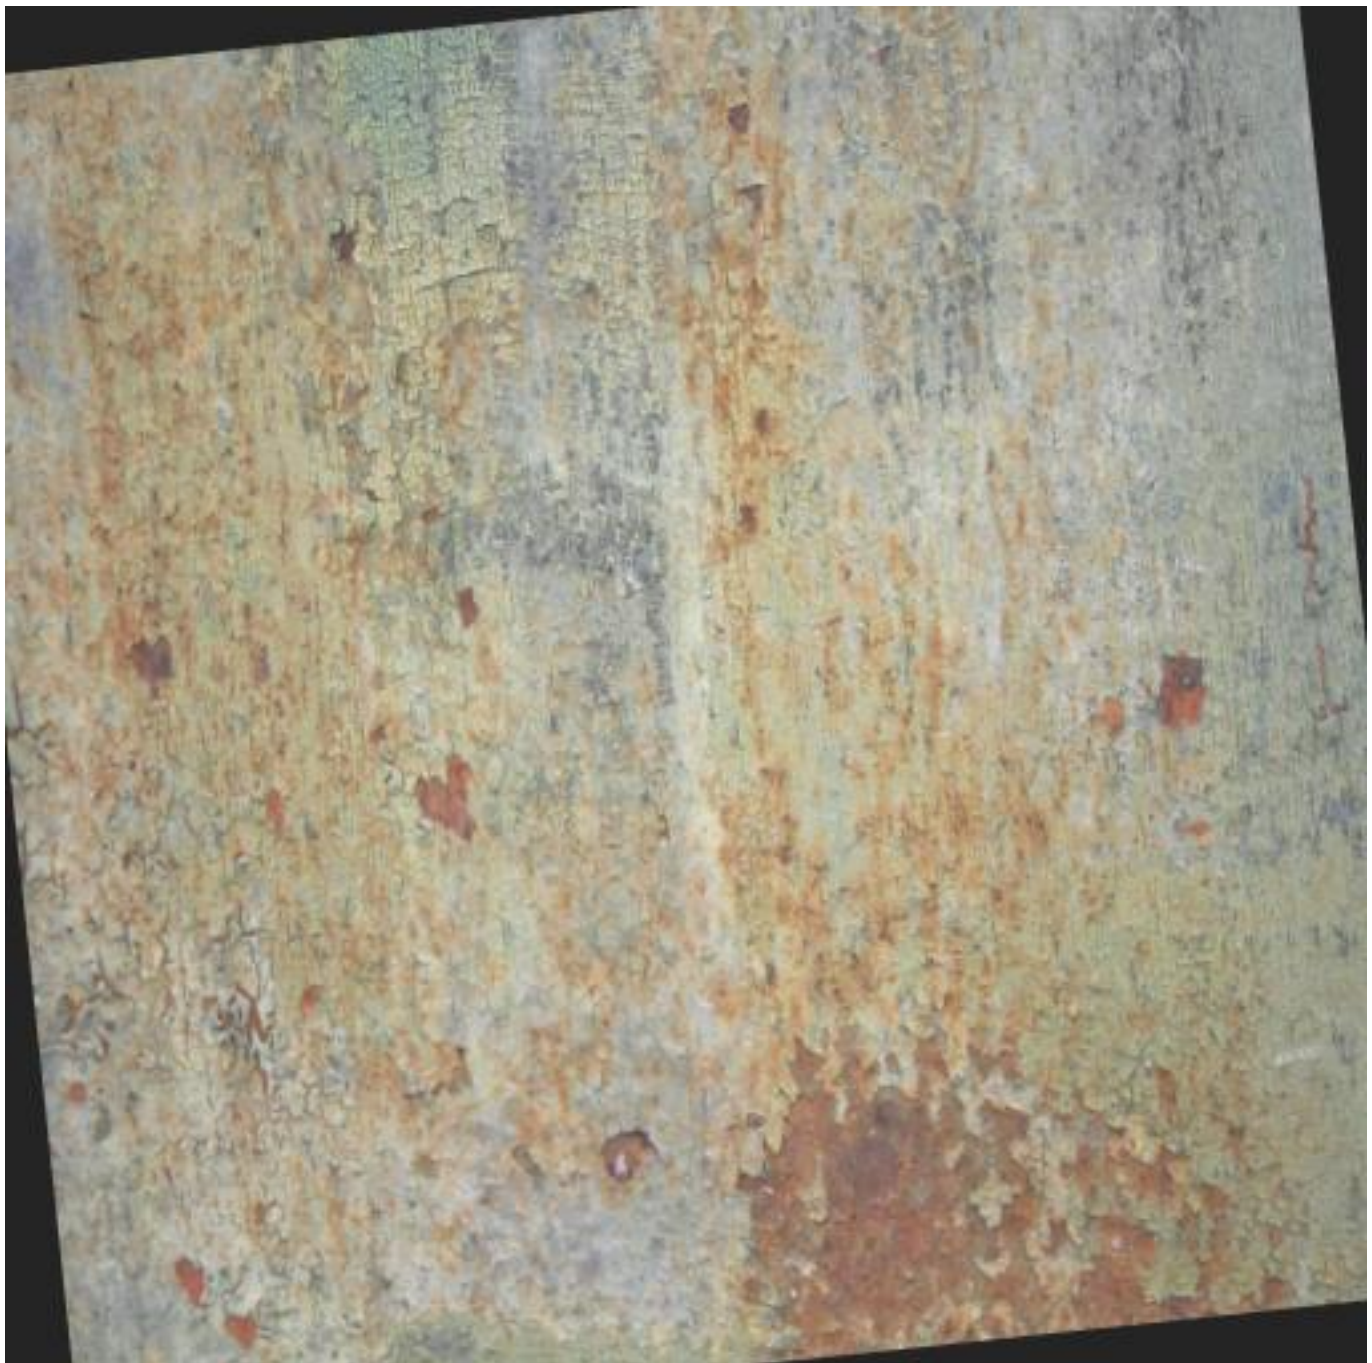
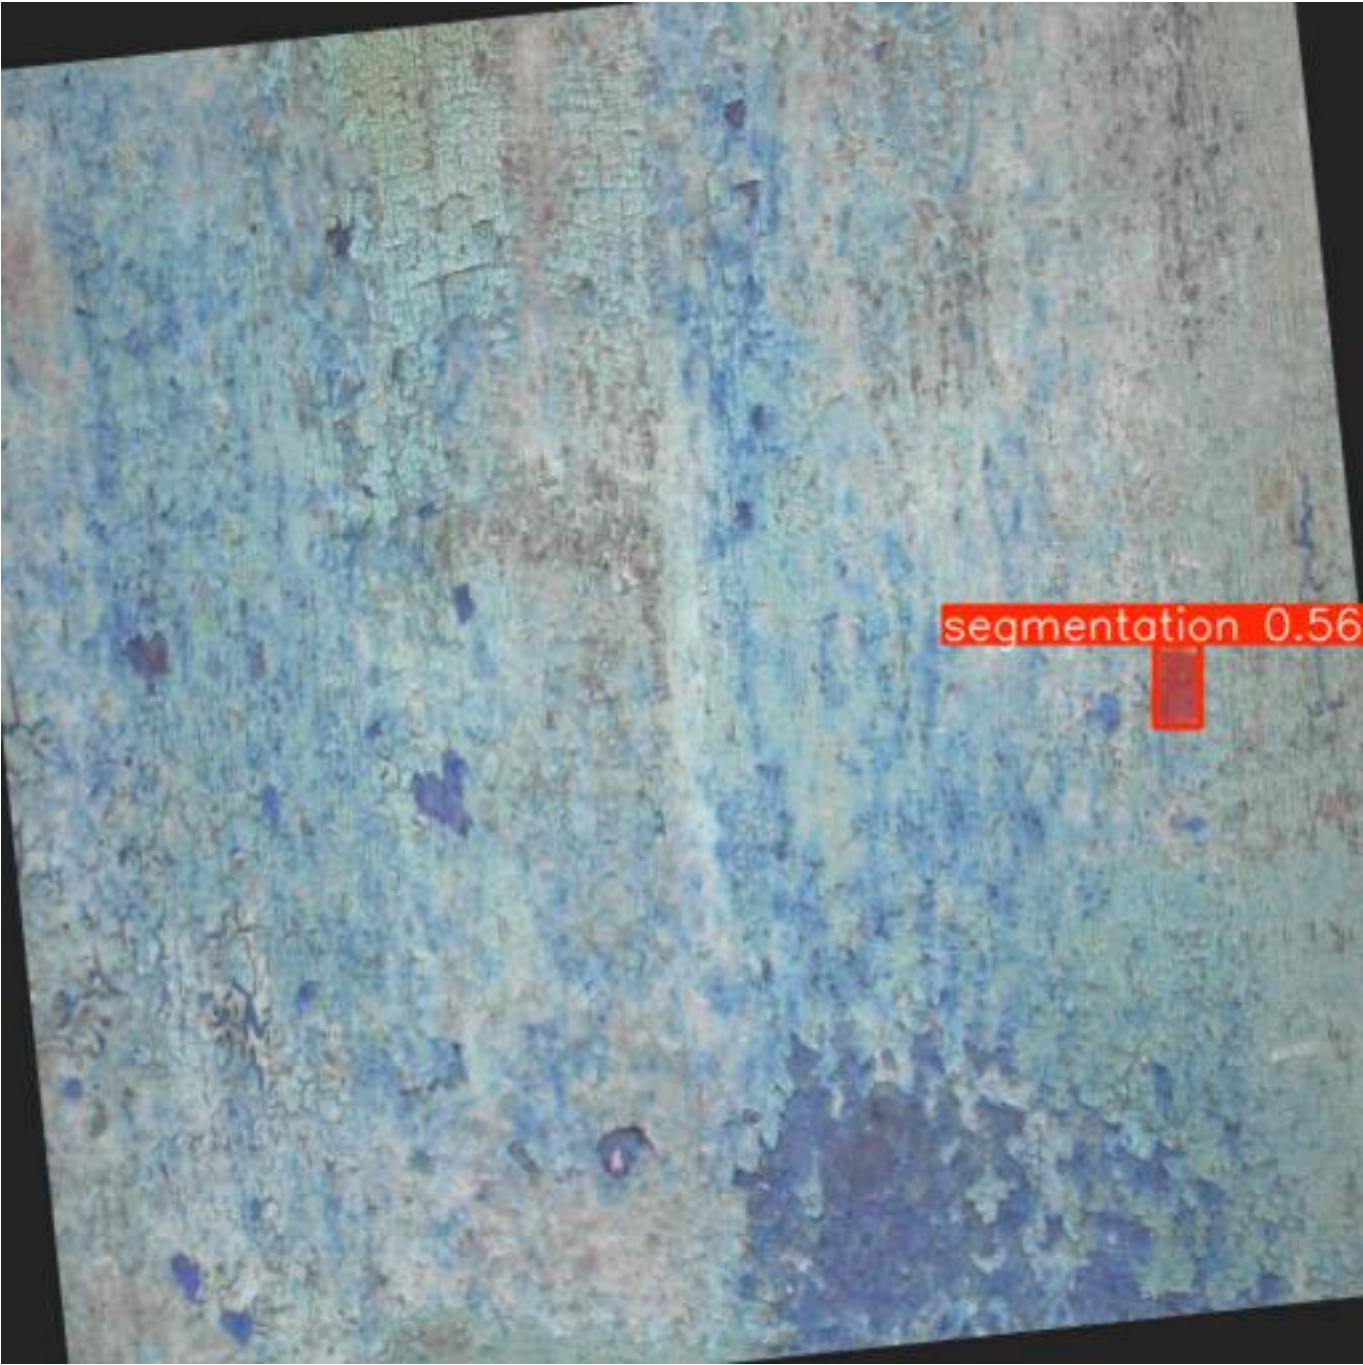
Detected Corrosion

Corrosion Detected: PASS (1 spot(s))

Severity: High=0, Medium=0, Low=1
