# CorrosionGuard AI

## Corrosion Inspection Report

Inspected Image: img129\_jpg.rf.81be984d7c0b757148478147a260ee4c.jpg

Generated on: 2025-08-22 22:28:57 (MYT)

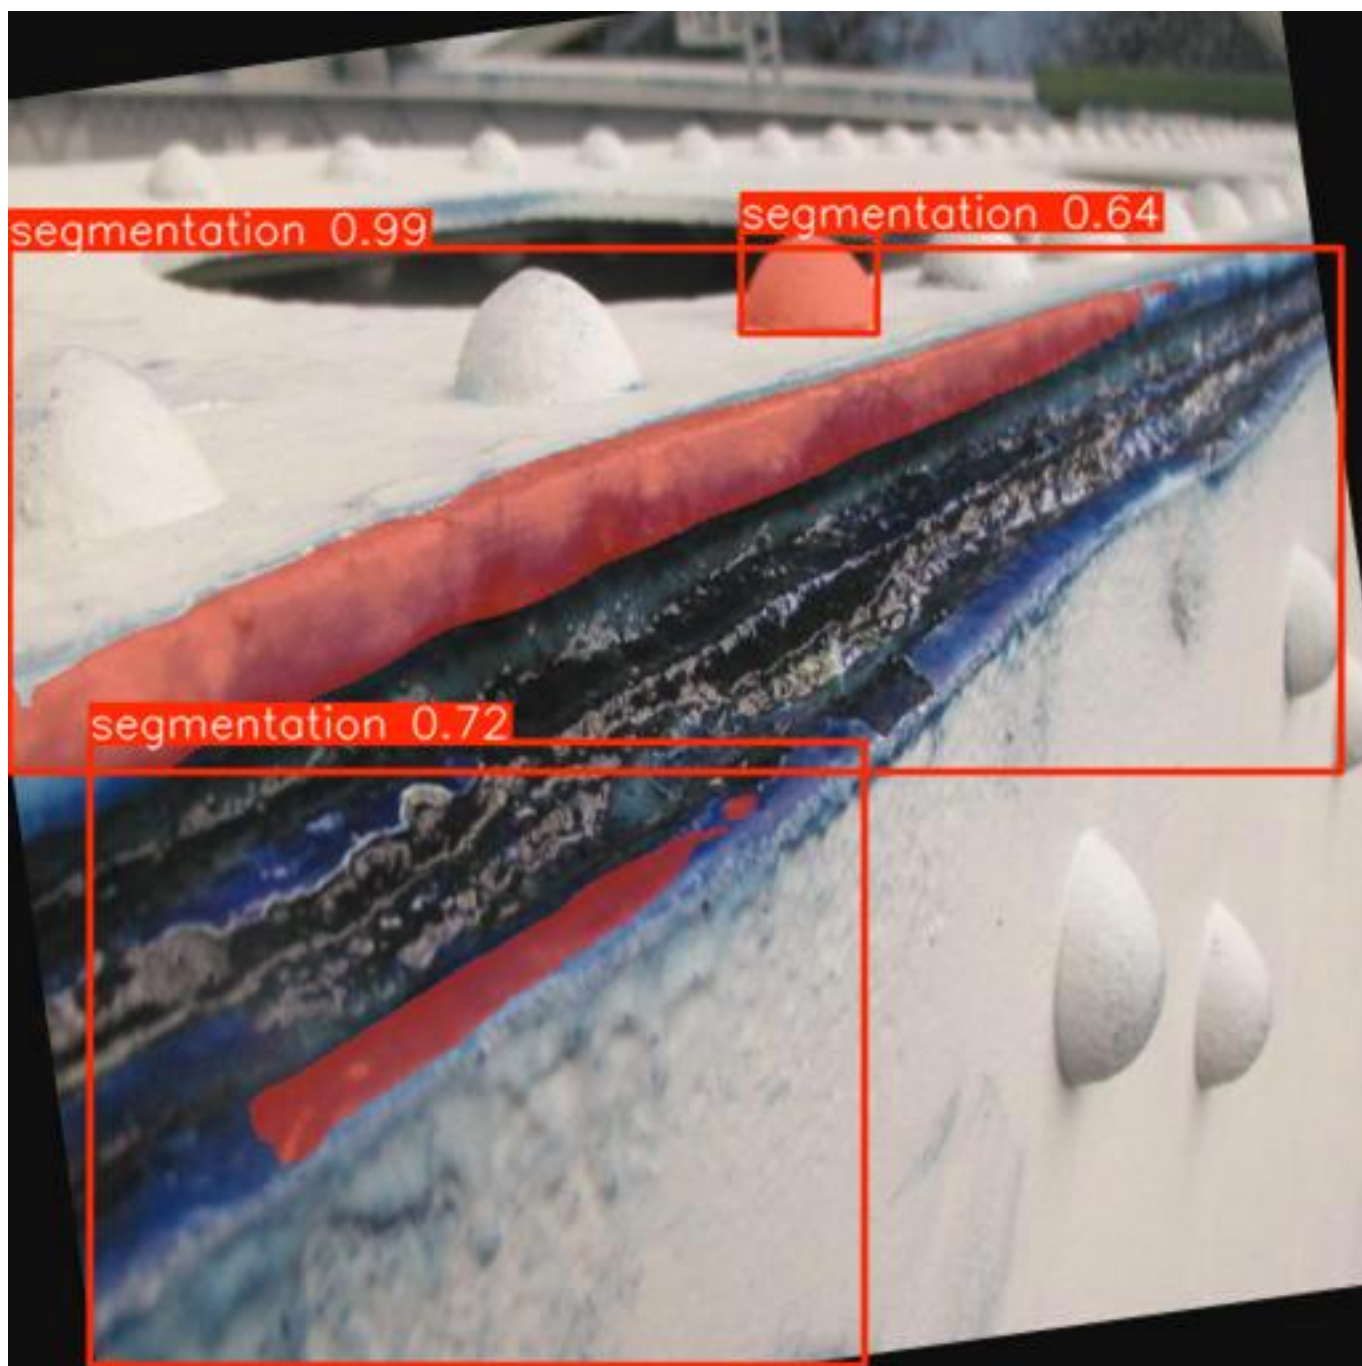
**Detected Corrosion**

Corrosion Detected: PASS (6 spot(s))

Severity: High=1, Medium=1, Low=4
