# Corrosion Inspection Report

Generated on: report\_24.pdf

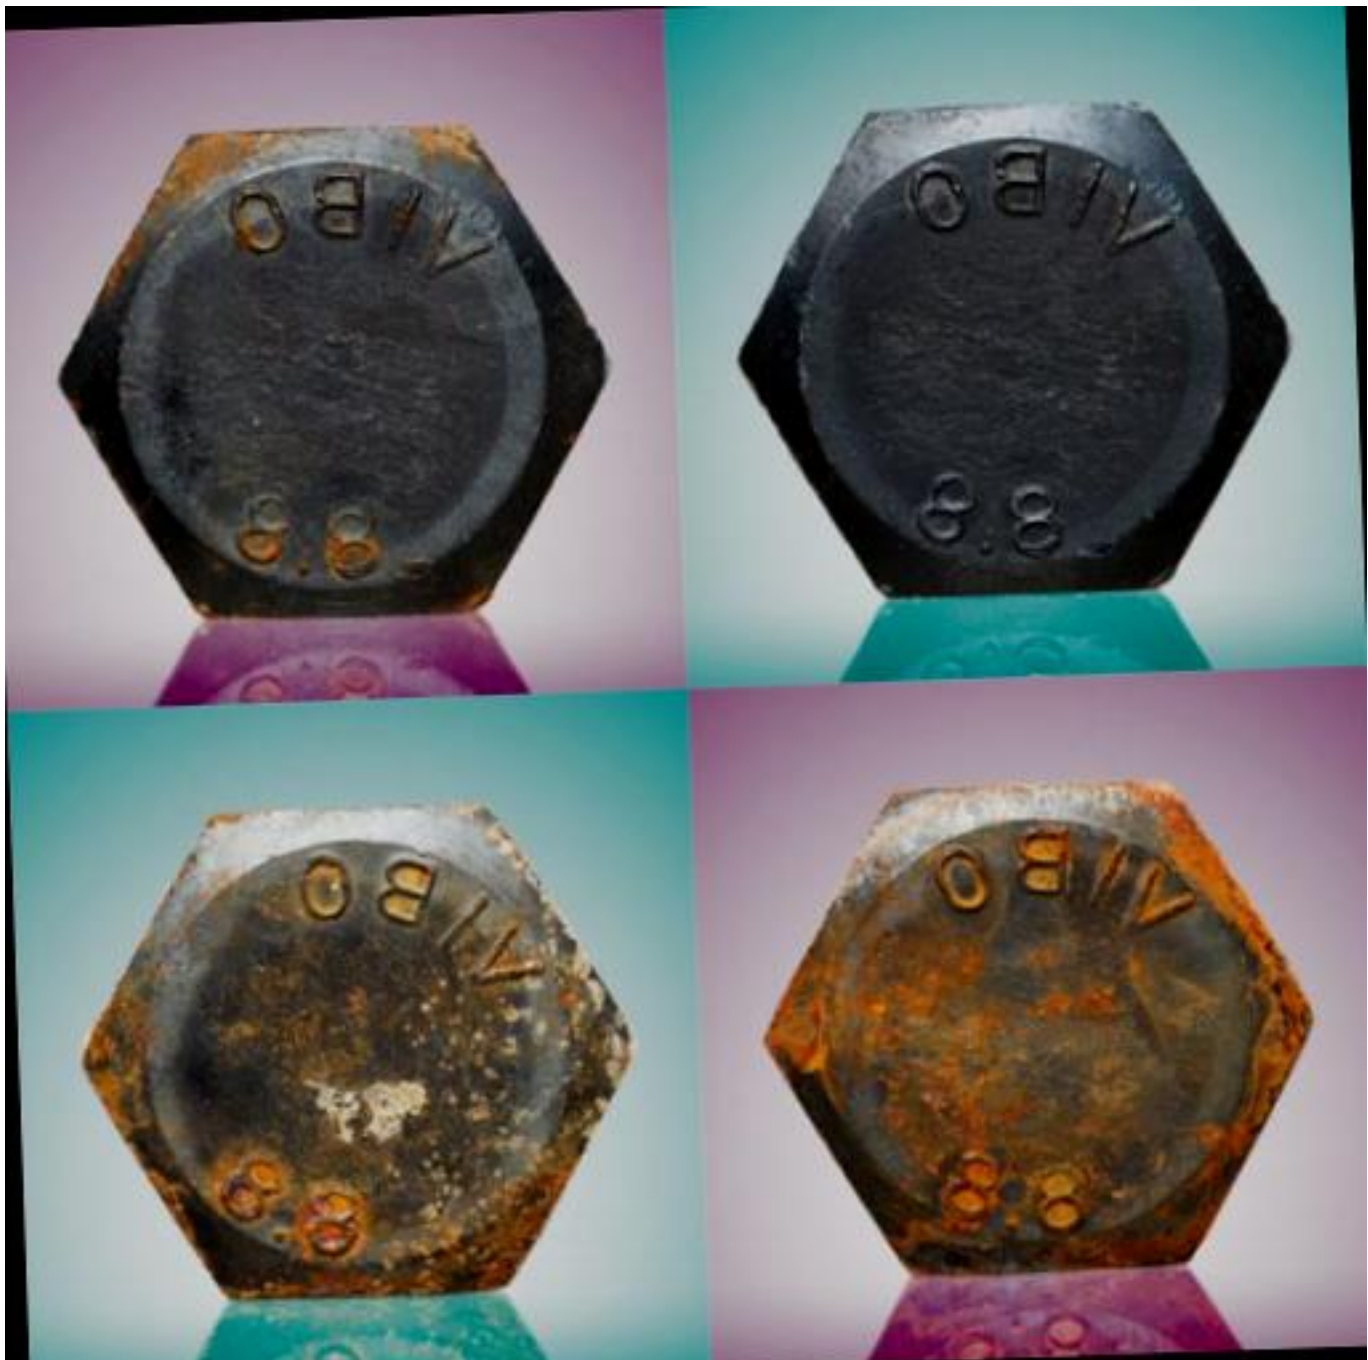
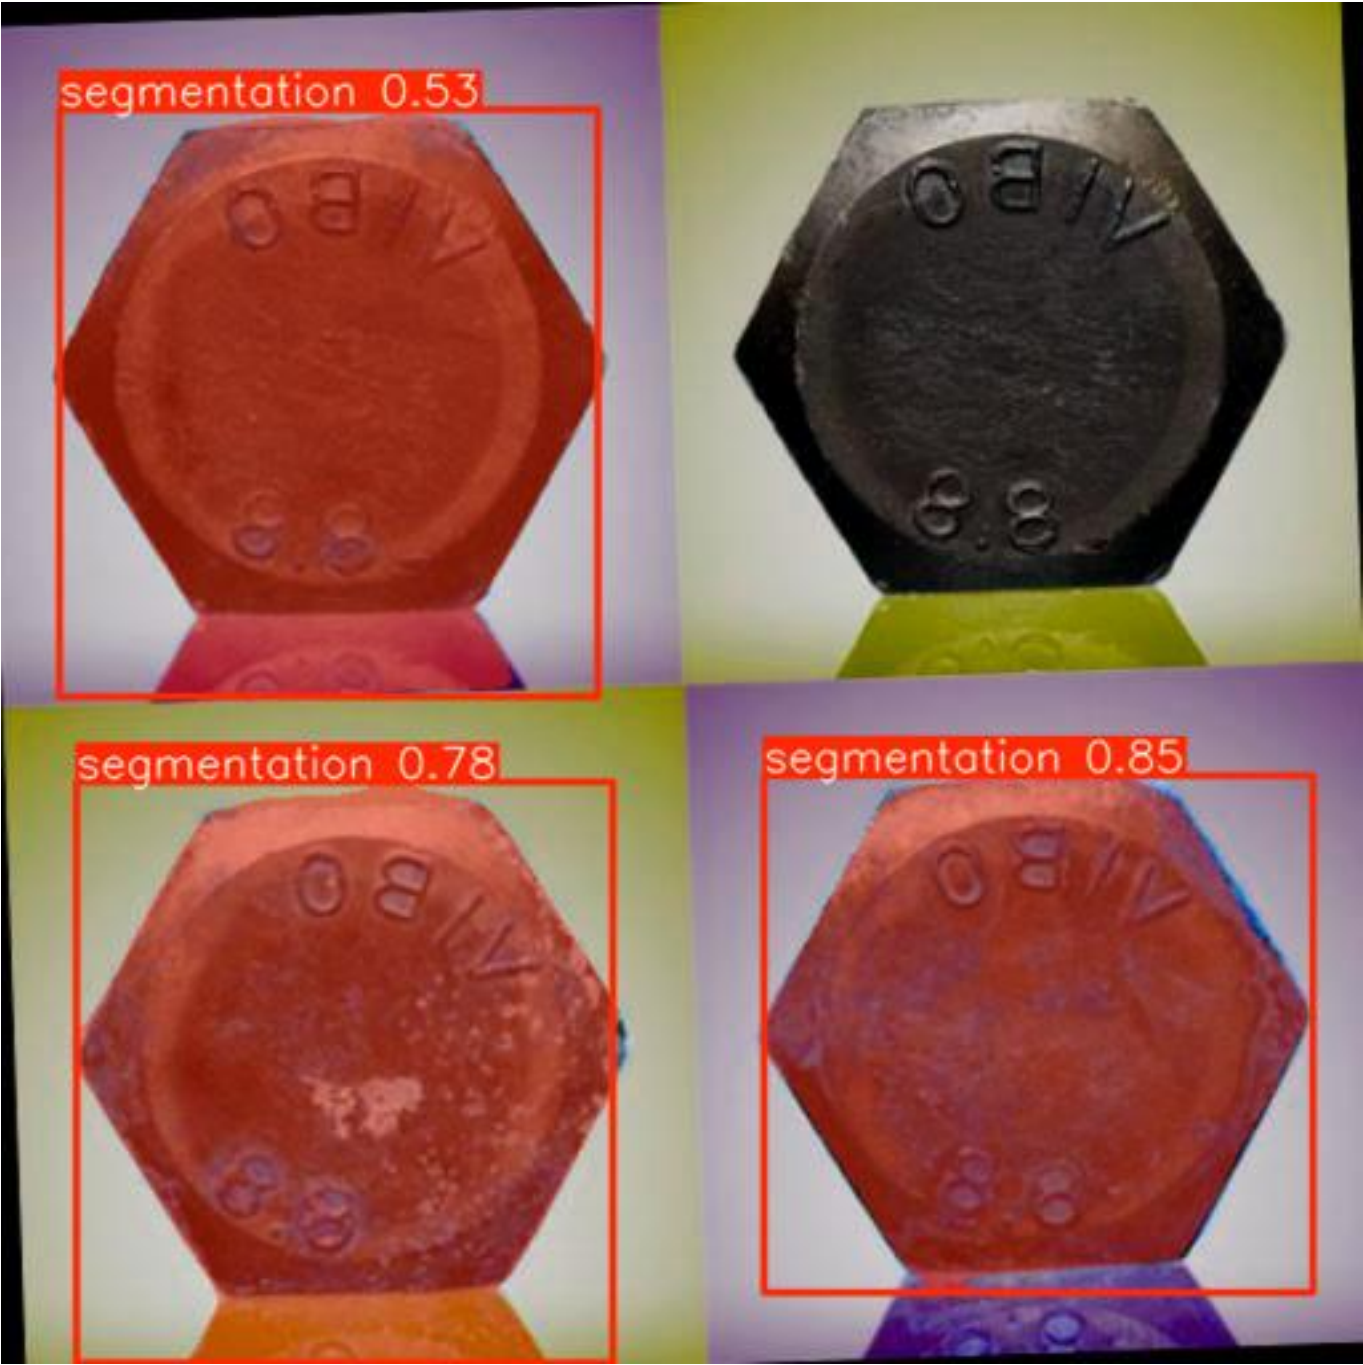
Detected Corrosion

Corrosion Detected: PASS (3 spot(s))

Severity: High=3, Medium=0, Low=0
