Corrosion Inspection Report

Image: img86_jpg.rf.28a592268618f80aaf0755f6d7af1550.jpg

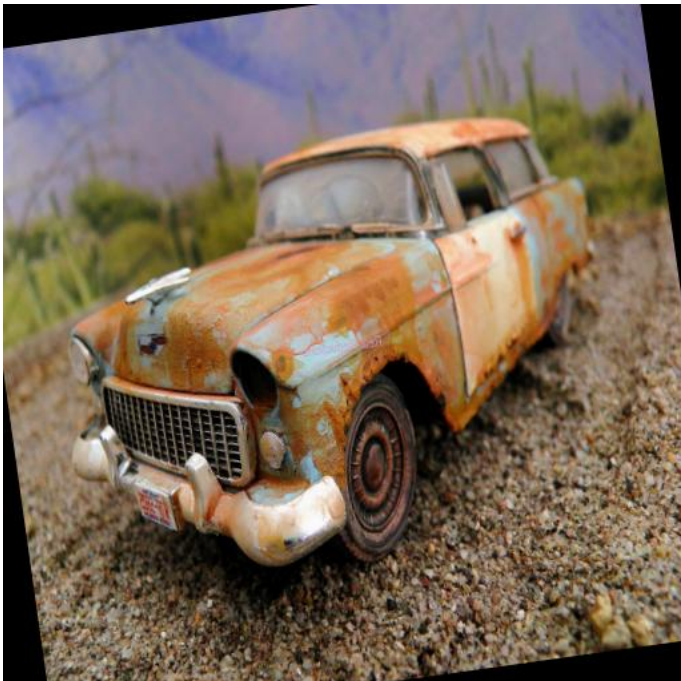
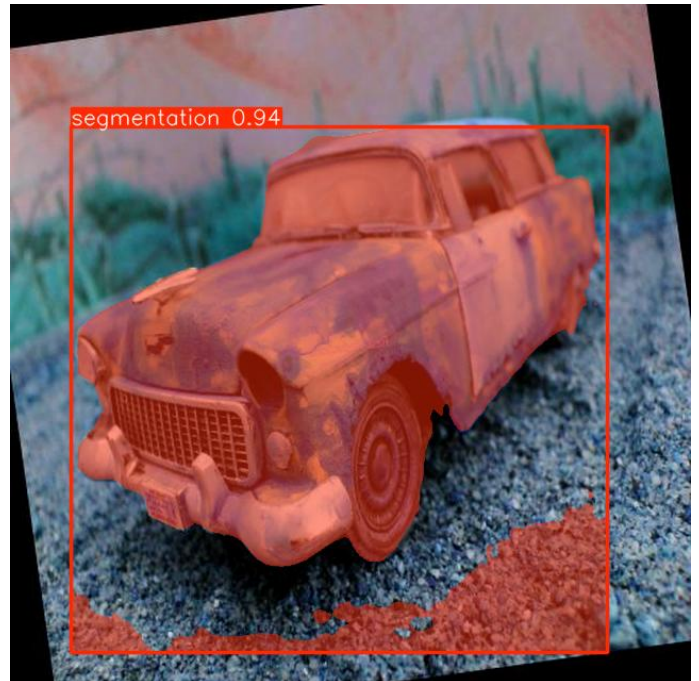
Marked-up Image

(8 spot(s))

High=2, Medium=0, Low=6
