Corrosion Inspection Report

Image: img0_jpg.rf.926a5df791764df3d1c28ae7e76c0b3c.jpg

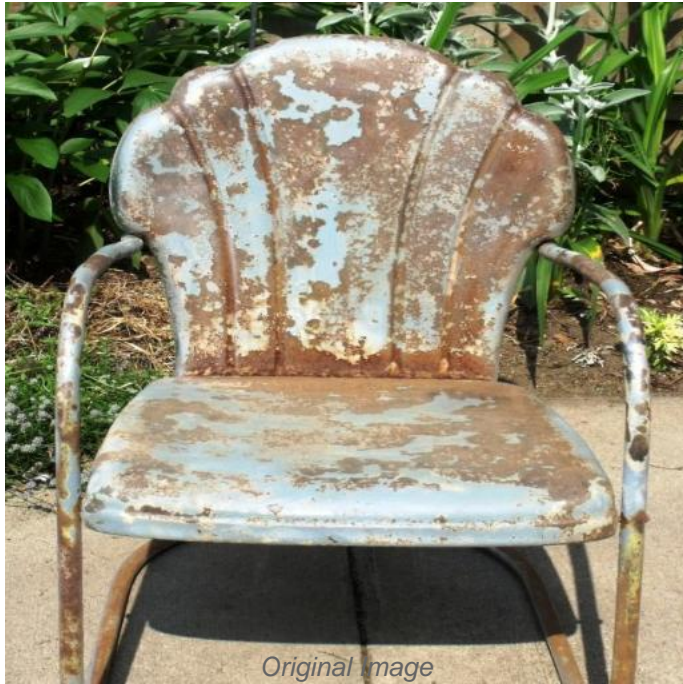
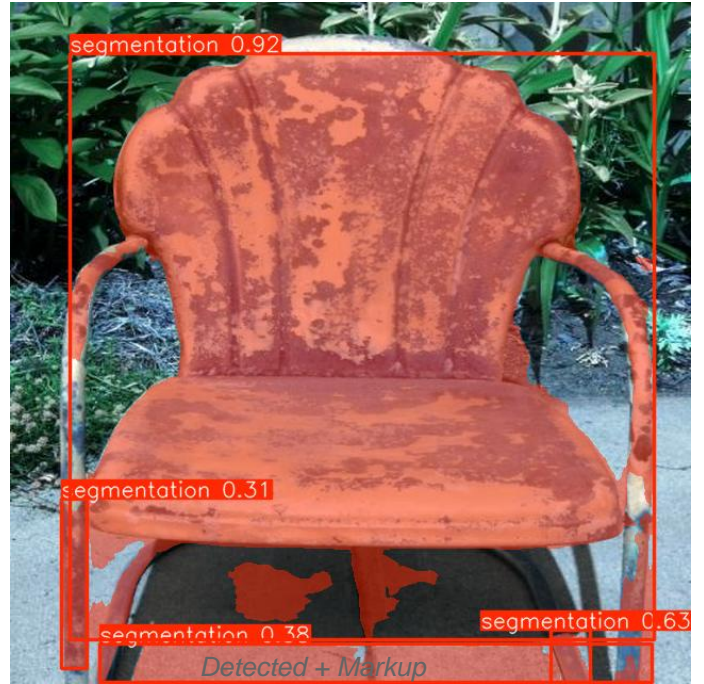
Detection Result:

(10 spot(s))

High=2, Medium=1, Low=7
