Corrosion Inspection Report

Image: img131_jpg.rf.0a38ff0cf1f908a7b26610d93a4596b2.jpg

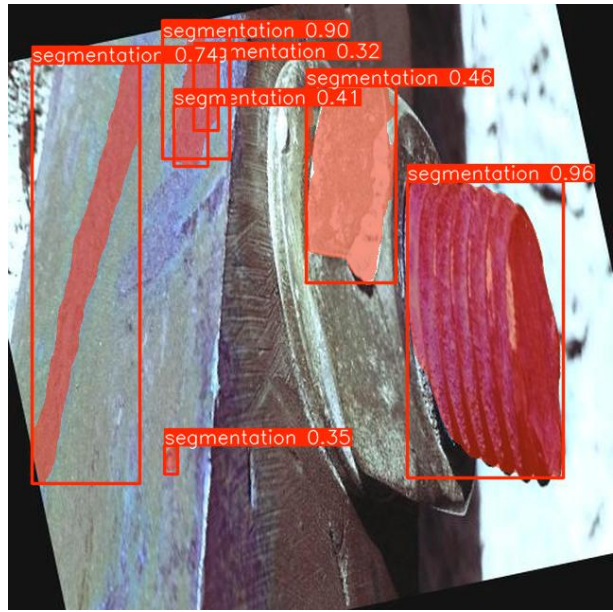
Detected Corrosion

(7 spot(s))

High=3, Medium=1, Low=3
