Corrosion Inspection Report

Image: img90_jpg.rf.af7268b2f45e41750f2693699bb0decd.jpg

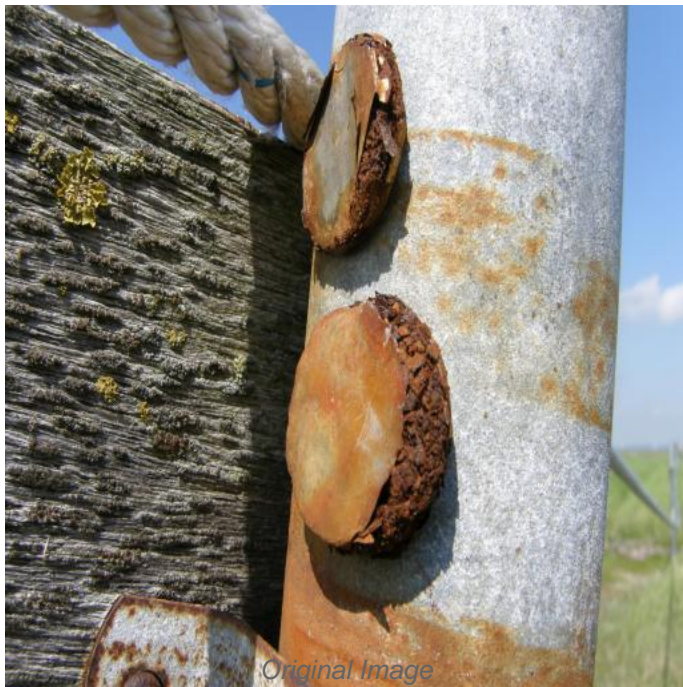
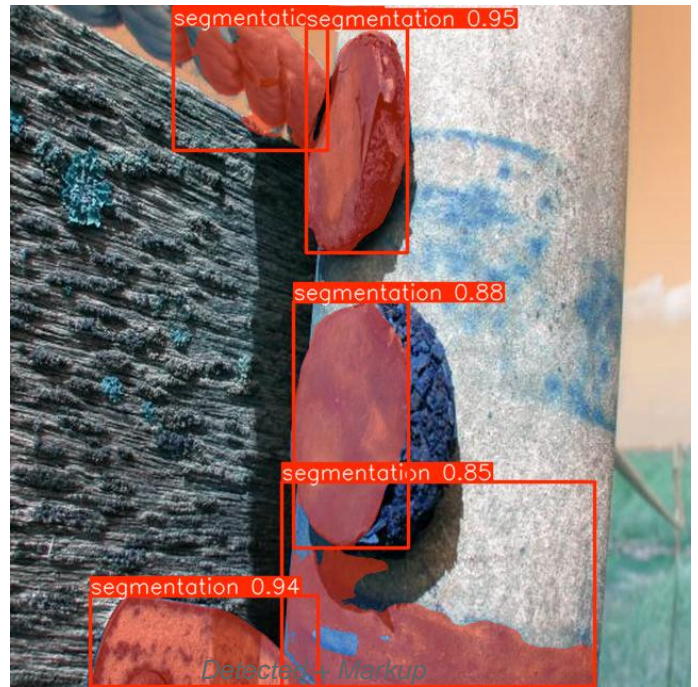
Detection Result:

(4 spot(s))

High=4, Medium=0, Low=0
