Corrosion Inspection Report

Image: img122_jpg.rf.9560046bbe77d2e3f94008bc2d30470f.jpg

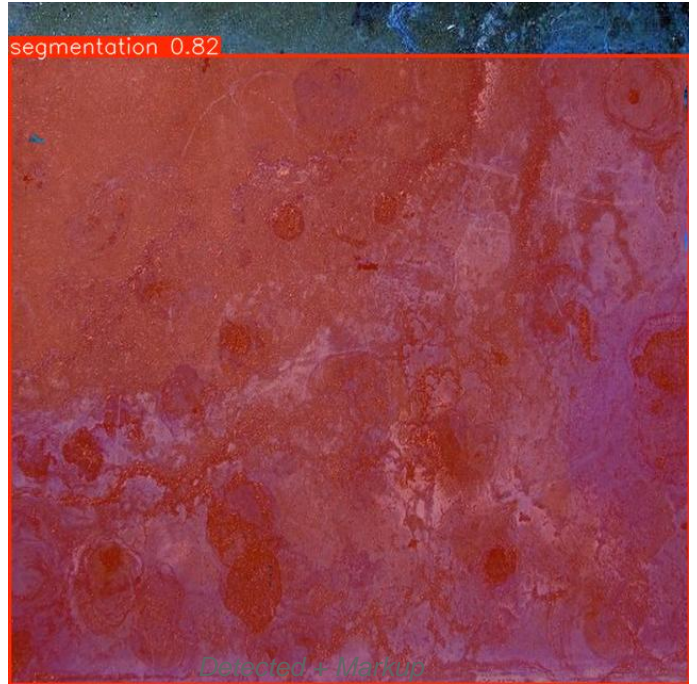
Detected + Masking

Detection Result:

(1 spot(s))

High=1, Medium=0, Low=0
