Corrosion Inspection Report

Generated on: report_88.pdf

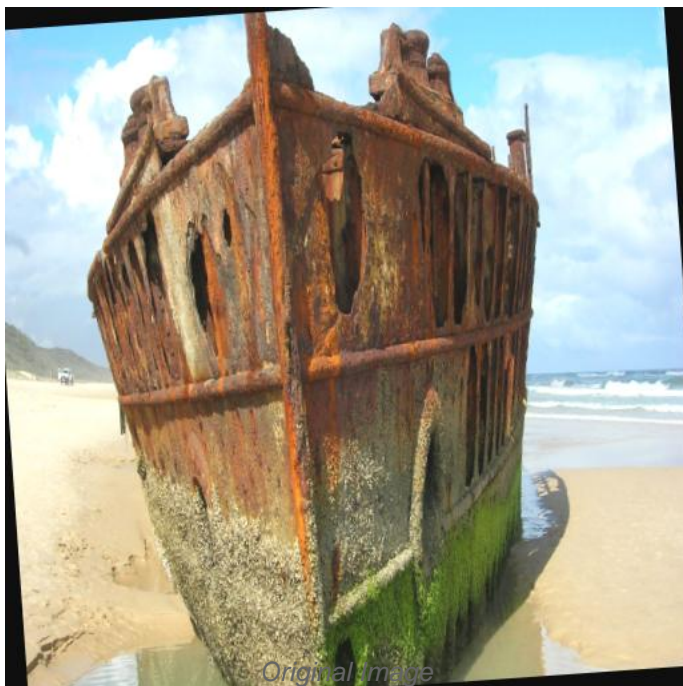
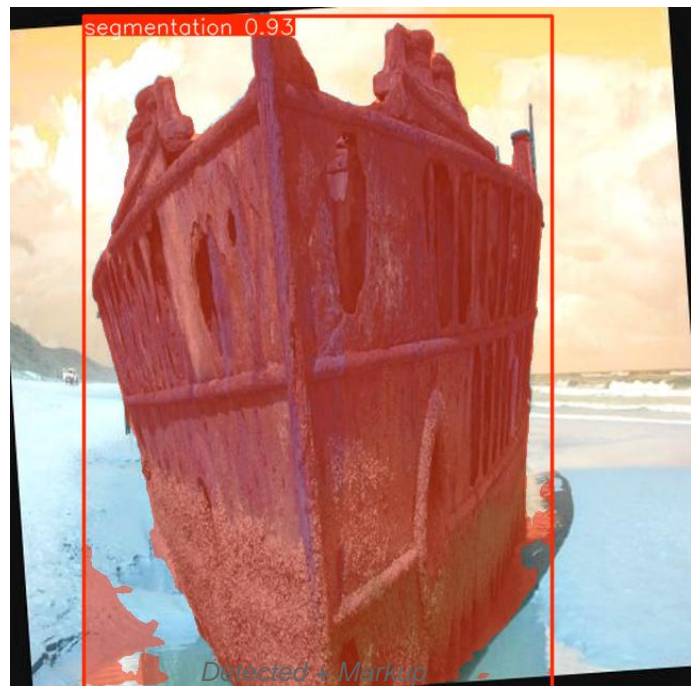
Image: img138_jpg.rf.5927d6bef02fe2b8ca547e37c6b18264.jpg

(8 spot(s))

High=1, Medium=1, Low=6

look good
