Corrosion Inspection Report

Image: img111_jpg.rf.73ae7e8bc747296dfa23451c128ab86c.jpg

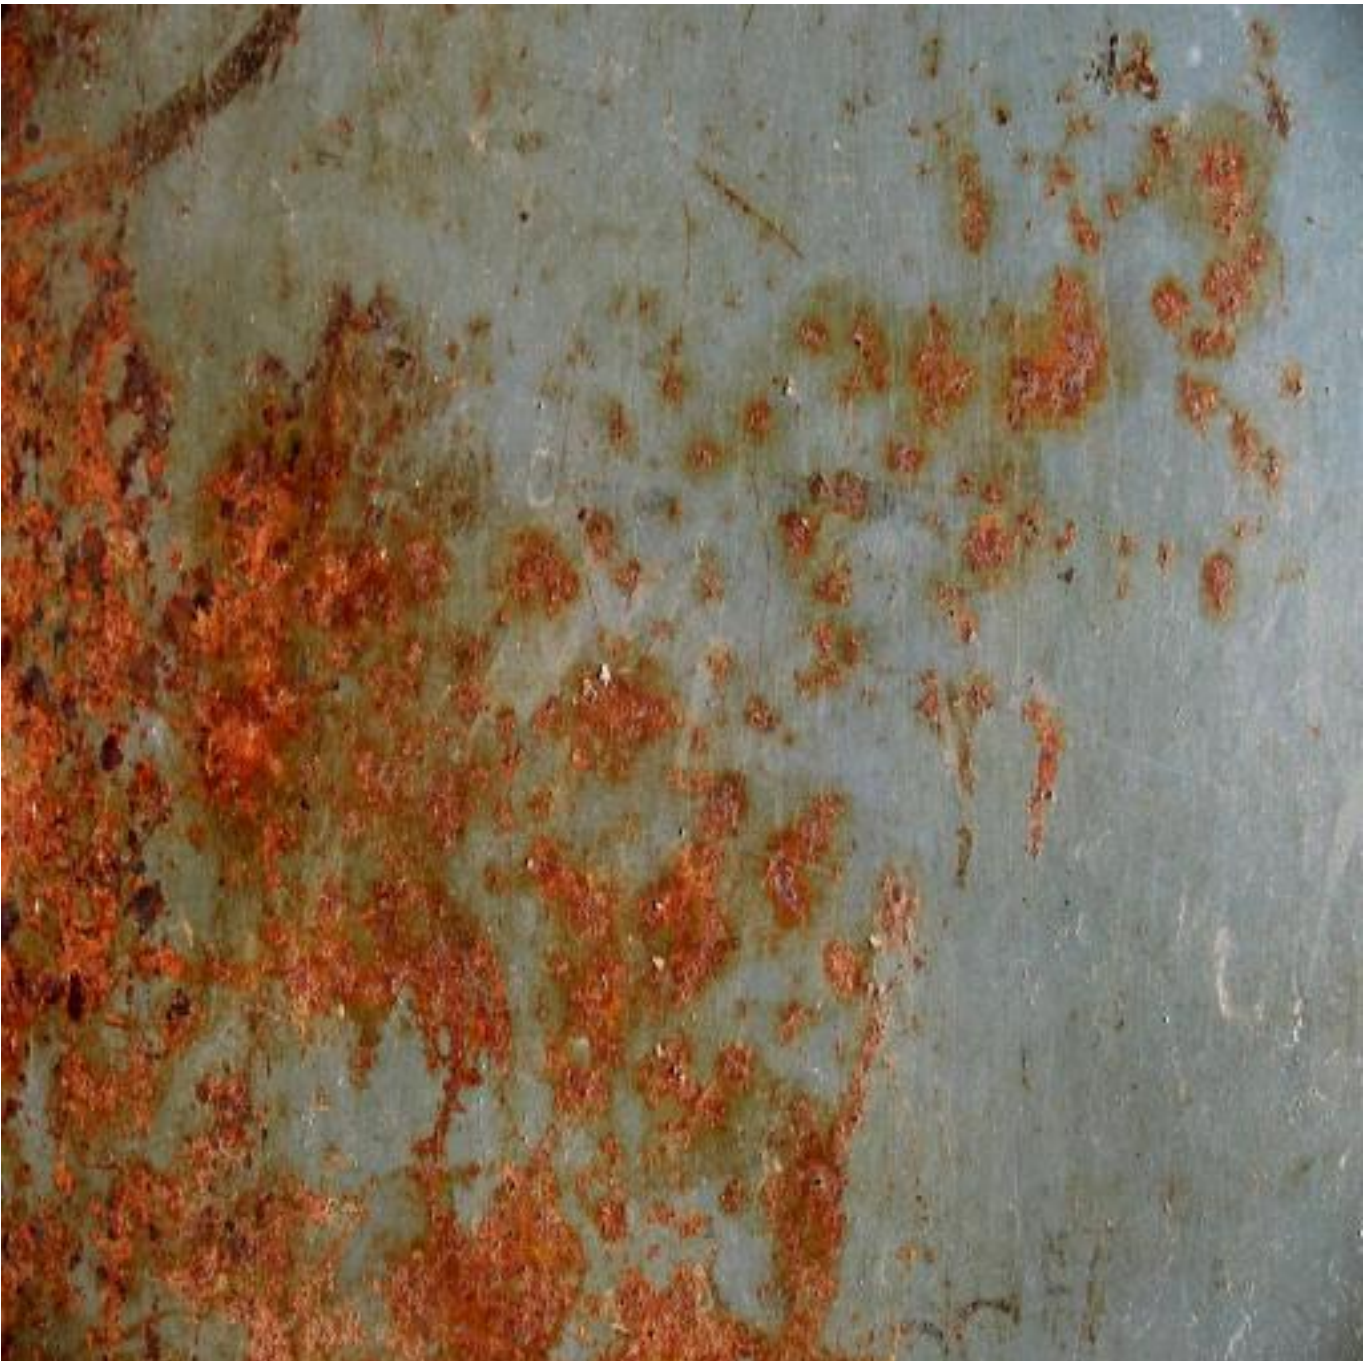
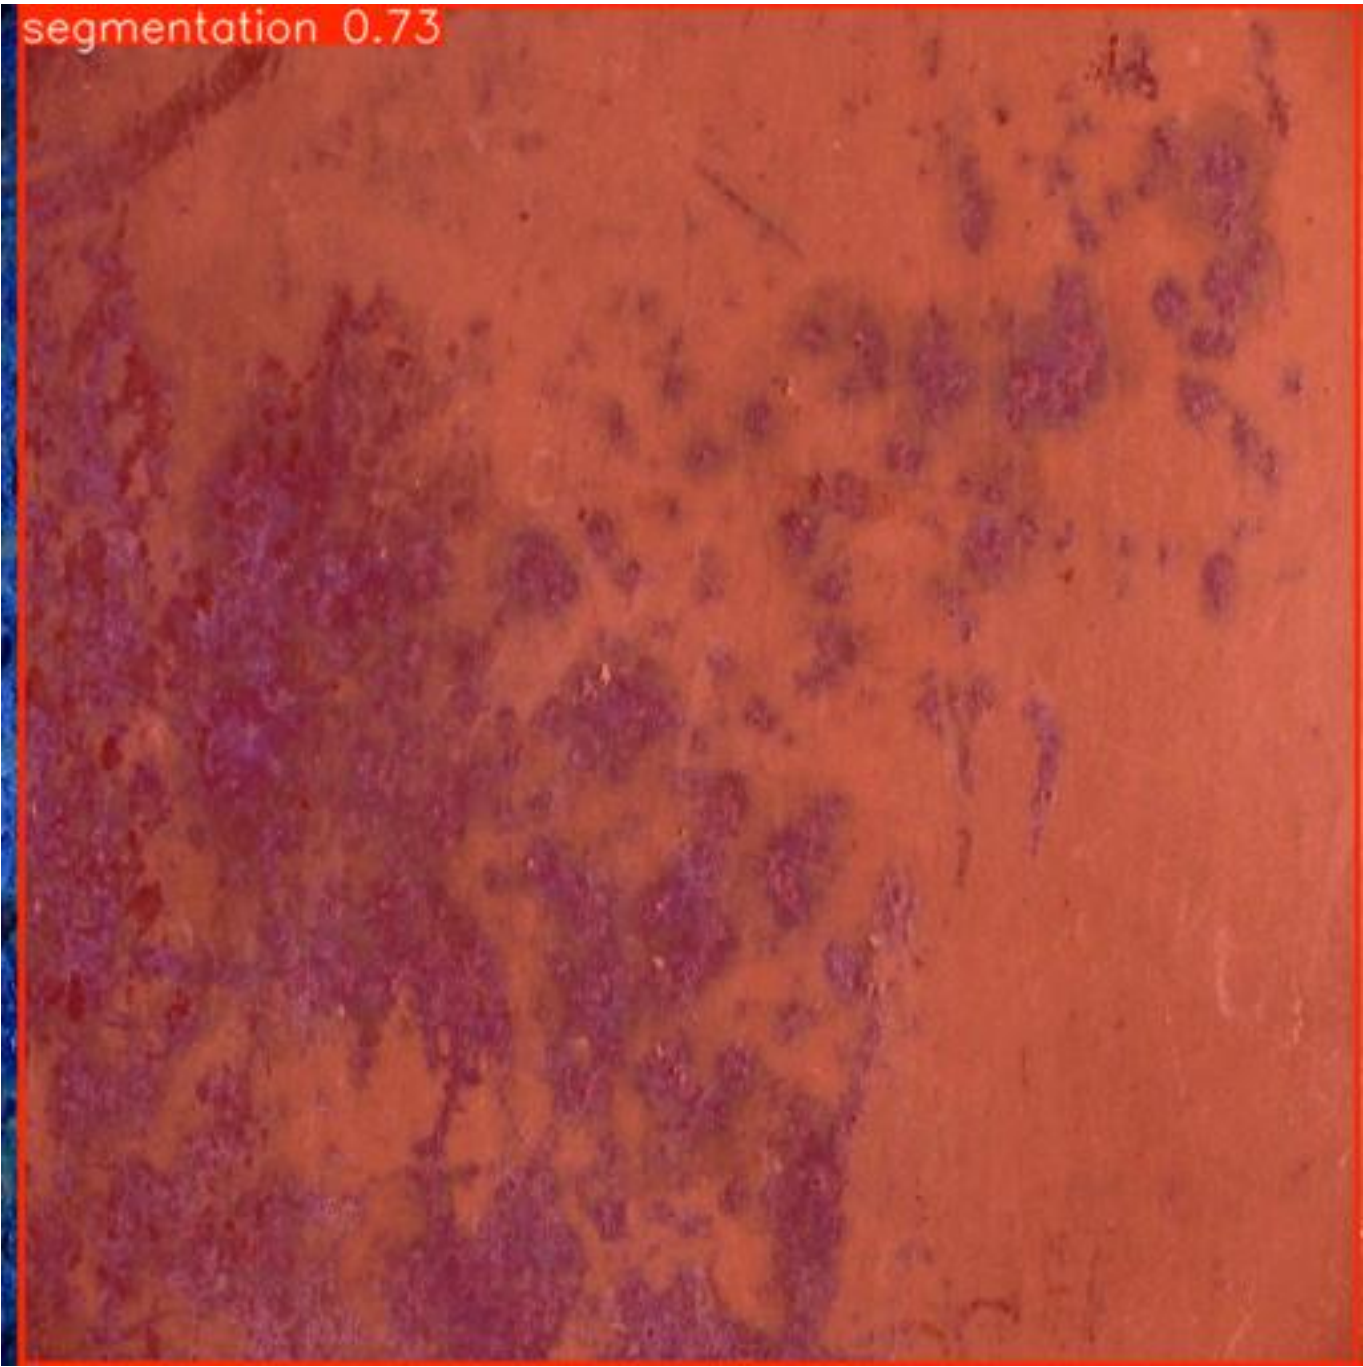
Corrosion Detected: PASS (1 spot(s))

Severity: High=1, Medium=0, Low=0
