Corrosion Inspection Report

Image: img0_jpg.rf.16fe45e444488606e751c13c499b90d0.jpg

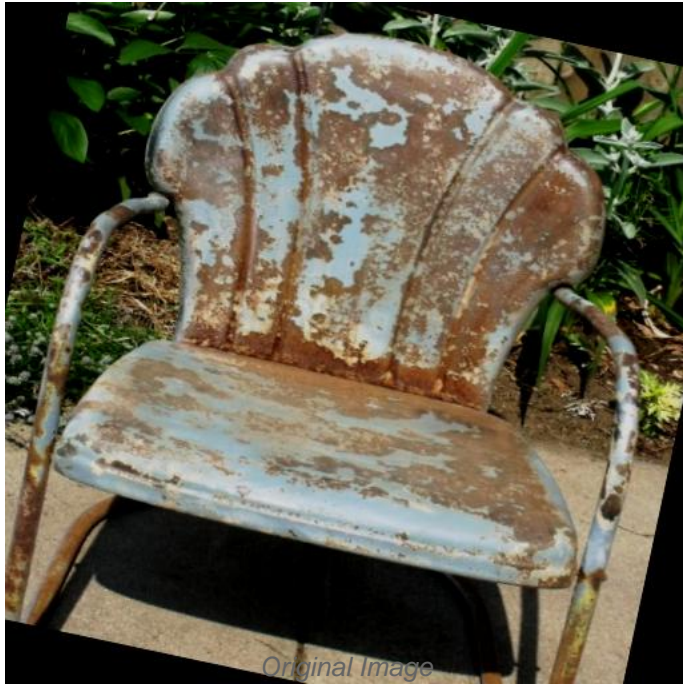
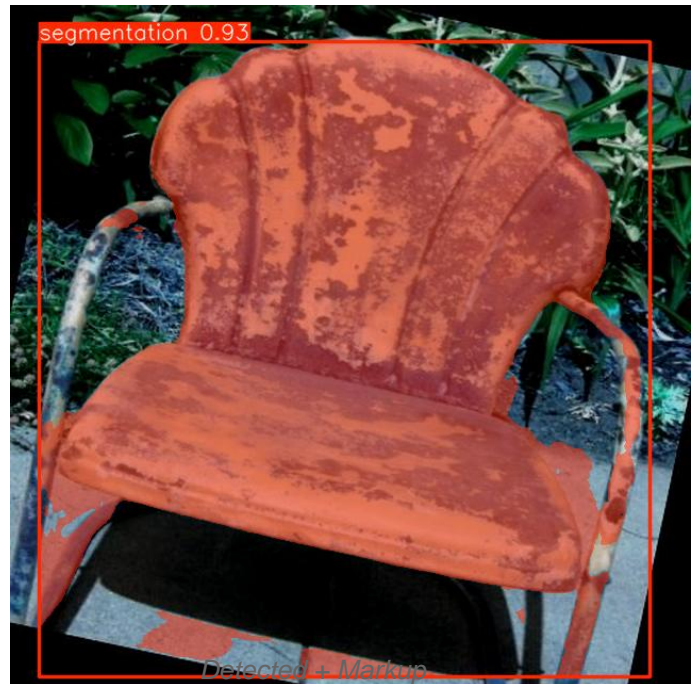
Detection Result:

(13 spot(s))

High=1, Medium=0, Low=12
