# Corrosion Inspection Report

Image: img1\_jpg.rf.5595321f0a8a5dfb6714400d5864b8ce.jpg

Generated on: report\_108.pdf

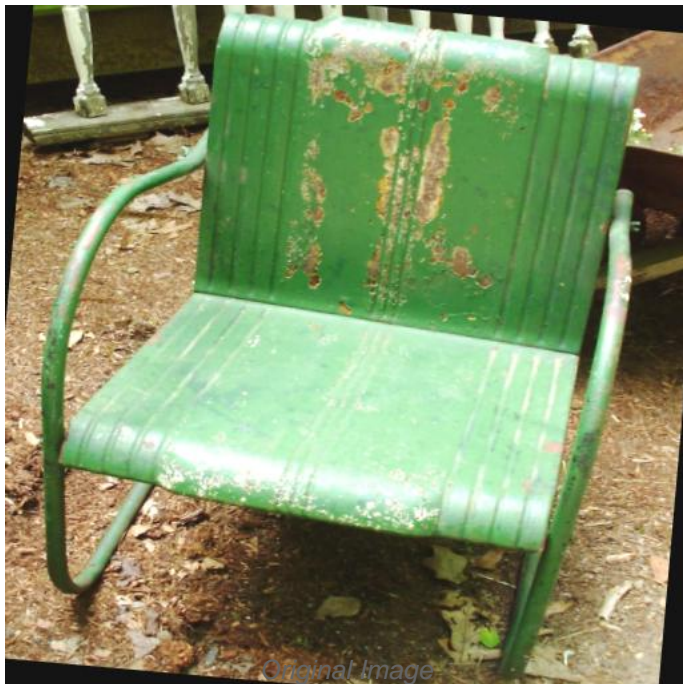
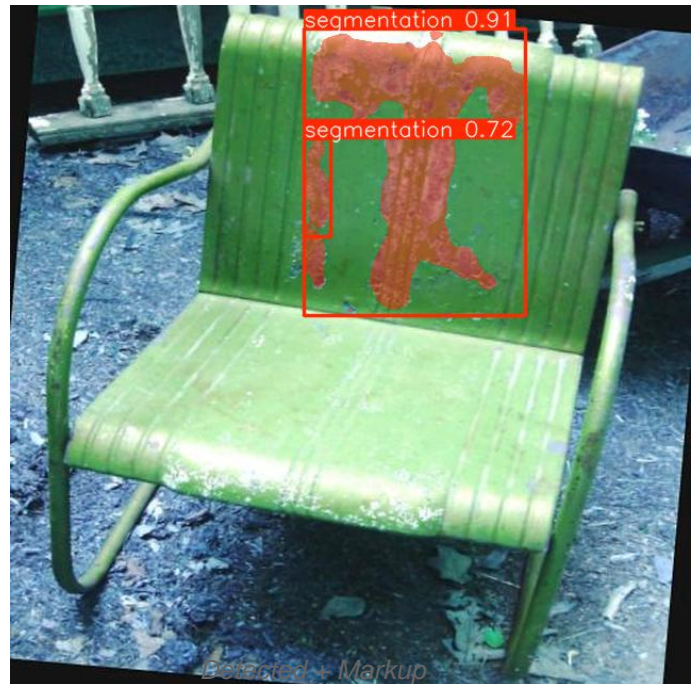
## Detection Result:

(4 spot(s))

High=1, Medium=0, Low=3
