Corrosion Inspection Report

Report: bolt inspection 24.08.2025

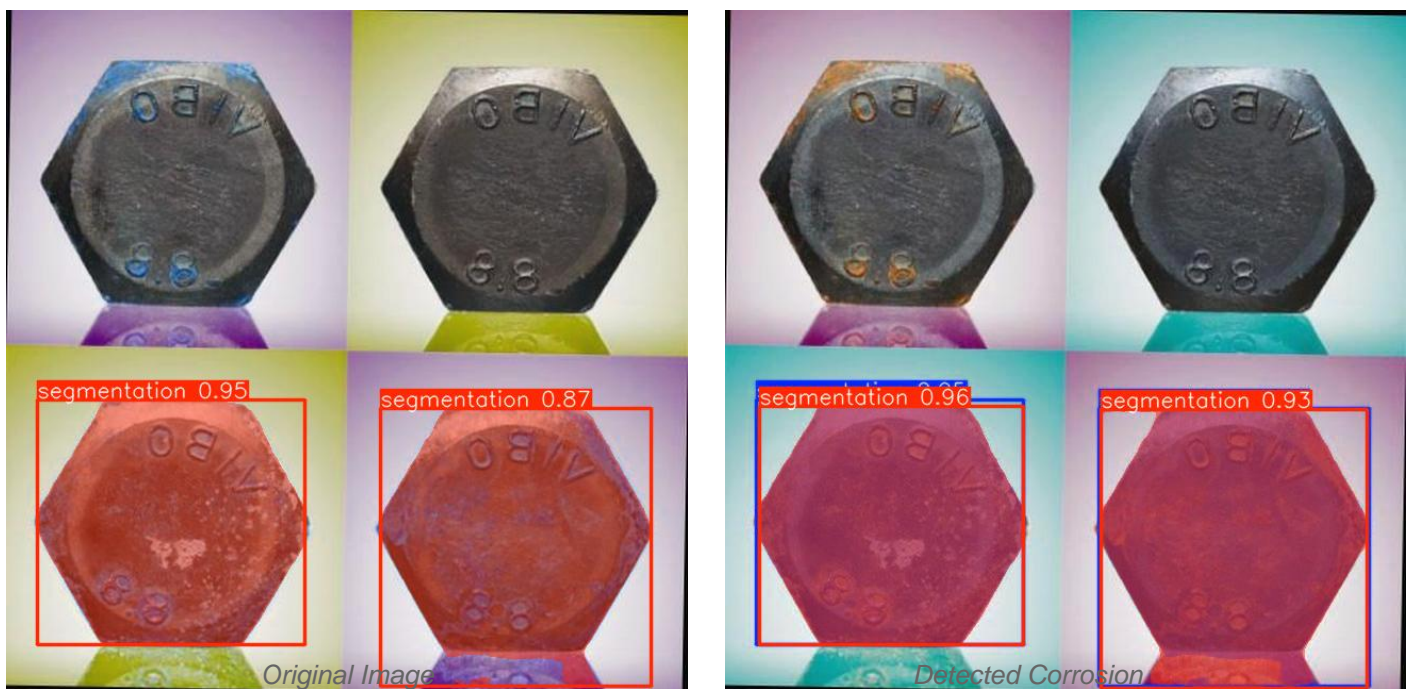
Image: marked_result_bc134143.jpg

Corrosion Detected: PASS (2 spot(s))

Severity: High=2, Medium=0, Low=0
