Corrosion Inspection Report

Image: img138_jpg.rf.7e7c41ed1affe91d34993ac1bc57ba51.jpg

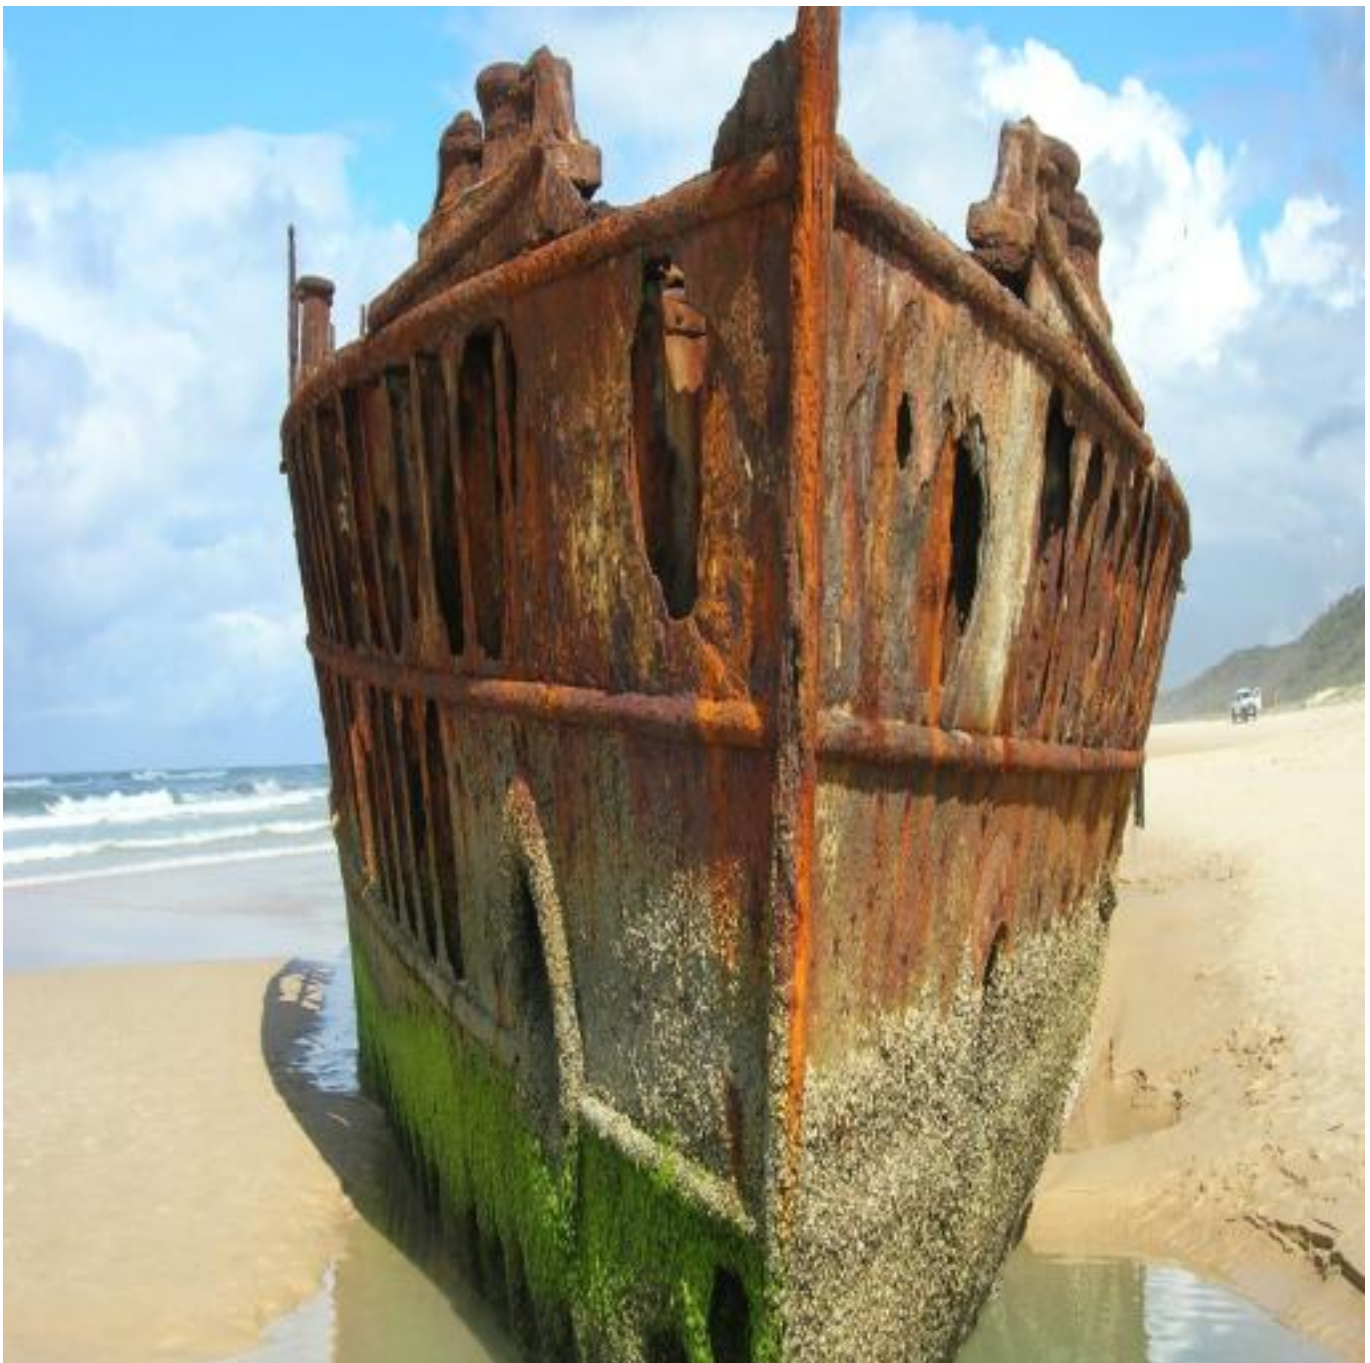
Original Image

Corrosion Detected: PASS (4 spot(s))

Severity: High=1, Medium=0, Low=3
