Corrosion Inspection Report

Image: img11_jpg.rf.5b3bee1524021488f28e3325da7c6bfd.jpg

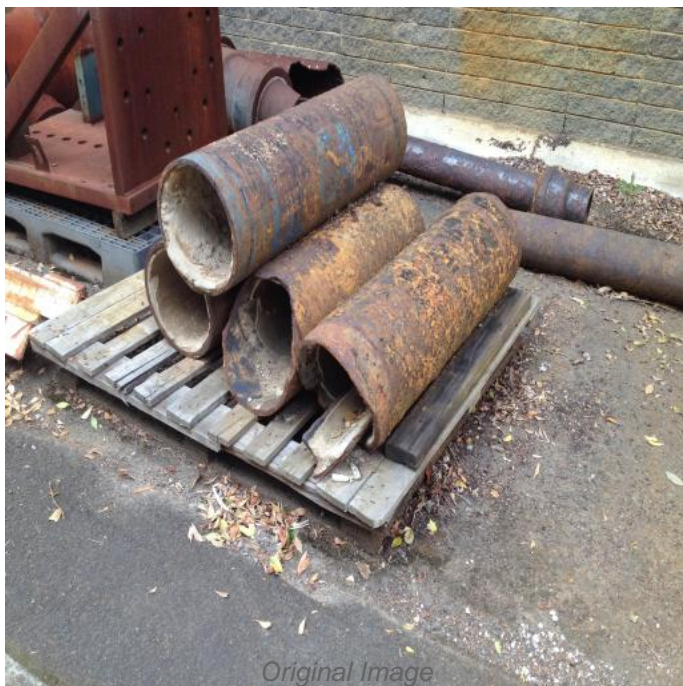
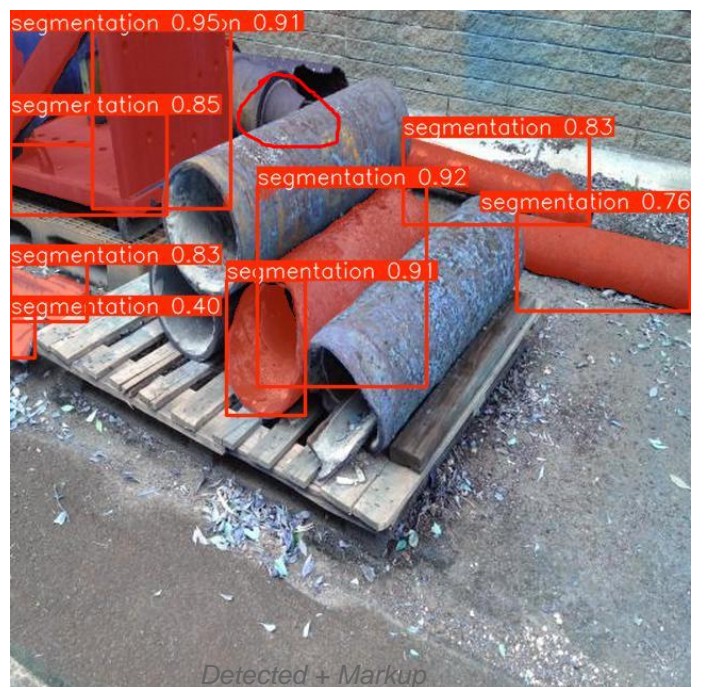
(8 spot(s))

High=3, Medium=0, Low=5

severely
