Corrosion Inspection Report

Image: img61_jpg.rf.4e88909ec64ec528fc831dbcfb8e9481.jpg

Generated on: report_112.pdf

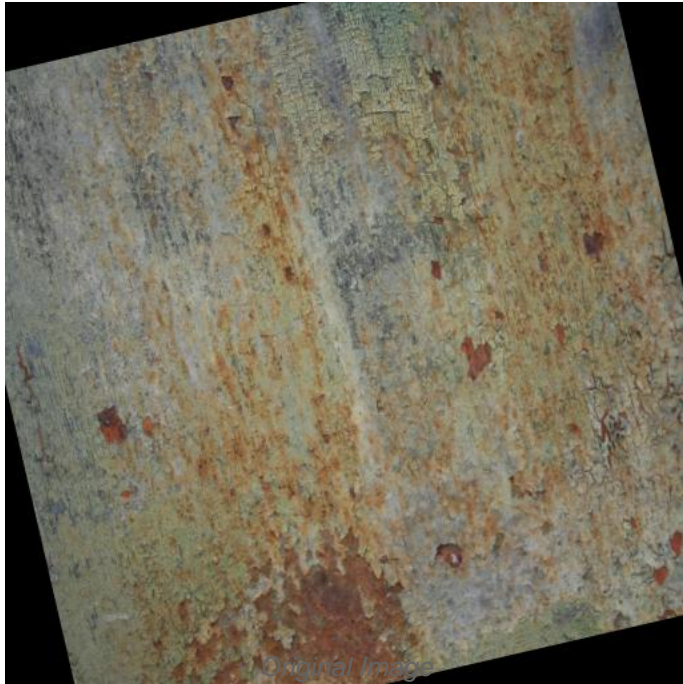
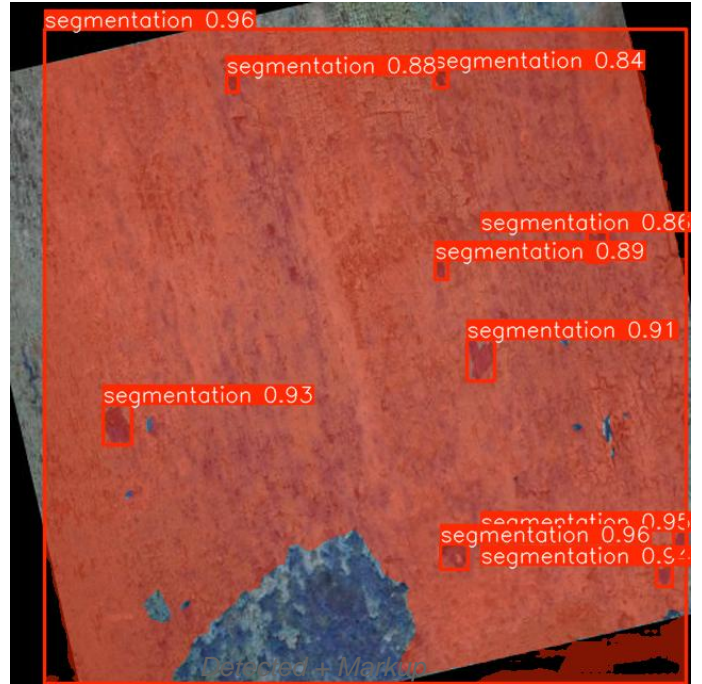
Detection Result:

(1 spot(s))

High=1, Medium=0, Low=0
