DOCUMENT NUMBER: MTN-0075B-18-NA

Motorola Solutions Technical Notification (MTN)

TITLE: APX, SRX Radios, radios cannot access a Type II Trunking site, resulting in retries/ NO COMMS/ unable to key up

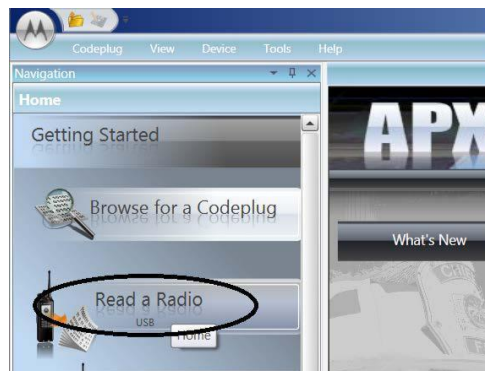
- In the opened codeplug, navigate to Trunking Configuration->Trunking Wide. The last field at the bottom of the Trunking Wide Page is the ISW Window Adjustment Setting.

- Modify the ISW Window Adjustment hex value**, the second field on the right to the correct value listed below in the table. It is possible that some radio models may have the default recommended values already programmed into them.
