Insured: Mark Malony
Property: 3239 Riders Row
Owensboro, KY 42303-4405

Claim Number: 1782D540N

Type of Loss: hail and wind damage

Date of Loss: 3/15/2025 12:00 AM
Date Inspected: 3/29/2025 12:00 AM

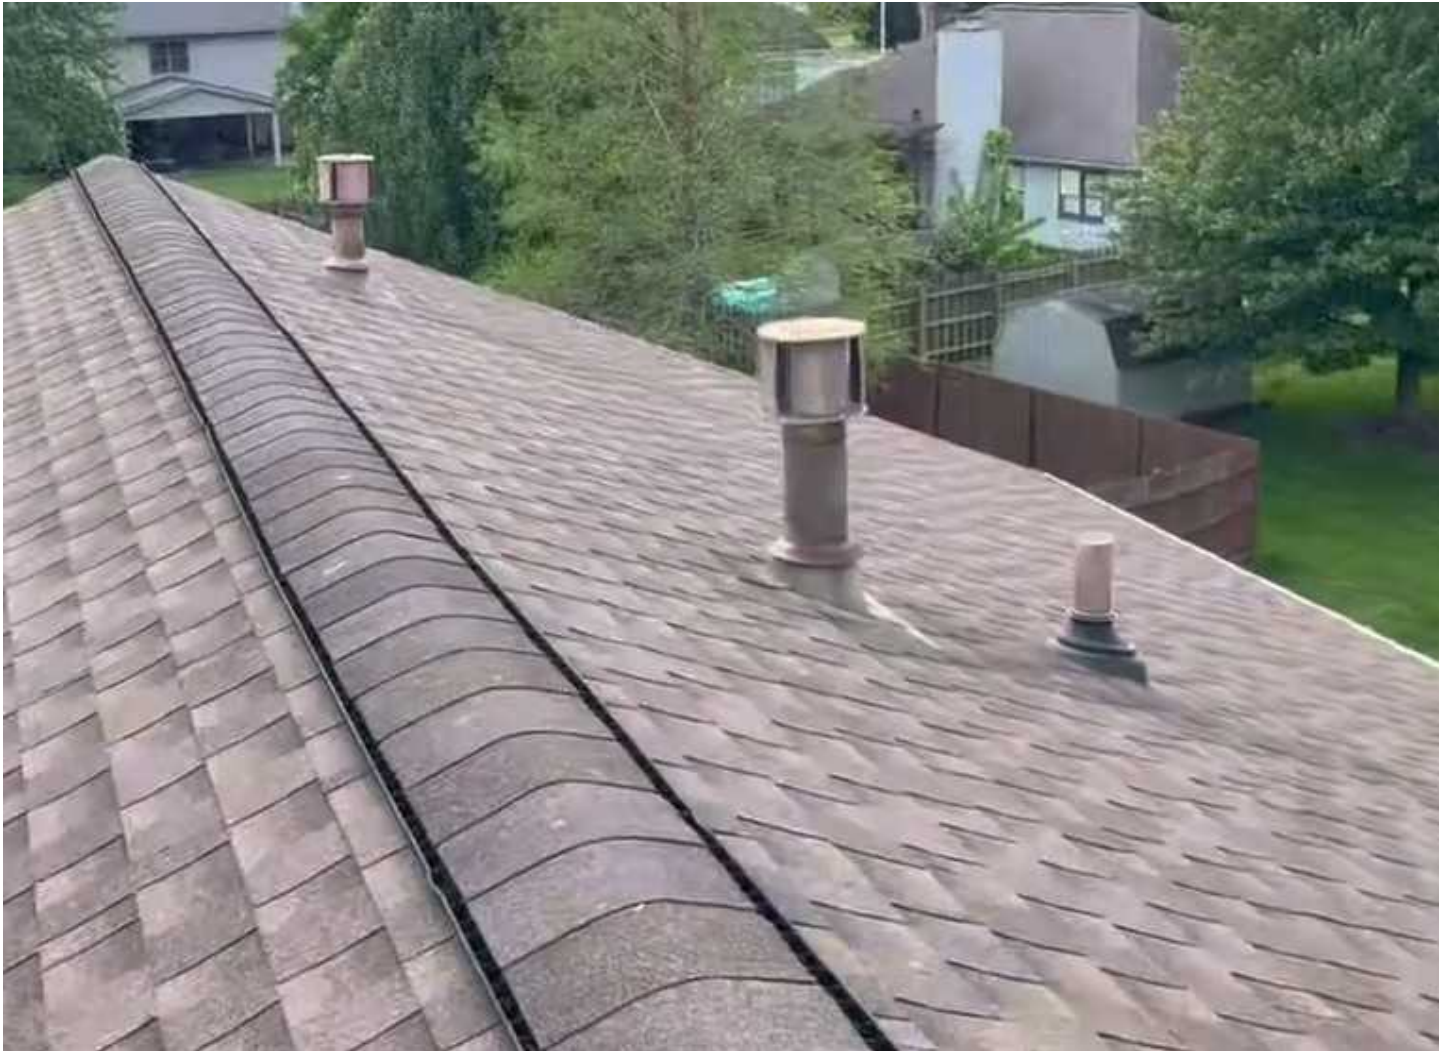
1 Furnace vent on roof

Furnace vent on roof There are two furnace vents on the roof which were overlooked by insurance. Please review and update.

There are two furnace vents on the roof which were overlooked by insurance. Please review and update.

12. R&R Furnace vent - rain cap and storm collar, 5"	2.00 EA	12.53	75.52	4.32	180.42

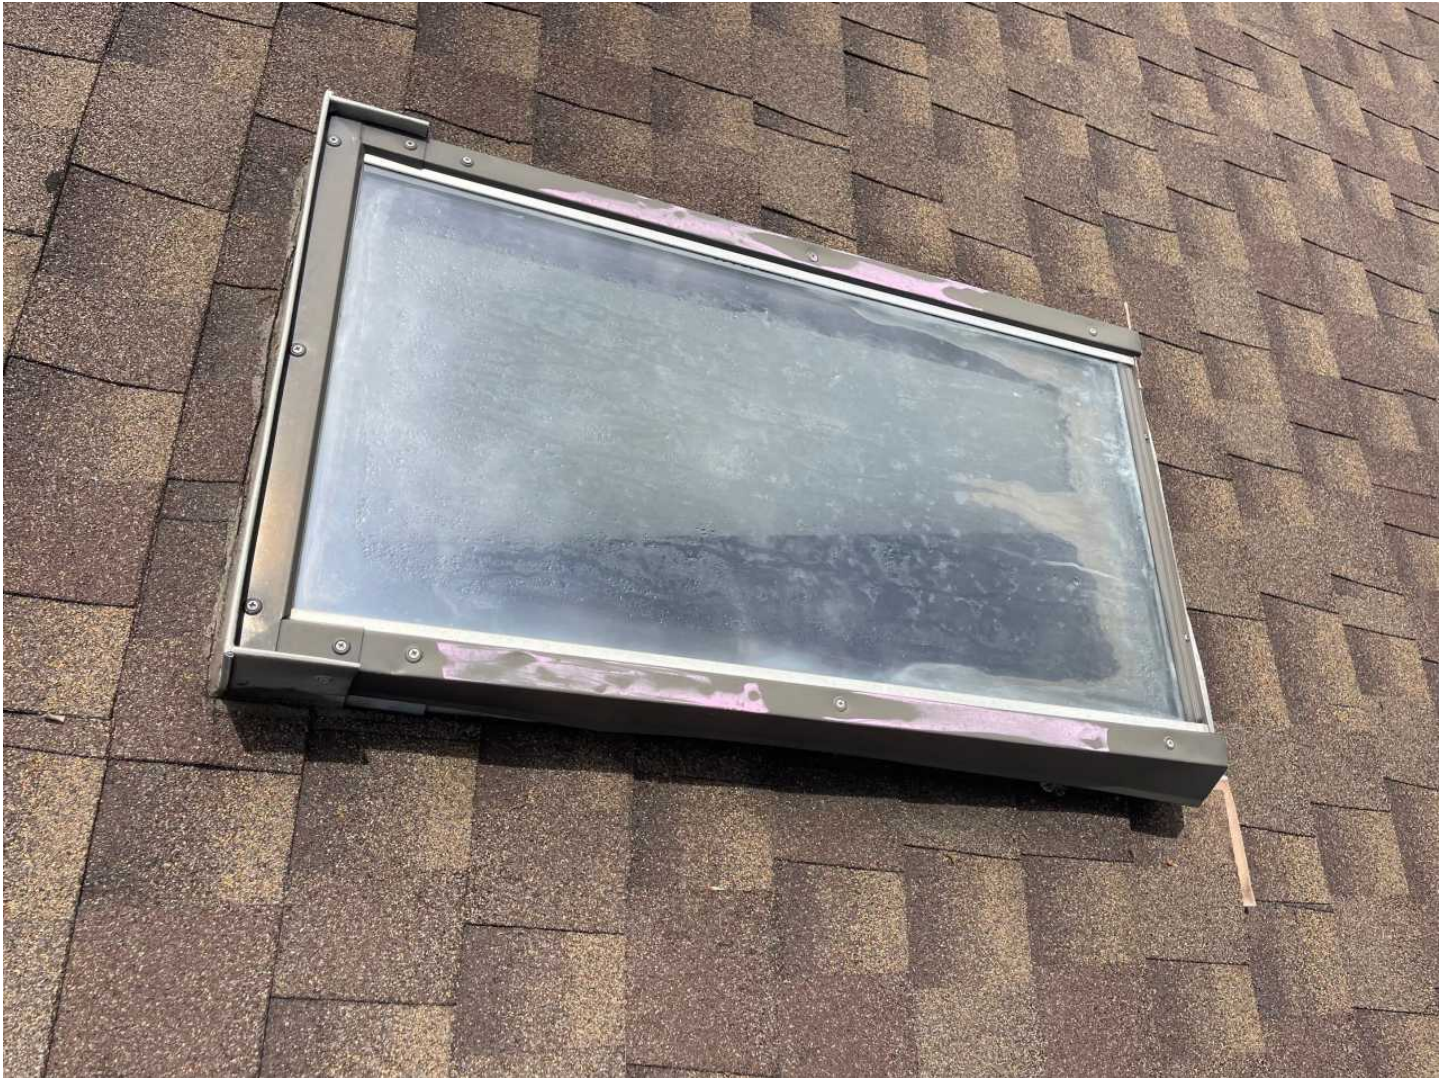
5/7/2025 Skylight damaged Damaged skylight over the roof needs to be removed and replaced.

2 Skylight damaged Date Taken: 5/7/2025 Taken By: Gregory Wood
Damaged skylight over the roof needs to be removed and replaced.

13. R&R Skylight - flat fixed, 6.1 - 9 sf	1.00 EA	52.79	803.76	41.46	898.01

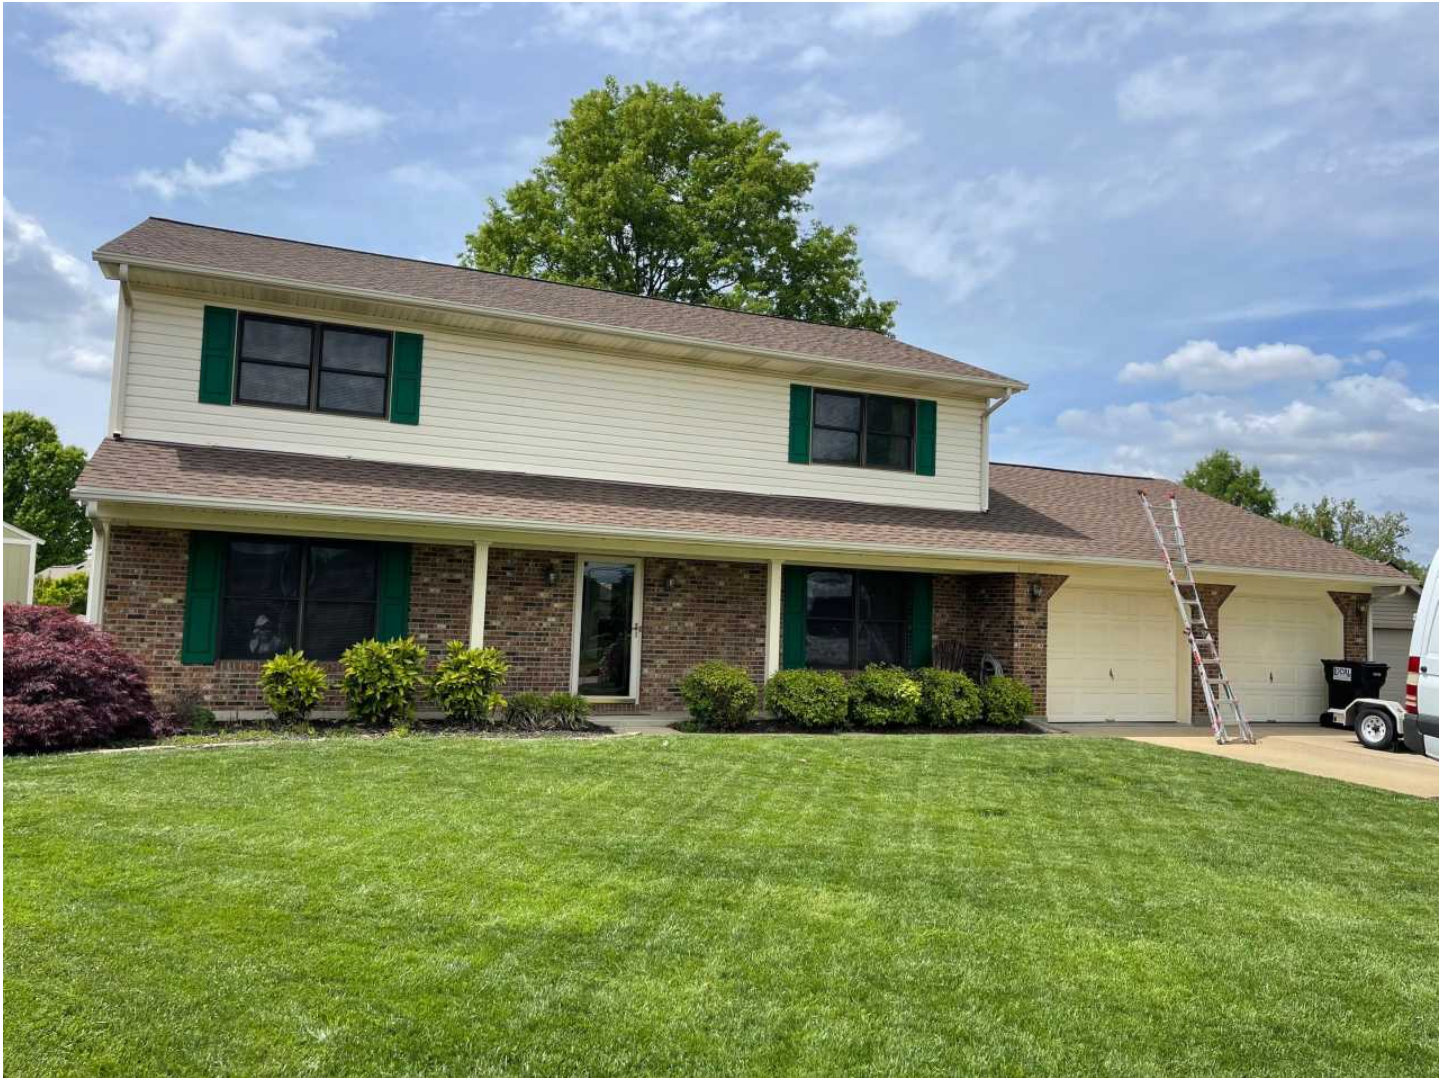
5/7/2025 Counterflashing Counter flashing needs to be replaced where the lower roof meets the vertical wall.

3 Counterflashing Date Taken: 5/7/2025 Taken By: Gregory Wood
Counter flashing needs to be replaced where the lower roof meets the vertical wall.

14. R&R Counterflashing - Apron flashing	41.00 LF	0.68	9.46	5.12	420.86

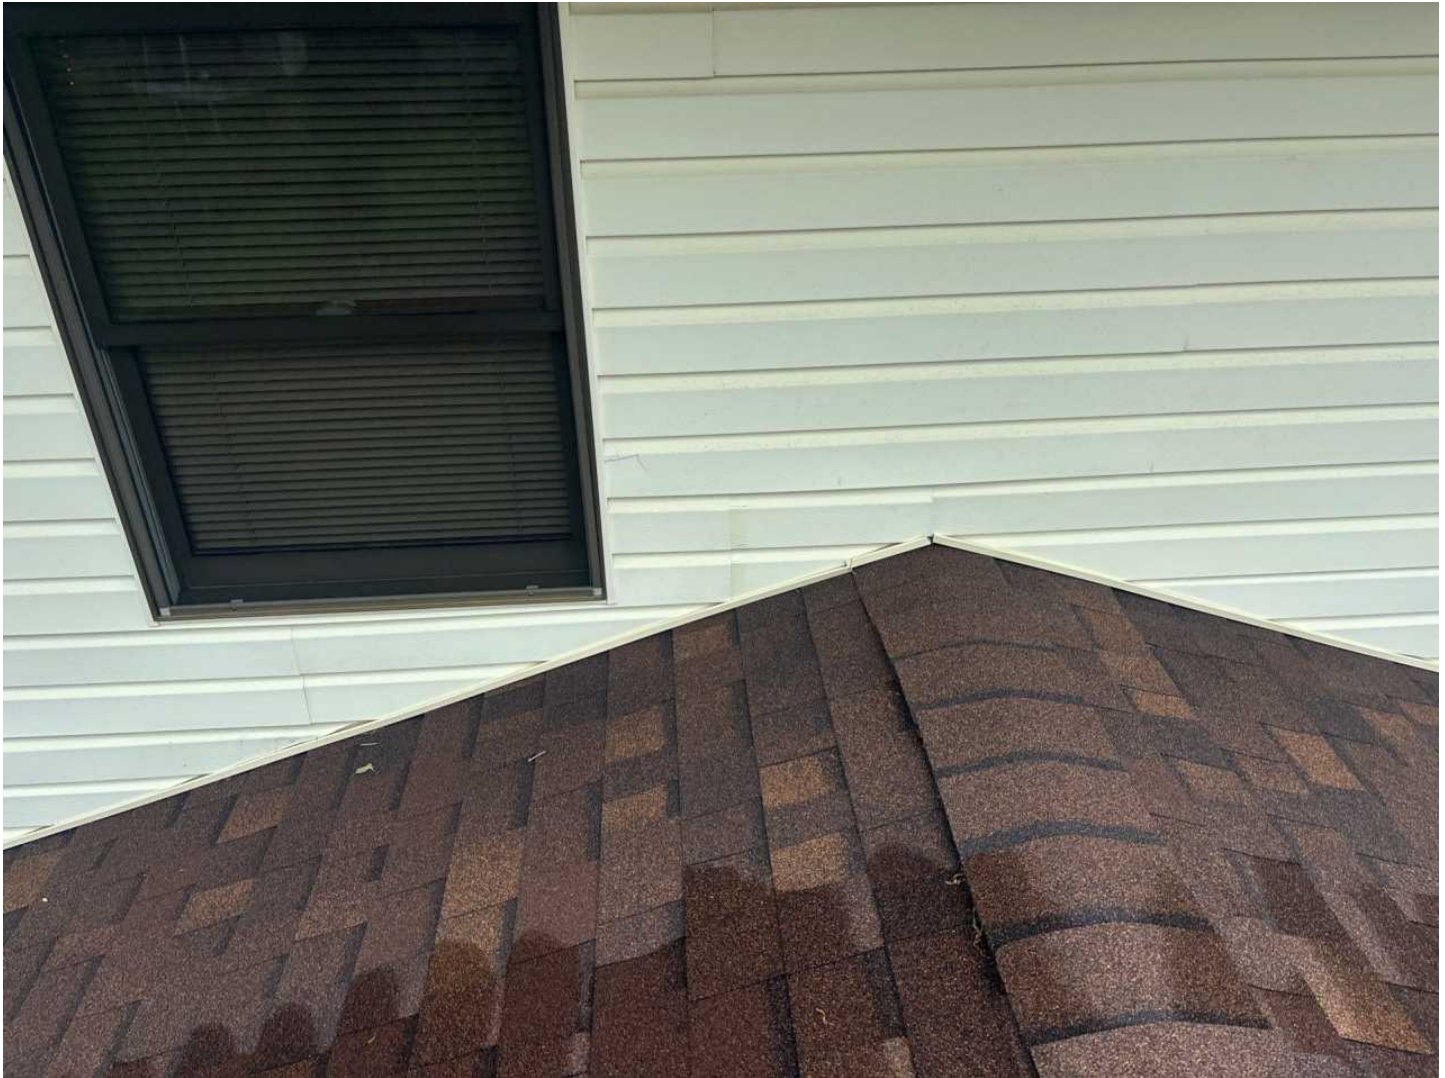
5/8/2025 Step flashing Step flashing is required where slope roof meets the vertical wall.					
16. Remove Additional charge for high roof (2 stories or greater)	7.37 SQ	6.18	0.00	0.00	45.55

4 Step flashing Date Taken: 5/8/2025 Taken By: Gregory Wood
Step flashing is required where slope roof meets the vertical wall.

15. Step flashing	33.00 LF	0.00	9.49	4.44	317.61

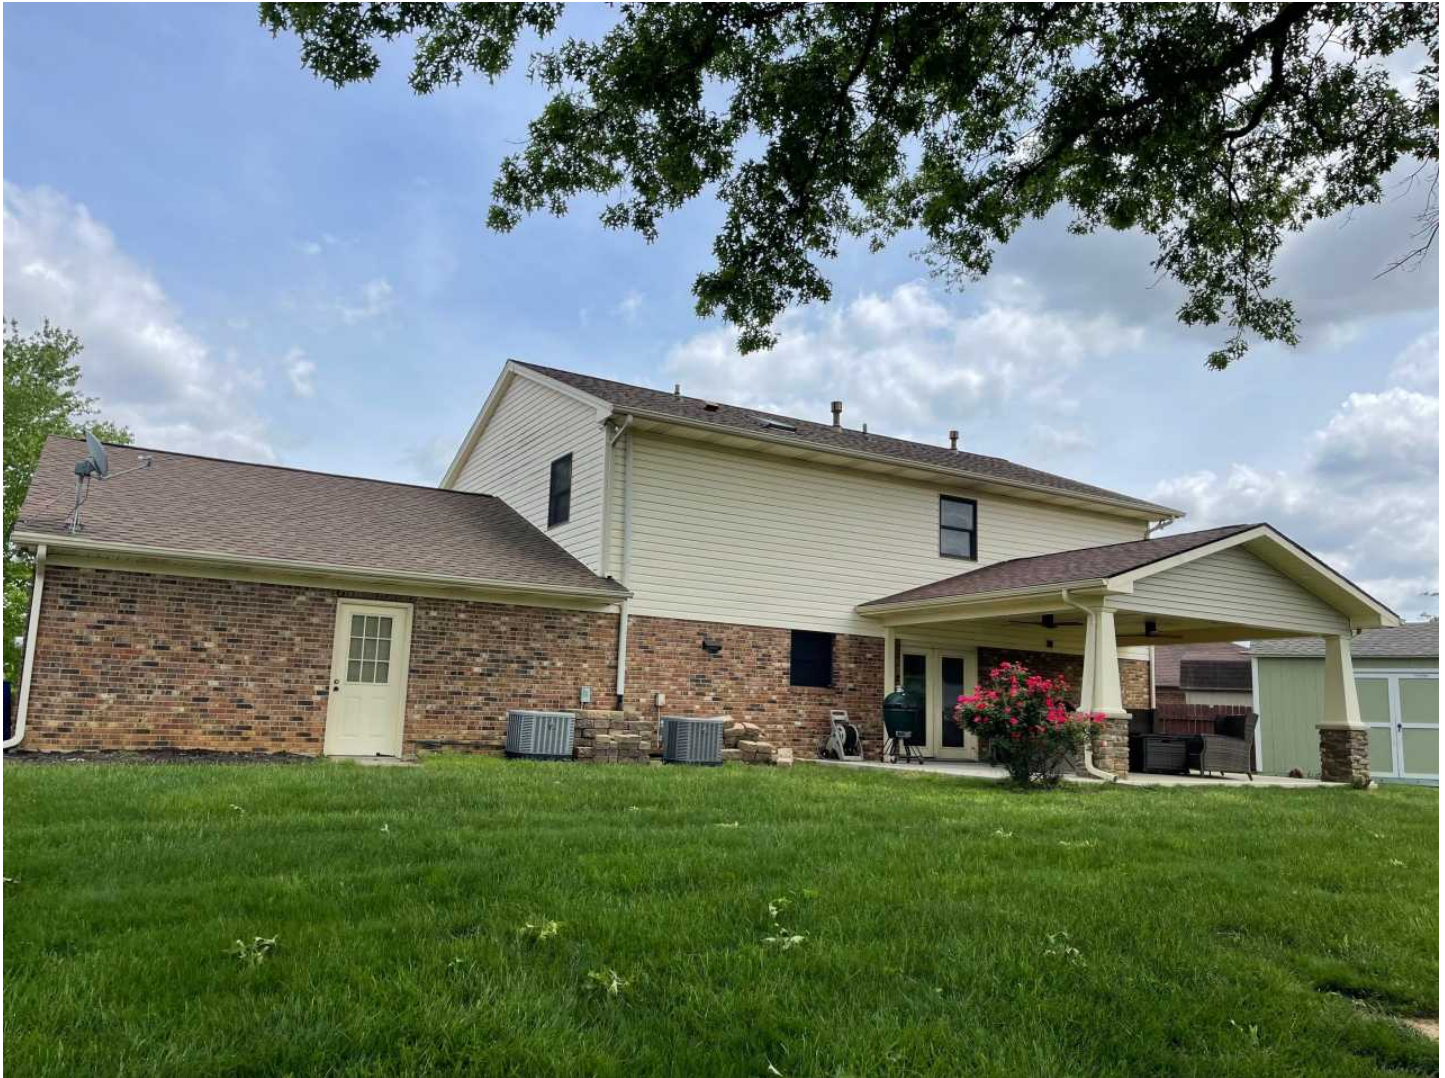
5/7/2025 High roof Additional charges to be accounted for tearing off the two-storey part of the dwelling roof.

5 High roof Date Taken: 5/7/2025 Taken By: Gregory Wood
Additional charges to be accounted for tearing off the two-storey part of the dwelling roof.

17. Additional charge for high roof (2 stories or greater)	7.37 SQ	0.00	17.72	0.00	130.60
<i>Additional charges to be accounted for replacement of high part of dwelling roof.</i>

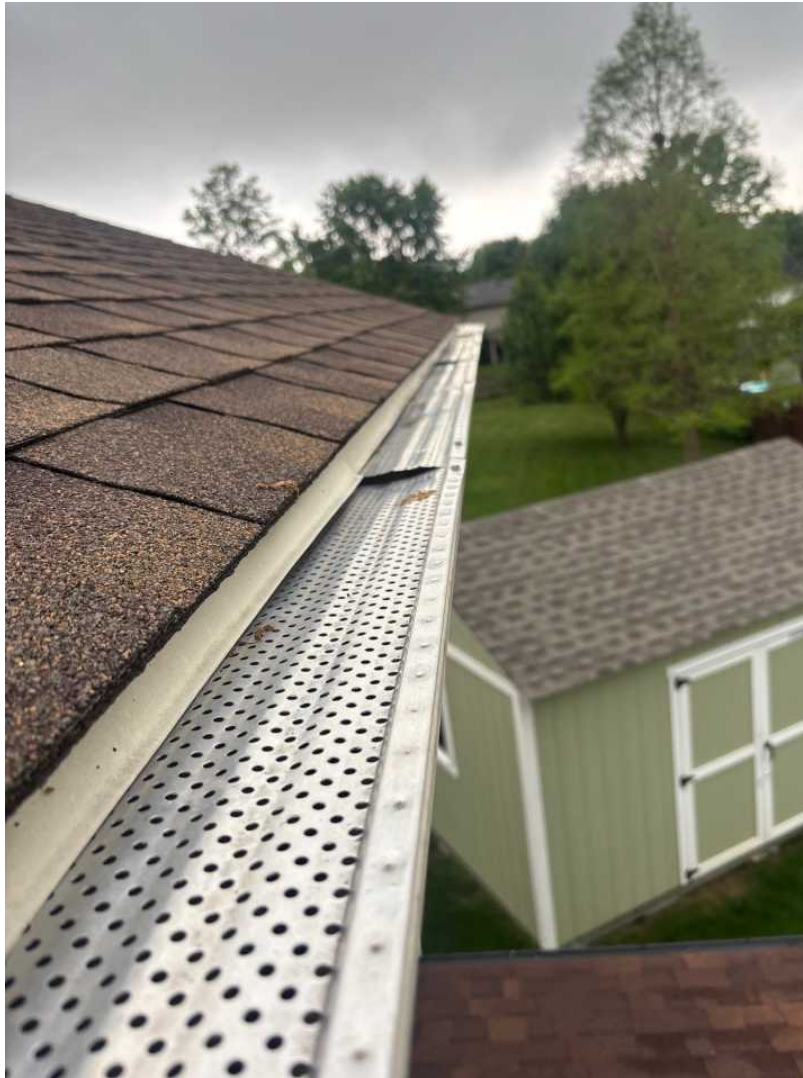
5/8/2025 Gutter screen Gutter screen on the eaves is damaged and therefore needs to be replaced.					
Totals: Dwelling Roof				385.51	15,675.30

6 Gutter screen Date Taken: 5/8/2025 Taken By: Gregory Wood
Gutter screen on the eaves is damaged and therefore needs to be replaced.

18. R&R Gutter guard/screen	173.00 LF	0.44	3.76	14.84	741.44

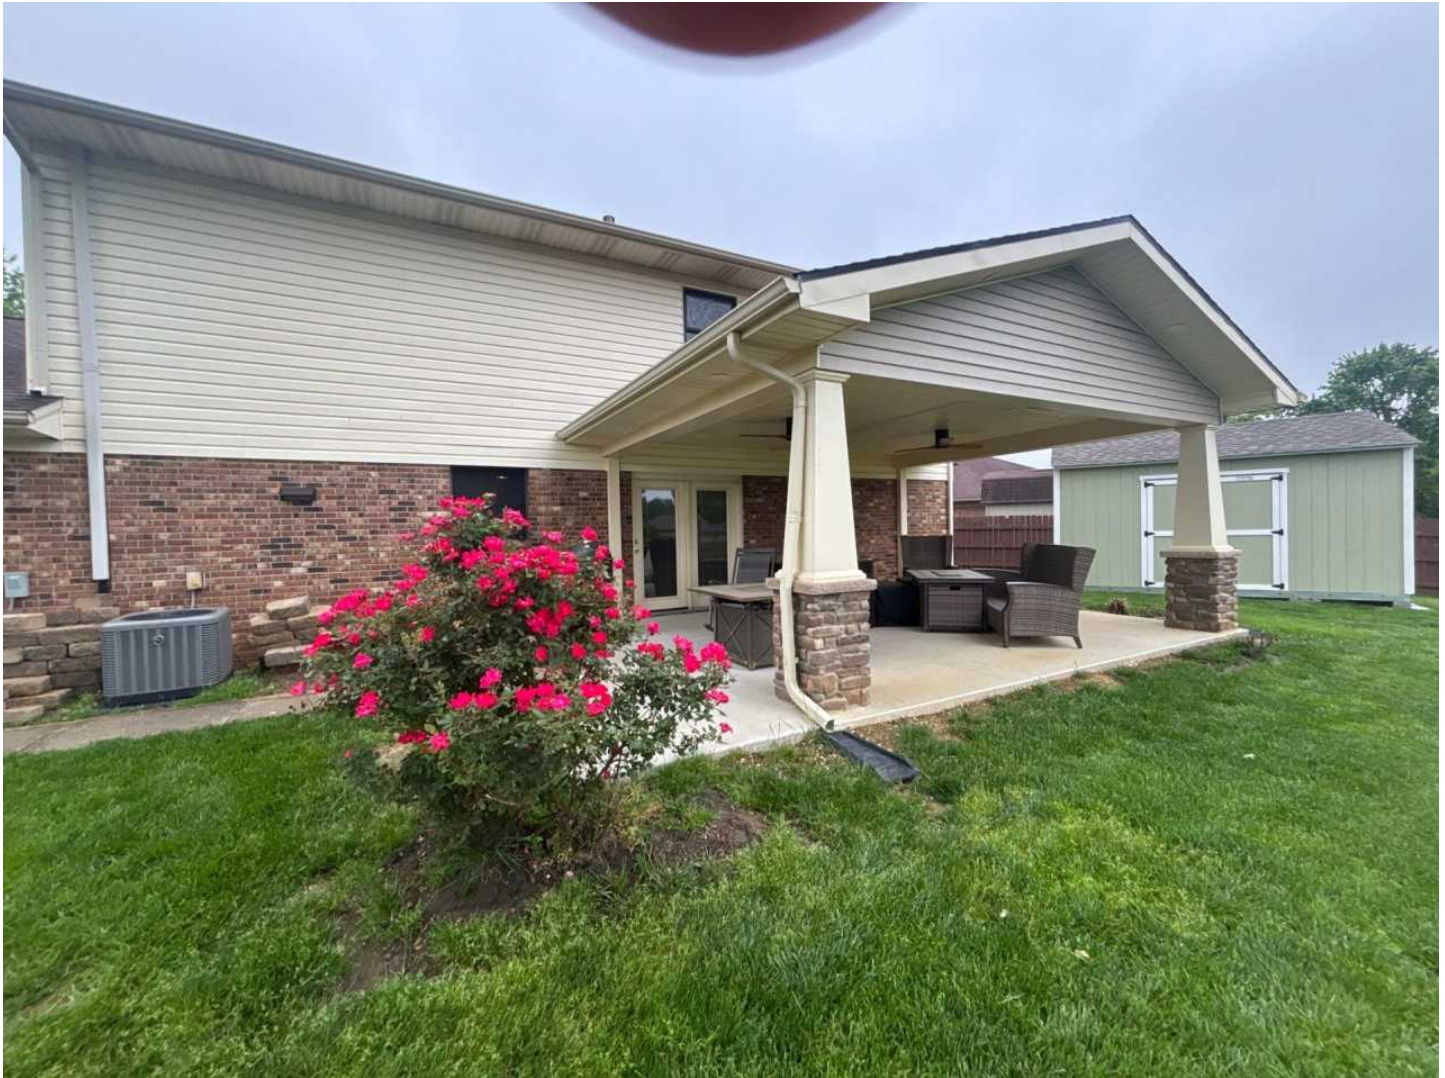
7 Patio Roof Date Taken: 5/8/2025 Taken By: Gregory Wood

***Patio roof on the front was missed/overlooked by insurance. Please review and include the removal and replacement of whole roof since damaged. The line items below account for the complete removal and replacement of this front patio roof. ***

19. Tear off, haul and dispose of comp. shingles - Laminated	4.23 SQ	62.09	0.00	0.00	262.64
20. Roofing felt - 15 lb.	4.23 SQ	0.00	31.49	2.21	135.41
21. Asphalt starter - universal starter course	83.72 LF	0.00	1.72	3.27	147.27
22. Laminated - comp. shingle rfg. - w/out felt	4.67 SQ	0.00	239.65	36.74	1,155.91
23. R&R Hip / Ridge cap - Standard profile - composition shingles	17.00 LF	2.45	5.24	2.65	133.38
24. R&R Drip edge	83.72 LF	0.38	2.60	5.83	255.31
25. R&R Continuous ridge vent - shingle-over style	13.60 LF	0.99	9.29	3.68	143.48
26. Step flashing	23.67 LF	0.00	9.49	3.18	227.81
27. R&R Gutter guard/screen	34.00 LF	0.44	3.76	2.92	145.72

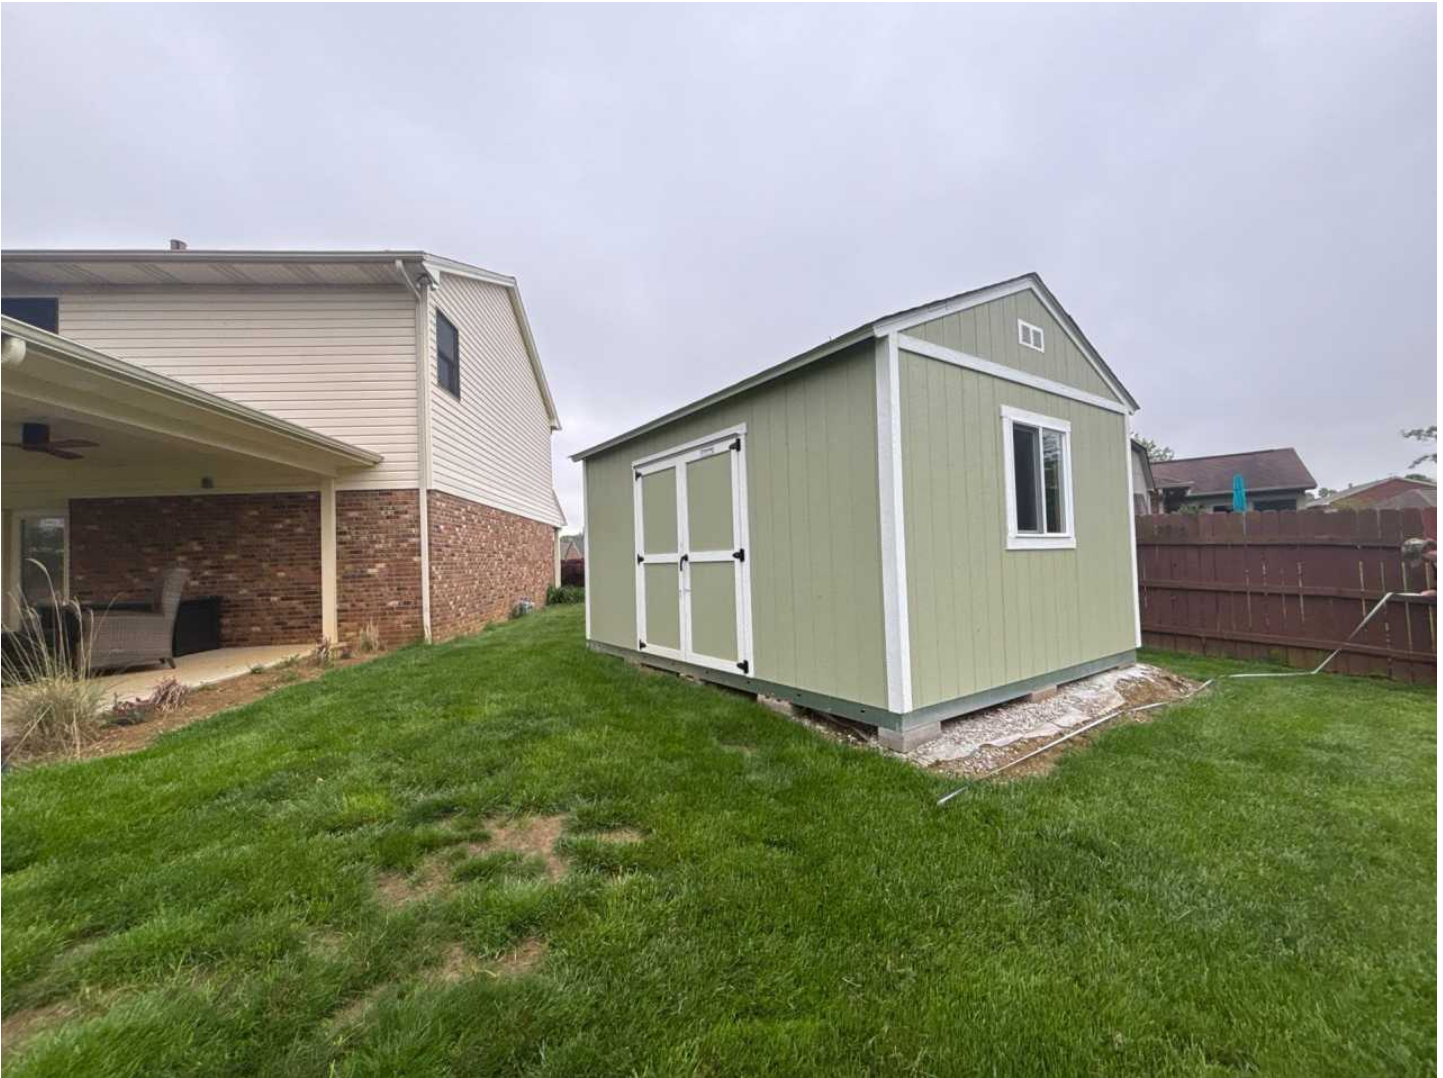
8 Detached shed Date Taken: 5/8/2025 Taken By: Gregory Wood

DESCRIPTION	QTY	REMOVE	REPLACE	TAX	TOTAL
<i>**This detached shed was overlooked by the insurance. Please review and include since it was damaged. The below line items account for the complete removal and replacement of this shed.**</i>					
28. Tear off, haul and dispose of comp. shingles - Laminated	2.70 SQ	62.09	0.00	0.00	167.64

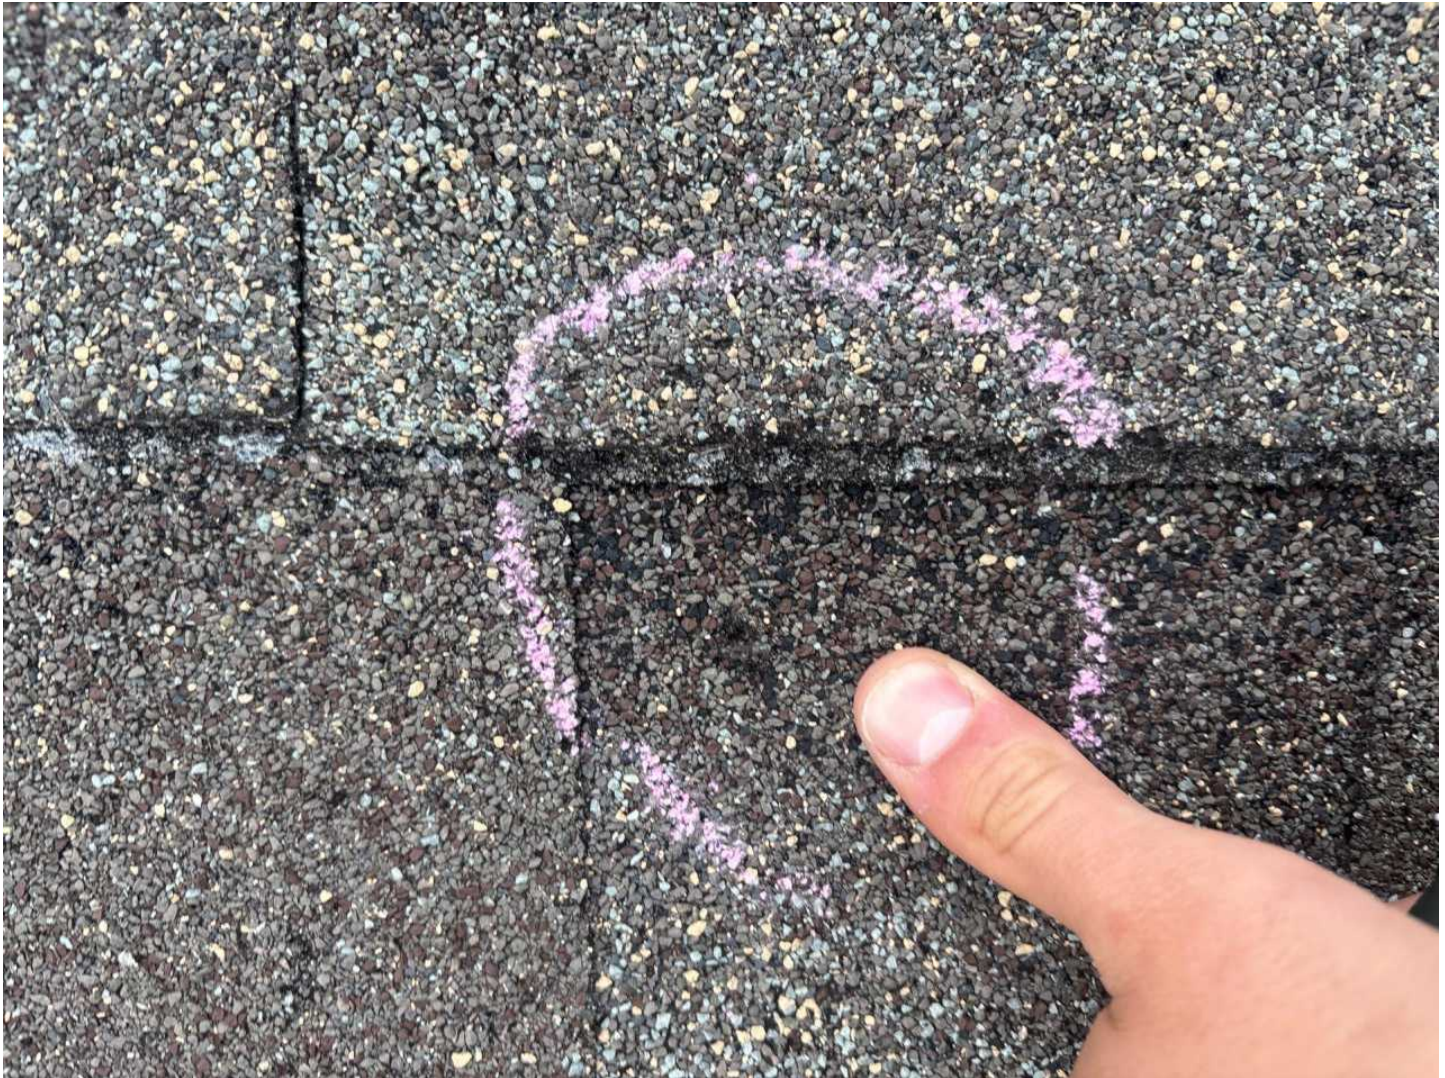
5/8/2025 Damage - Shed roof Damage to shed roof.					
29. Roofing felt - 15 lb.	2.70 SQ	0.00	31.49	1.41	86.43
30. Asphalt starter - universal starter course	65.73 LF	0.00	1.72	2.56	115.62
31. Laminated - comp. shingle rfg. - w/out felt	3.00 SQ	0.00	239.65	23.60	742.55
32. R&R Hip / Ridge cap - Standard profile - composition shingles	16.00 LF	2.45	5.24	2.50	125.54
33. R&R Drip edge	65.73 LF	0.38	2.60	4.58	200.46
Totals: Detached Shed				34.65	1,438.24

9 Damage - Shed roof Date Taken: 5/8/2025 Taken By: Gregory Wood
Damage to shed roof.
