STM32L476xx/STM32L486xx device limitations

Silicon identification

This errata sheet applies to revisions '3' and '4' of the STMicroelectronics STM32L476xx and STM32L486xx products. The STM32L4x6xx family features an ARM® 32-bit Cortex®-M4 core.

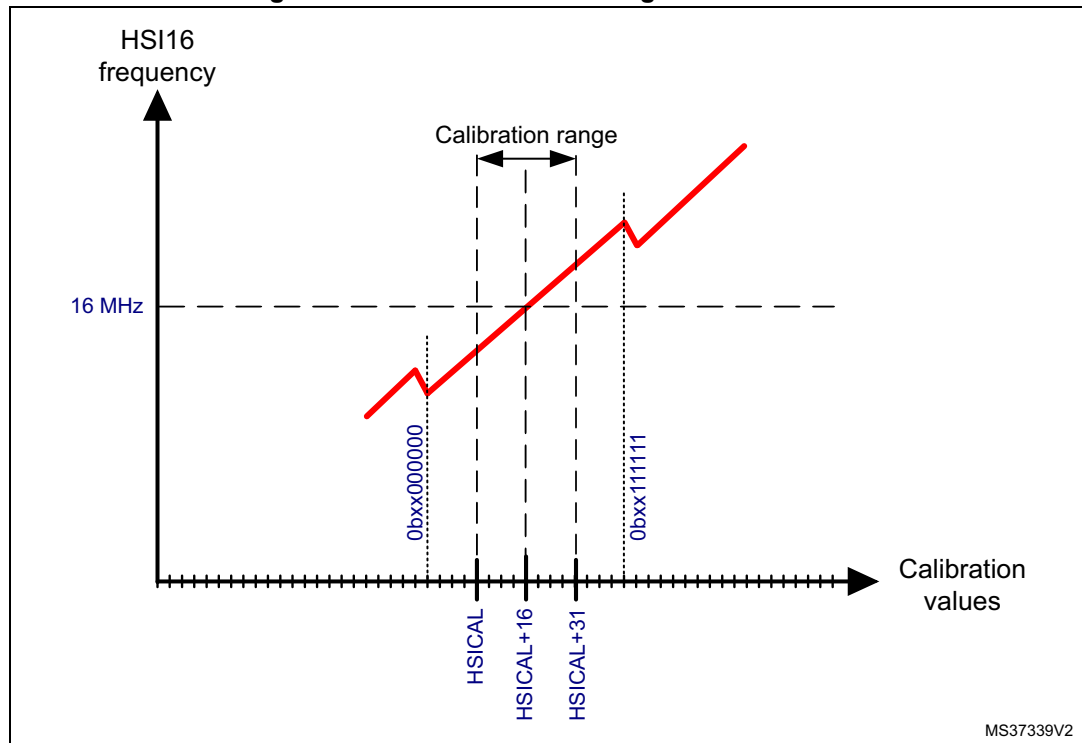
Figure 1. HSI oscillator trimming characteristics

2.1.10 HSI user trim is limited on some samples**Description**

Consequently, the user trim correction must not jump over the codes multiple of 64, which can limit the user correction either in positive or in negative direction.

Workaround

None.

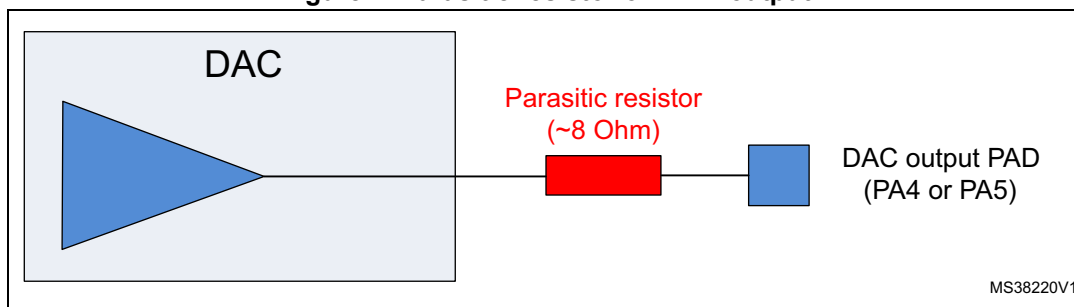
Figure 2. Parasitic resistor on DAC output

2.15.4 DAC characteristics can be degraded depending on the current sunk on DAC output

Resistor value between DAC outputs and I/O (PA4 or PA5) is greater than expected: 8ohm typical, as shown in [Figure 2](#). As a consequence the DAC characteristics can be impacted depending on the current sunk on DAC output.

Workaround

None.

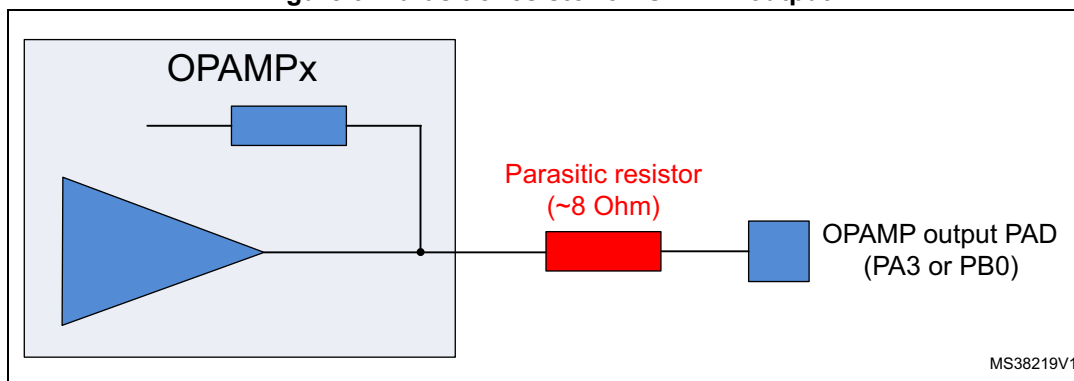
Figure 3. Parasitic resistor on OPAMP output

2.16.1 OPAMP characteristics can be degraded depending on the current sunk on OPAMP output

Resistor value between OPAMP outputs and I/O (PA3 or PB0) is greater than expected: 8 ohm typical, as shown in [Figure 3](#). As a consequence the OPAMP characteristics can be impacted depending on the current sunk on the output.

Workaround

None.
