Job Site

CRAWLEY RTW,
PRIESTLEY WAY,
CRAWLEY,
RH10 9NT

Job Number	16944	Reference	475.100.
Logged	25/09/2024	Job Type	Contract - PUWER
Contact	Michael William	Tel.	01293 721800

PUWER Inspections

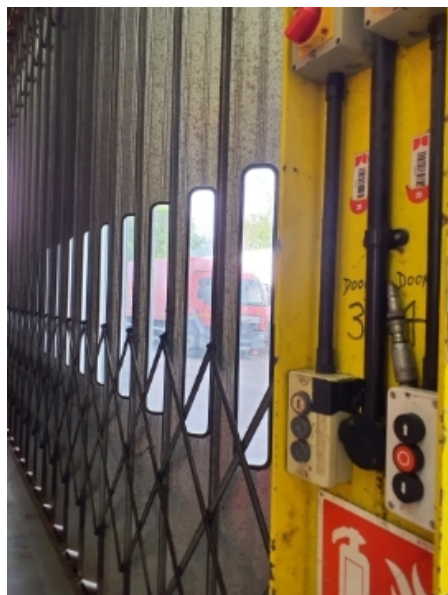
ISI Equipment No	Make / Model	Serial No	Client ID
0000152256	Door Powered Vertical		0000152256

Intolerable - Defects requiring immediate action	None
Substantial - Defects requiring attention within a time period	None
Moderate - Other defects requiring attention	The travel of the leading edge of the door within floor guide is compromised causing operation to stop when opening.
Tolerable - Observations	None
