CRAWLEY DO/RET,  
7 THE BOULEVARD,  
CRAWLEY,  
RH10 1AA

<b>Job Number</b>	16946	<b>Reference</b>	1480.100.
<b>Logged</b>	25/09/2024	<b>Job Type</b>	Contract - PUWER
<b>Contact</b>	Nuno Dias	<b>Tel.</b>	01293 574001

PUWER Inspections

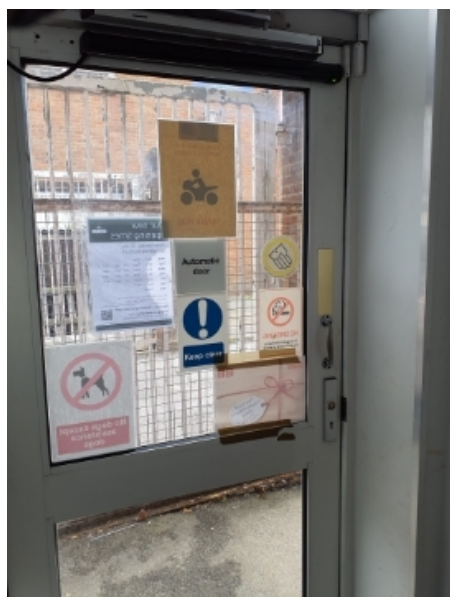
Capture photograph of Asset, including asset number	See Photo 1
---	-------------

ISI Equipment No	Make / Model	Serial No	Client ID
000000000000150	Door Automatic Pedestrian		000000000000150

Intolerable - Defects requiring immediate action	None
Substantial - Defects requiring attention within a time period	None
Moderate - Other defects requiring attention	None
Tolerable - Observations	None

None

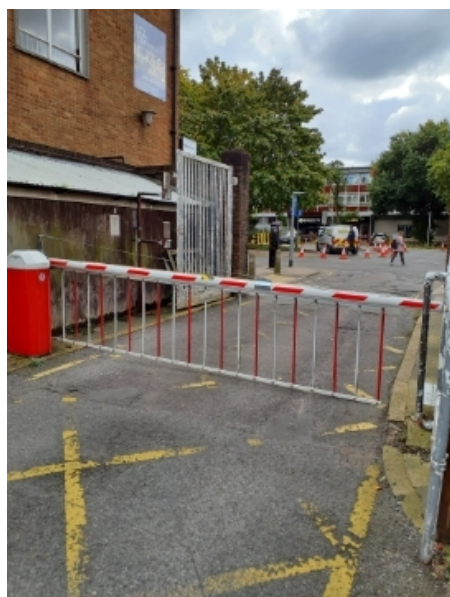
Capture photograph of Asset, including asset number	See Photo 1
---	-------------

ISI Equipment No	Make / Model	Serial No	Client ID
0000680645	Barrier Traffic		0000680645

Intolerable - Defects requiring immediate action	None
Substantial - Defects requiring attention within a time period	None
Moderate - Other defects requiring attention	None
Tolerable - Observations	None

None

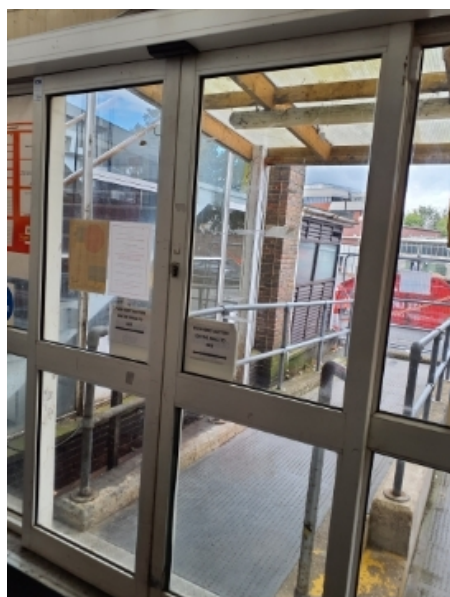
Capture photograph of Asset, including asset number	See Photo 1
---	-------------

ISI Equipment No	Make / Model	Serial No	Client ID
0000000000000151	Door Automatic Pedestrian		0000000000000151

Intolerable - Defects requiring immediate action	None
Substantial - Defects requiring attention within a time period	None
Moderate - Other defects requiring attention	None
Tolerable - Observations	None

None
