Pipeline Defect Detection Report

Generated: 2026-02-08 19:11:59

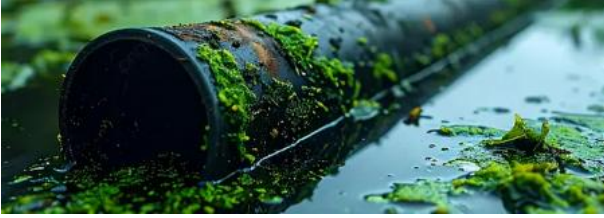
1. PIPE_001 - CRACK

Status: CRACK

Affected Area: 50.82%

CRACK Detected! Found 1 linear region(s). Geometry: High Aspect Ratio.

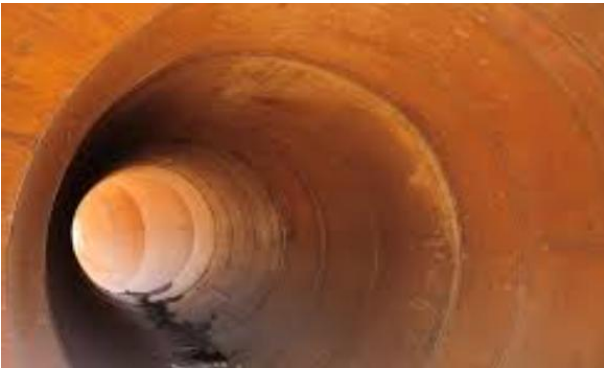
2. PIPE_002 - INVALID

Status: INVALID

INVALID: No Pipe Detected. Largest Object is only 5.0% of image (Threshold 10%).

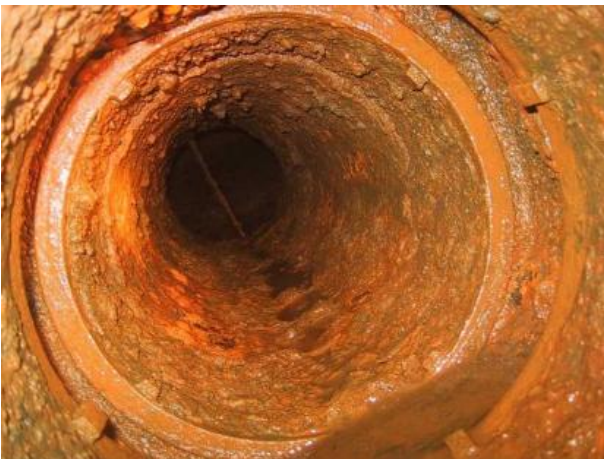
3. PIPE_003 - HEALTHY

Status: HEALTHY

Minor anomalies detected but classified as Normal/Noise.

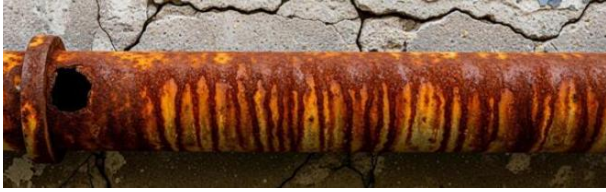
4. PIPE_004 - CRACK

Status: CRACK

Affected Area: 74.63%

CRACK Detected! Found 2 linear region(s). Geometry: High Aspect Ratio.

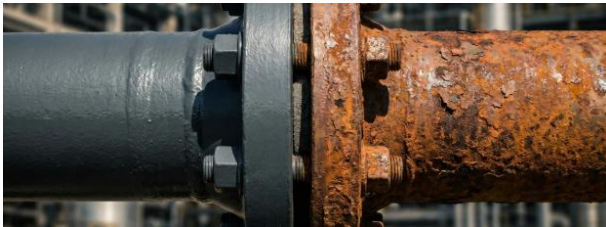
5. PIPE_005 - CORROSION

Status: CORROSION

Affected Area: 66.84%

CORROSION Detected. Found 4 irregular region(s). Geometry: High Solidity + Red/Brown Color.

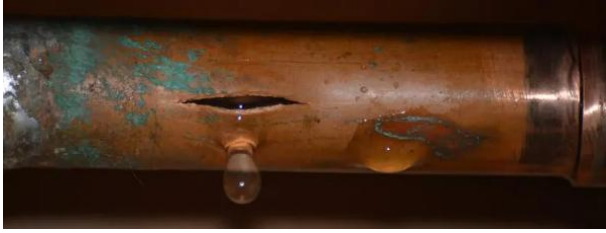
8. PIPE_008 - CRACK

Status: CRACK

Affected Area: 72.45%

CRACK Detected! Found 4 linear region(s). Geometry: High Aspect Ratio.

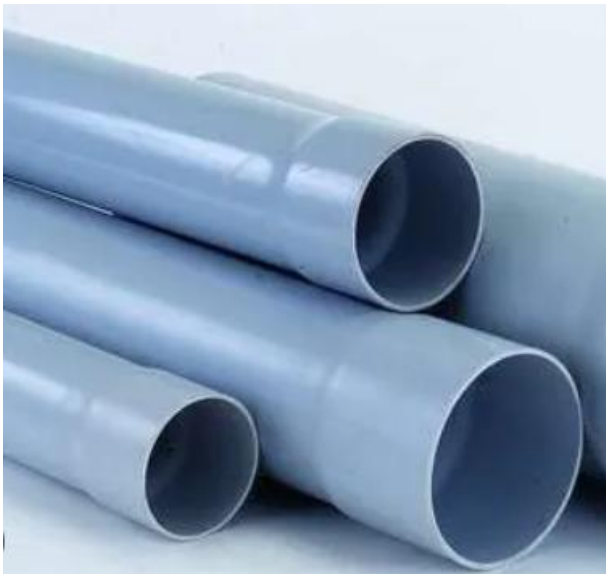
10. PIPE_010 - CRACK

Status: CRACK

Affected Area: 24.01%

CRACK Detected! Found 2 linear region(s). Geometry: High Aspect Ratio.
