CE3115 Experiment G4A—Slope Design

Mohanadas Harish Chandar (U067314J)

A back-analysis of a slope failure was conducted for the client Department of Civil Engineering, National University of Singapore.

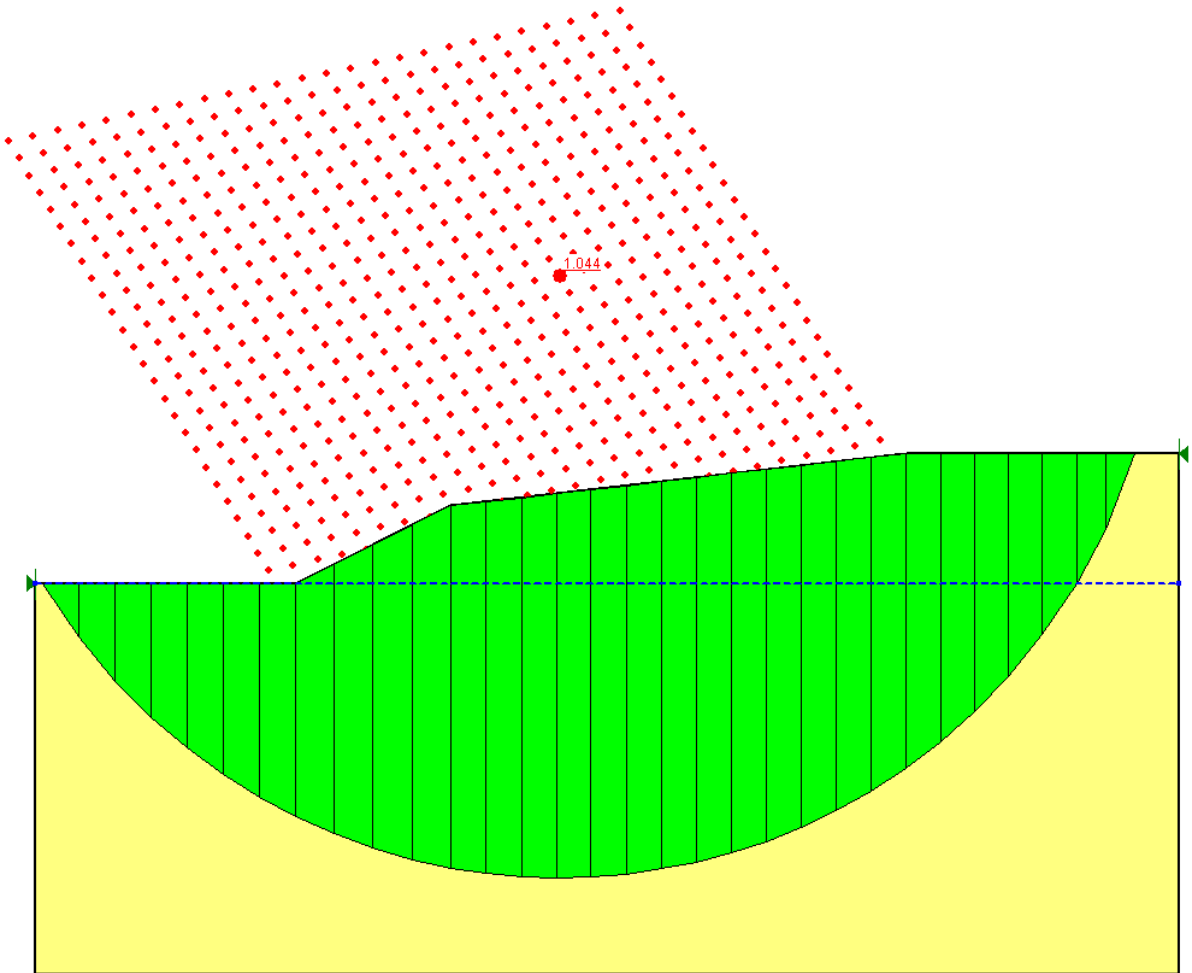
The undrained analysis (see Figure 1) revealed that in the short term the safety factor was above 1. Thus, it did not fail. However, the safety factor was below 1.3 and thus it did not meet the design requirements.

Figure 1: Conditions just after slope was cut. Safety factor is above 1 but still below design requirement of 1.3.

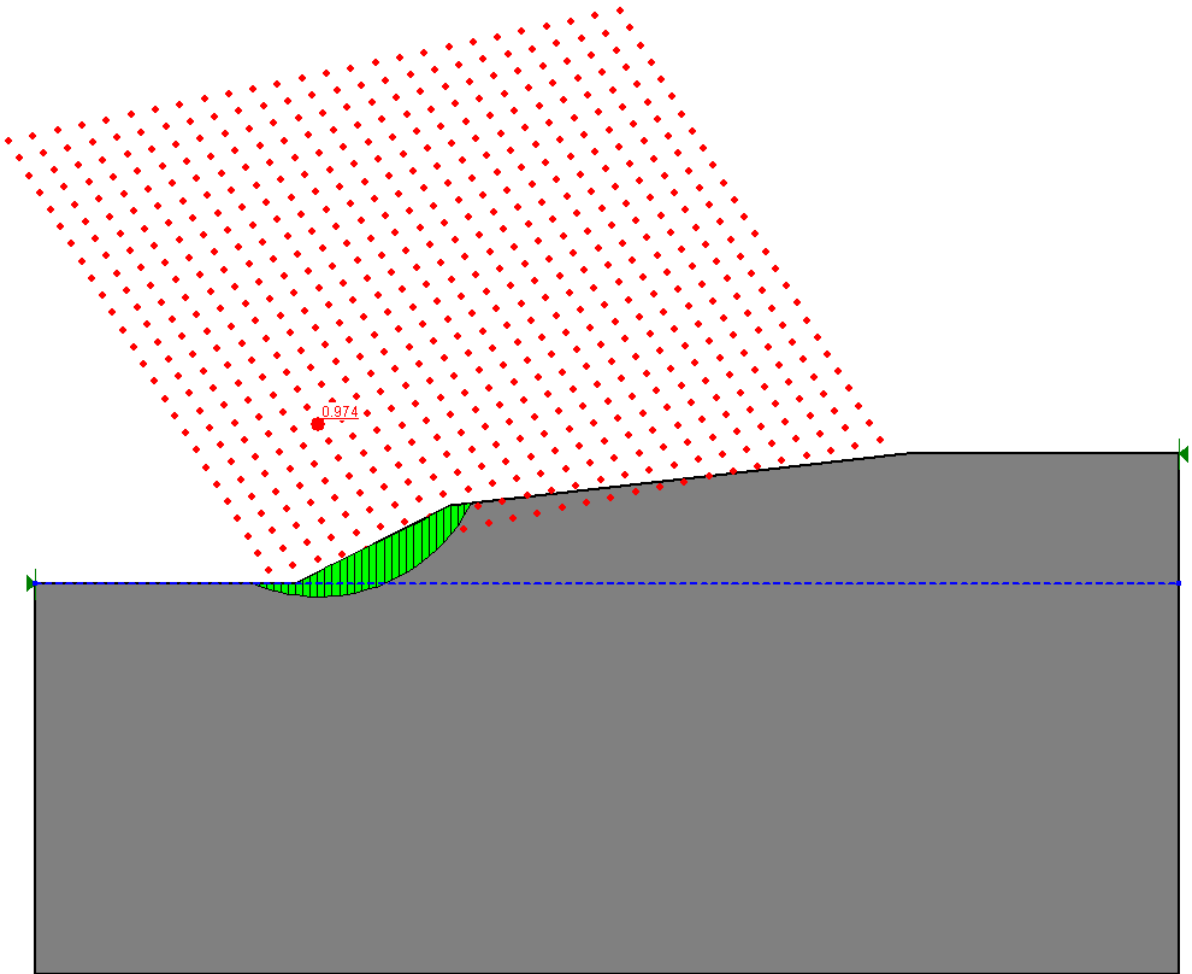
The slope failed in the long term as the safety factor become less than 1. This was found to be the case for several different water table conditions. Figure 2 shows one such condition.

The mechanism of failure is as follows. Due to unloading because of excavation, pore water pressure increased over time. This lead to reduced effective stress and thus reduced shear strength in the soil. Reduced shear strength in turn lead to reduced maximum resisting moments. Failure occured when the maximum resisting moment for the failure surface could no longer overcome the disturbing moment.

Figure 2: Conditions at slope failure for one of the water table condition. Failure occurs as safety factor is below 1.

For long term excavations, the safety factor needs to be above 1.5. Several measures can be taken to achieve this:

- Reduction of slope gradient
- Inclusion of a backfill in front of the slope
- Installation of permanent retaining structures
- Installation of soil anchors to reach beyond the slip surface

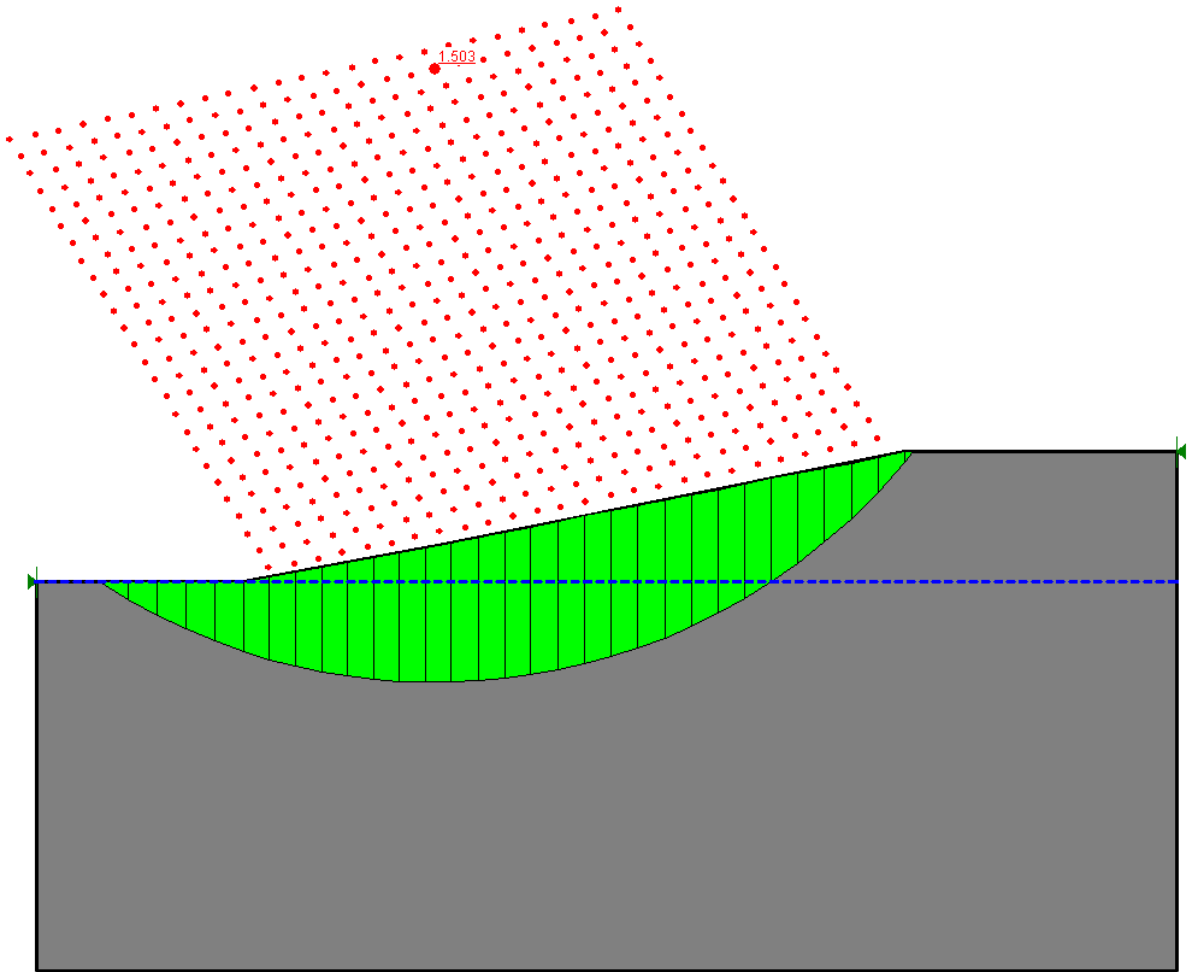
Figure 3: Improved slope design satisfying long term design criteria.

A proposed slope with increased stability is given in Figure 3. It utilises a reduced slope gradient and a backfill in front of the slope.
