**RE: Incorrect Thermal broken Aluminum Joinery: 2 Rapare St. Job No.27363 - JSR Construction.**

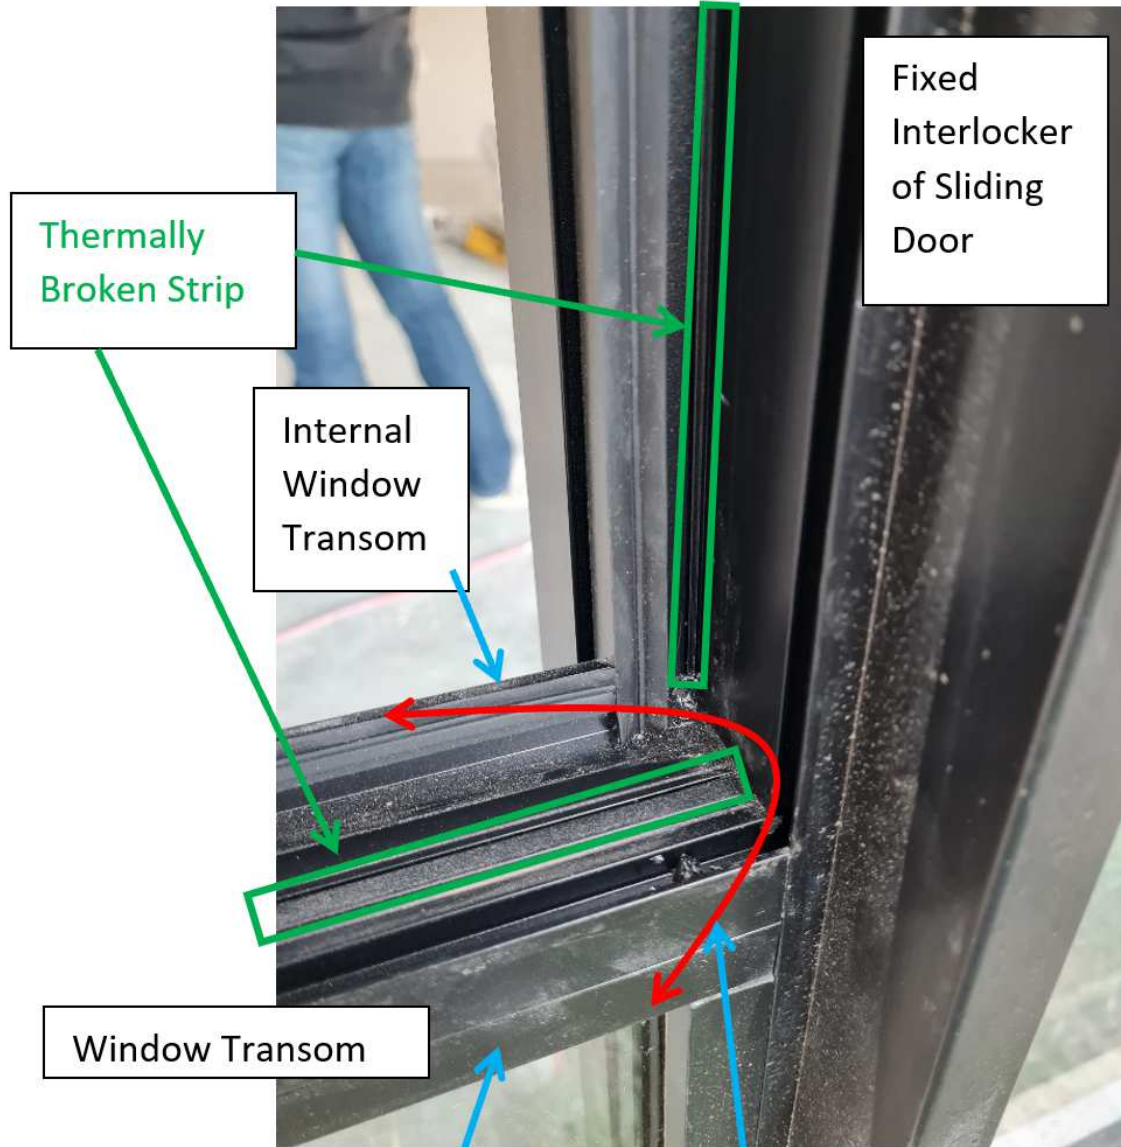
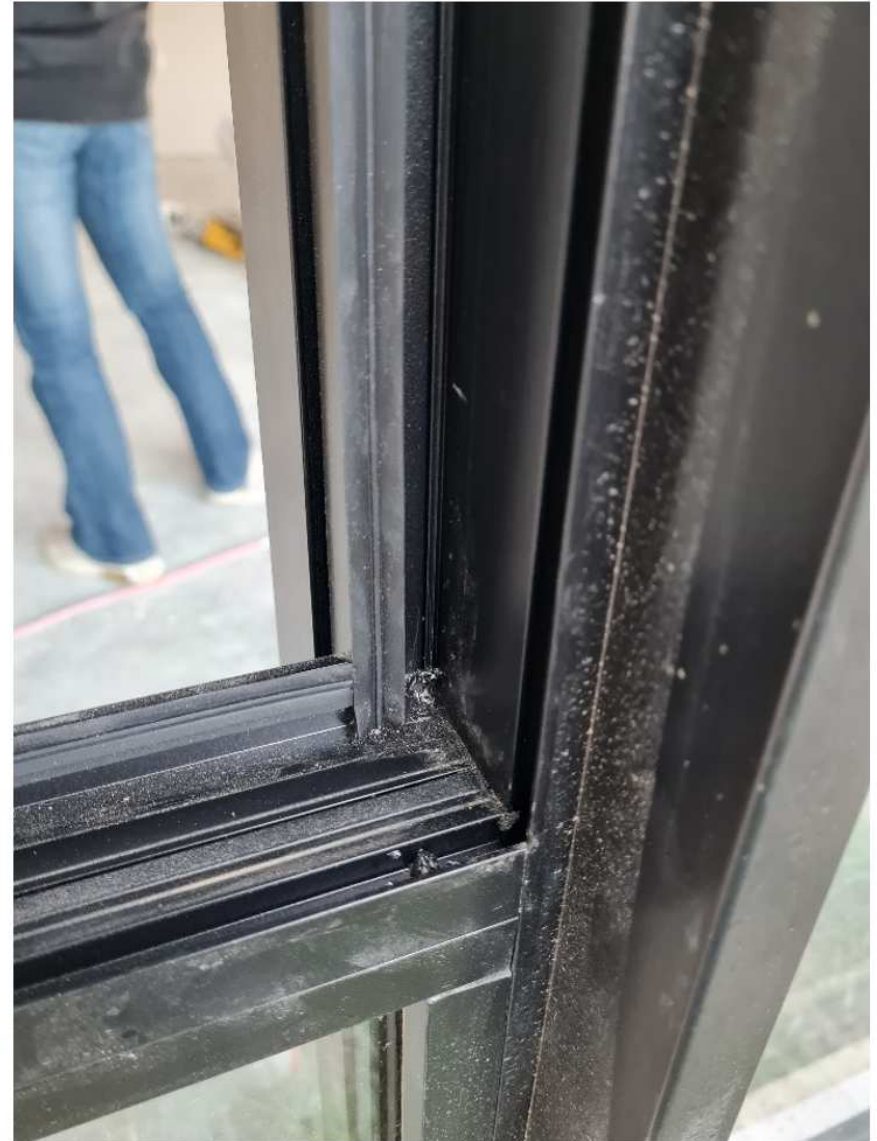
**Photo 1:** Path of thermal conduction at the joint of window transom and sliding-door fixed interlocker and the same photo without marking is given side by side for easy reference

Path of thermal conduction (red line) between internal and external parts of the window

1. You shall replace all non-thermally broken components of the sliding doors and windows which including but not limited to the stiles and fixed interlocker. There is a path of thermal conduction where it is not thermally broken at the joint of the window transom and sliding-door fixed interlocker as indicated by the red line on the marked photo as shown on Photo 1 below. The same photo without marking is given side by side for easy reference. You are required to change the fixed interlocker to have the proper thermally broken strip align with the strip on the window transom. I also took a thermal image (see Photo 2) with the sunshine reaching half the height of the sliding door. It showed that the non-thermally broken components (the joint in between the interlocker and the window transom, and the stiles) creating a thermal conduction between the internal and external parts of the thermally-broken members (e.g. bottom of the sliding door frames and the window transom).

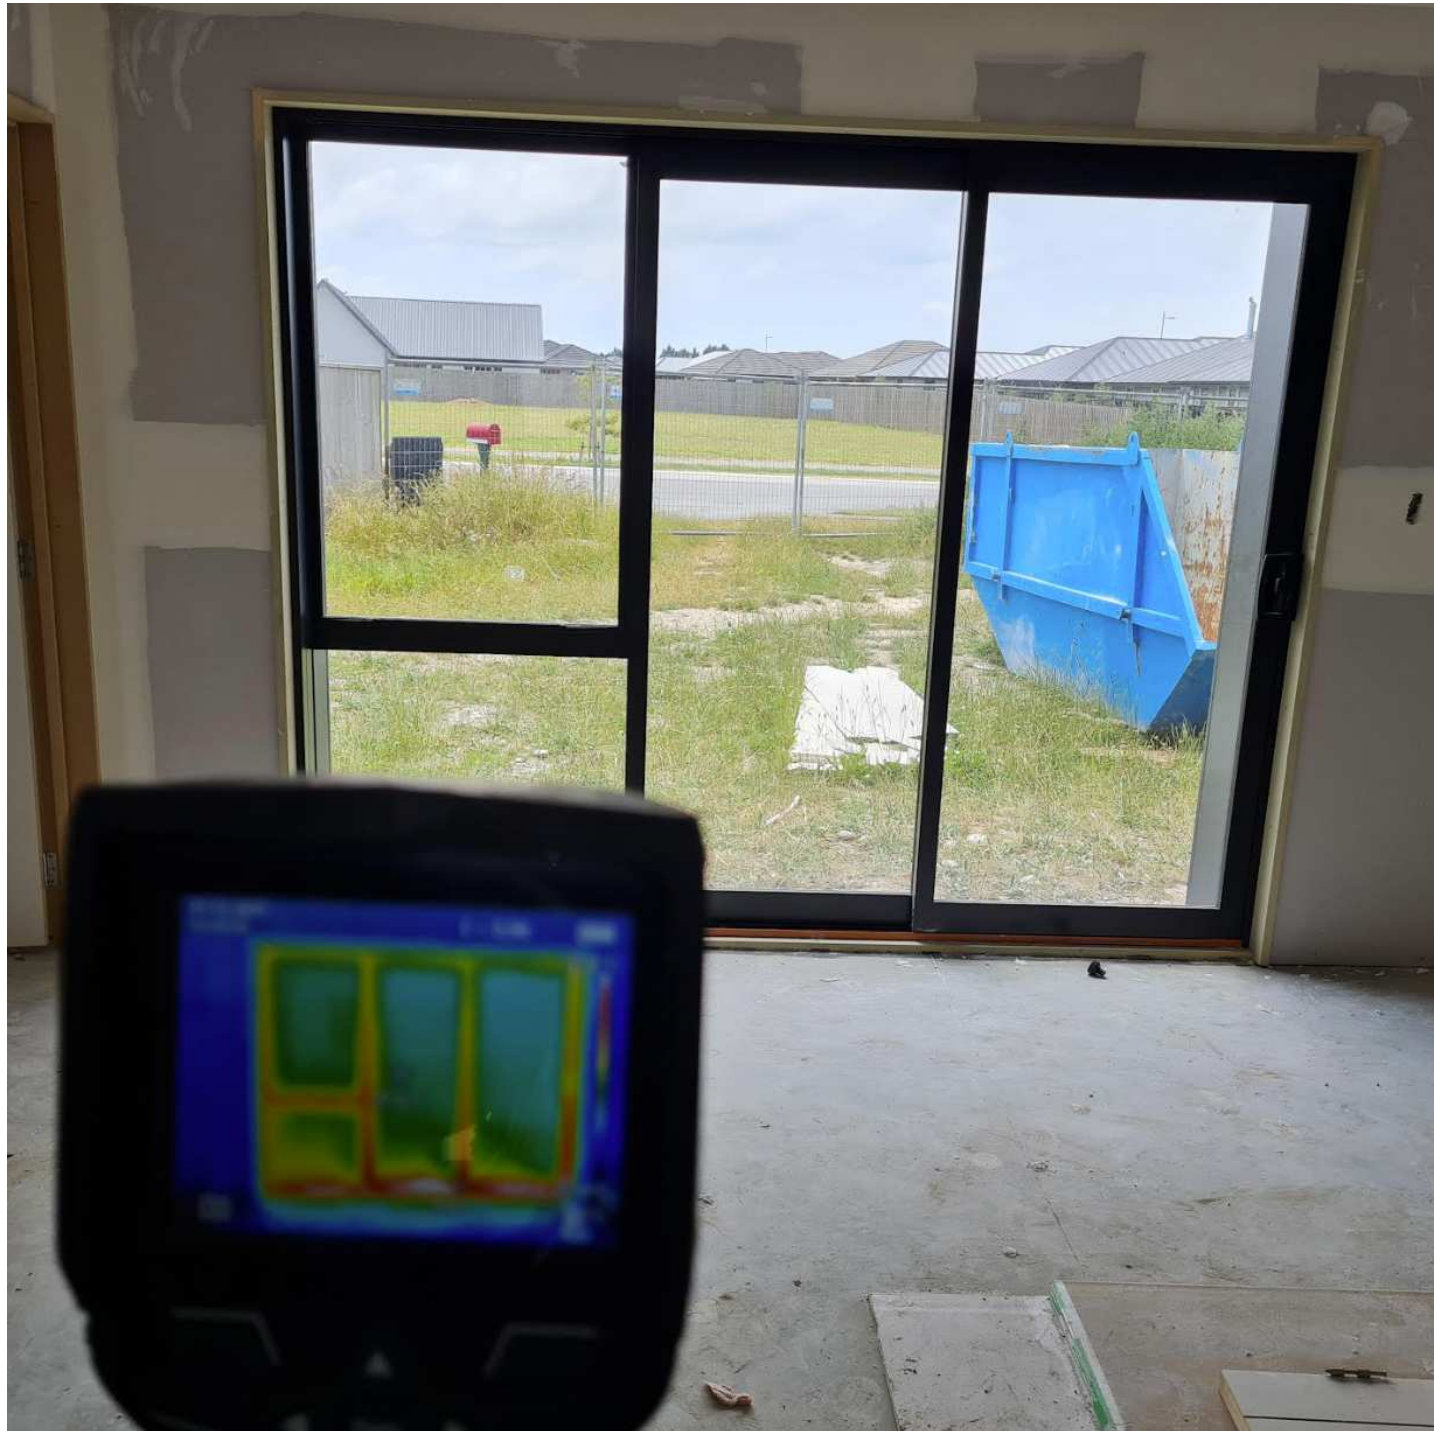
**Photo 2:** Thermal image of the sliding door and window with the sunshine reaching half the height of the sliding door. It showed that the non-thermally broken components (the joint in between the interlocker and the window transom, and the stile) creating a thermal conduction between the internal and external parts of the thermally-broken members (e.g. bottom of the sliding door frames and the window transom).

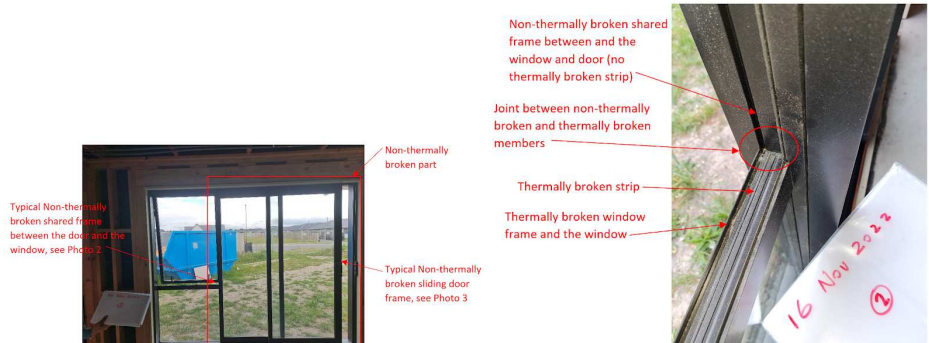
- a) Photo 1 – Indicating the non-thermally broken parts of the Sliding Door “Lounge D6” (Door number referred to the attached quote no. 27363) (Trim Size: 2130 x 2700; Area: 5.751 m sq.)

Photo 1 – Indicating the non-thermally broken parts of the Sliding Door “Lounge D6” (Door number referred to the attached quote no. 27363) (Trim Size: 2130 x 2700; Area: 5.751 m sq.)

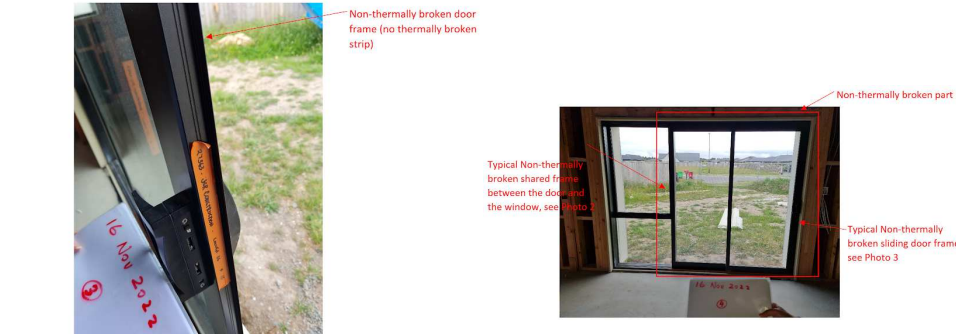
- c) Photo 3 – Typical slide door frame shows that the slide door does not have thermally broken strip
  - d) Photo 4 – Indicating the non-thermally broken parts of the Sliding Door “Living D6” (Door number referred to the attached quote no. 27363) (Trim Size: 2130 x 2700; Area: 5.751 m sq.)

Photo 3 – Typical slide door frame shows that the slide door does not have thermally broken

Photo 4 – Indicating the non-thermally broken parts of the Sliding Door “Living D6” (Door number referred to the attached quote no. 27363) (Trim Size: 2130 x 2700; Area: 5.751 m sq.)

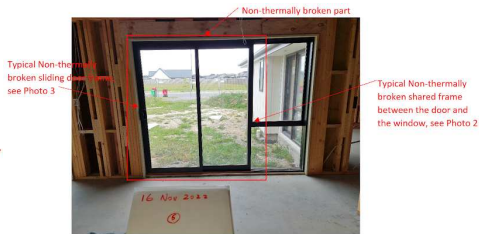
- e) Photo 5 – Indicating the non-thermally broken parts of the Sliding Door “Dining D6” (Door number referred to the attached quote no. 27363) (Trim Size: 2130 x 2700; Area: 5.751 m sq.)

Photo 5 – Indicating the non-thermally broken parts of the Sliding Door “Dining D6” (Door number referred to the attached quote no. 27363) (Trim Size: 2130 x 2700; Area: 5.751 m sq.)

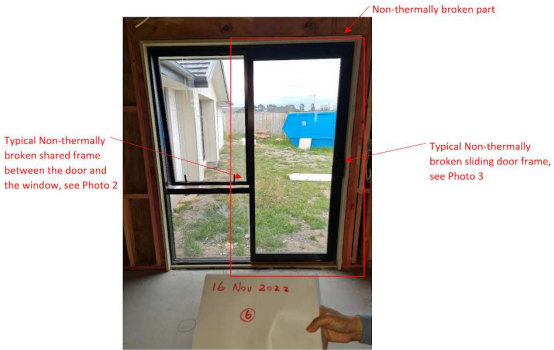
- f) Photo 6 – Indicating the non-thermally broken parts of the Sliding Door “Bedroom 3 D5” (Door number referred to the attached quote no. 27363) (Trim Size: 2130 x 1800; Area: 3.834 m sq.)

Photo 6 – Indicating the non-thermally broken parts of the Sliding Door “Bedroom 3 D5” (Door number referred to the attached quote no. 27363) (Trim Size: 2130 x 1800; Area: 3.834 m sq.)

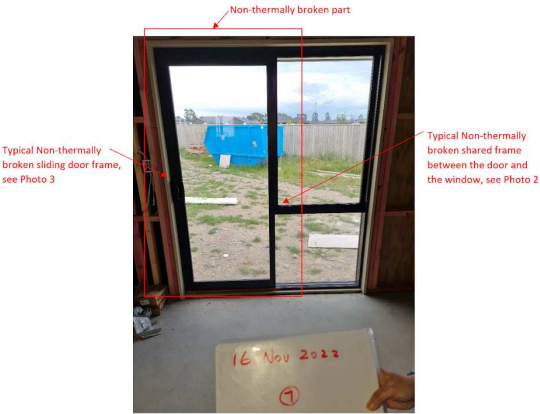
- g) Photo 7 – Indicating the non-thermally broken parts of the Sliding Door “Bedroom 2 D4” (Door number referred to the attached quote no. 27363) (Trim Size: 2130 x 1800; Area: 3.834 m sq.)

Photo 7 – Indicating the non-thermally broken parts of the Sliding Door “Bedroom 2 D4” (Door number referred to the attached quote no. 27363) (Trim Size: 2130 x 1800; Area: 3.834 m sq.)

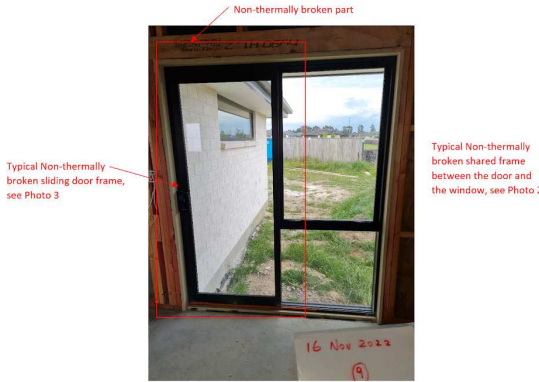
- h) Photo 9 – Indicating the non-thermally broken parts of the Sliding Door “Master Bedroom D3” (Door number referred to the attached quote no. 27363) (Trim Size: 2130 x 1800; Area: 3.834 m sq.)

Photo 9 – Indicating the non-thermally broken parts of the Sliding Door “Master Bedroom D3” (Door number referred to the attached quote no. 27363) (Trim Size: 2130 x 1800; Area: 3.834 m sq.)

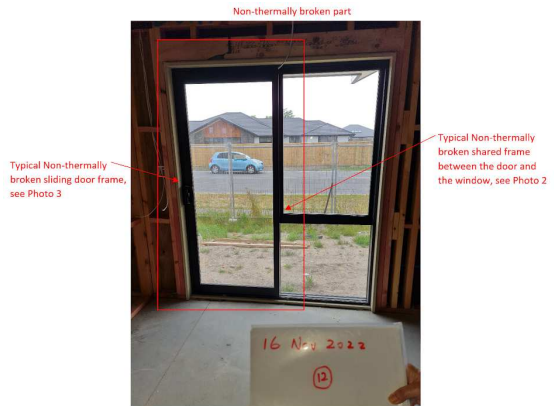
- i) Photo 12 – Indicating the non-thermally broken parts of the Sliding Door “Bedroom 4 D4” (Door number referred to the attached quote no. 27363) (Trim Size: 2130 x 1800; Area: 3.834 m sq.)

Photo 12 – Indicating the non-thermally broken parts of the Sliding Door “Bedroom 4 D4” (Door number referred to the attached quote no. 27363) (Trim Size: 2130 x 1800; Area: 3.834 m sq.)

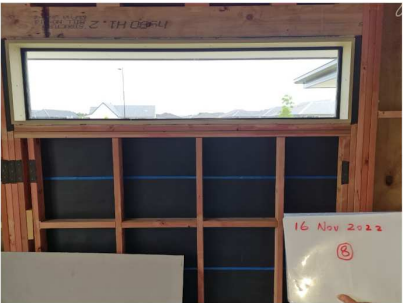
- a) Photo 8 – Indicating uncertain thermally broken window “Bedroom 2 W5” (Door number referred to the attached quote no. 27363) (Trim Size: 600 x 2400; Area: 1.37 m sq)

Photo 8 – Indicating uncertain thermally broken window “Bedroom 2 W5” (Door number referred to the attached quote no. 27363) (Trim Size: 600 x 2400; Area: 1.37 m sq.)

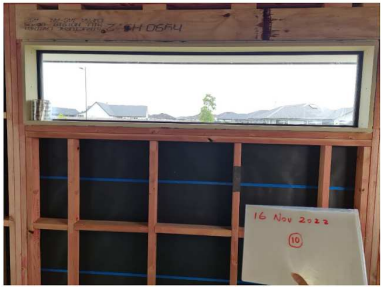
- b) Photo 10 – Indicating uncertain thermally broken window “Master Bedroom W4” (Door number referred to the attached quote no. 27363) (Trim Size: 600 x 2400; Area: 1.37 m sq)
- c) Photo 11 – Indicating uncertain thermally broken window “Master Bedroom W3” (Door number referred to the attached quote no. 27363) (Trim Size: 1000 x 1500; Area: 1.5 m sq)

Photo 10 – Indicating uncertain thermally broken window “Master Bedroom W4” (Door number referred to the attached quote no. 27363) (Trim Size: 600 x 2400; Area: 1.37 m sq.)

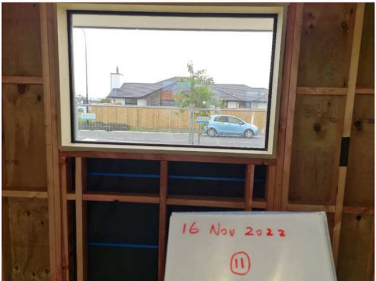
Photo 11 – Indicating uncertain thermally broken window “Master Bedroom W3” (Door number referred to the attached quote no. 27363) (Trim Size: 1000 x 1500; Area: 1.5 m sq.)
