Re: Incorrect Thermal broken Aluminum Joinery: 2 Rapare St. Job No.27363 - JSR Construction.

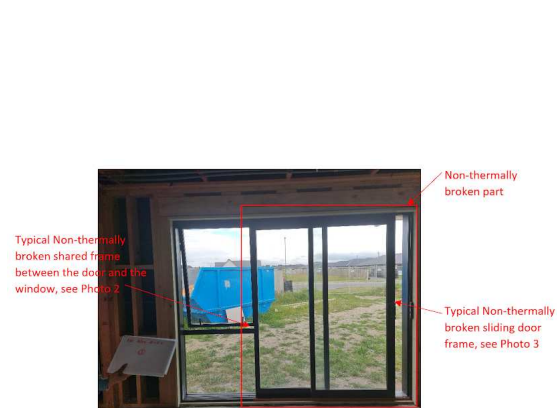
- a) Photo 1 – Indicating the non-thermally broken parts of the Sliding Door “Lounge D6” (Door number referred to the attached quote no. 27363) (Trim Size: 2130 x 2700; Area: 5.751 m sq.)

Photo 1 – Indicating the non-thermally broken parts of the Sliding Door “Lounge D6” (Door number referred to the attached quote no. 27363) (Trim Size: 2130 x 2700; Area: 5.751 m sq.)

You shall provide us with all the satisfied up-to-standard thermally broken aluminium joinery. You are requested to replace and re-install all the incorrect entire windows and doors. Partly replacement of aluminium materials on the site is not acceptable. You are also liable for all our losses of cost including but not limited to the related matter of any material reinstatements, any material variations, any time delay and any opportunity costs incurred by the correction of the aluminium windows and doors. The incorrect

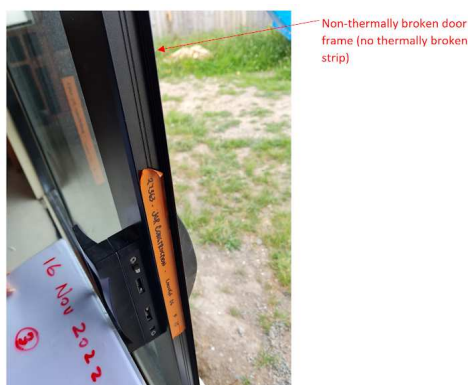
- c) Photo 3 – Typical slide door frame shows that the slide door does not have thermally broken strip
 - d) Photo 4 – Indicating the non-thermally broken parts of the Sliding Door “Living D6” (Door number referred to the attached quote no. 27363) (Trim Size: 2130 x 2700; Area: 5.751 m sq.)

Photo 3 – Typical slide door frame shows that the slide door does not have thermally broken

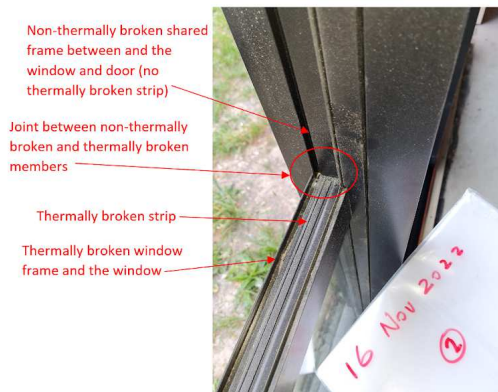
- b) Photo 2 – Typical joint between the vertical frame of the sliding door and the horizontal frame of the window shows that the shared frame between door and the window do not have the thermally broken strip.

Photo 2 – Typical joint between the vertical frame of the sliding door and the horizontal frame of the window shows that the shared frame between the door and the window do not have the thermally broken strip.

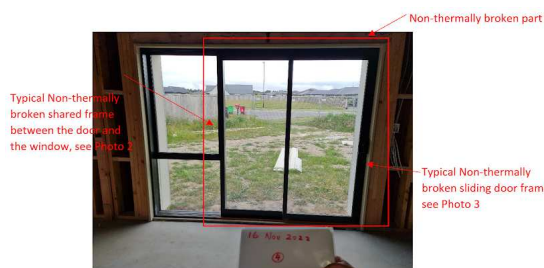
Photo 4 – Indicating the non-thermally broken parts of the Sliding Door “Living D6” (Door number referred to the attached quote no. 27363) (Trim Size: 2130 x 2700; Area: 5.751 m sq.)

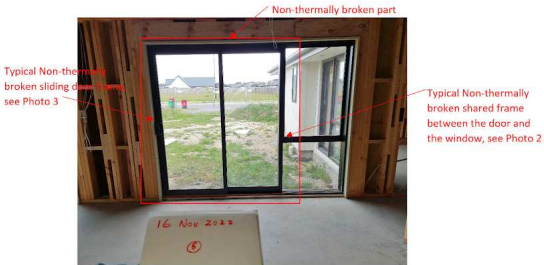
- e) Photo 5 – Indicating the non-thermally broken parts of the Sliding Door “Dining D6” (Door number referred to the attached quote no. 27363) (Trim Size: 2130 x 2700; Area: 5.751 m sq.)

Photo 5 – Indicating the non-thermally broken parts of the Sliding Door “Dining D6” (Door number referred to the attached quote no. 27363) (Trim Size: 2130 x 2700; Area: 5.751 m sq.)

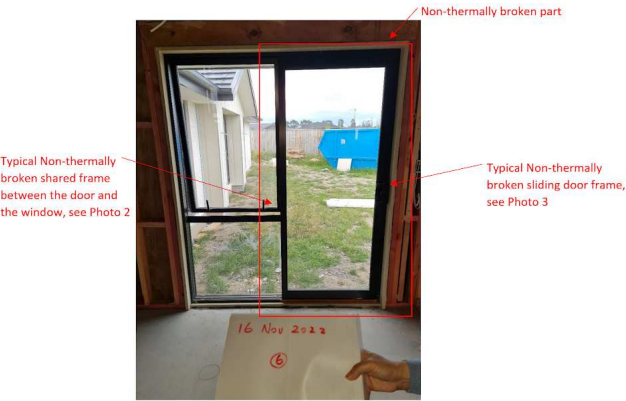
- f) Photo 6 – Indicating the non-thermally broken parts of the Sliding Door “Bedroom 3 D5” (Door number referred to the attached quote no. 27363) (Trim Size: 2130 x 1800; Area: 3.834 m sq.)

Photo 6 – Indicating the non-thermally broken parts of the Sliding Door “Bedroom 3 D5” (Door

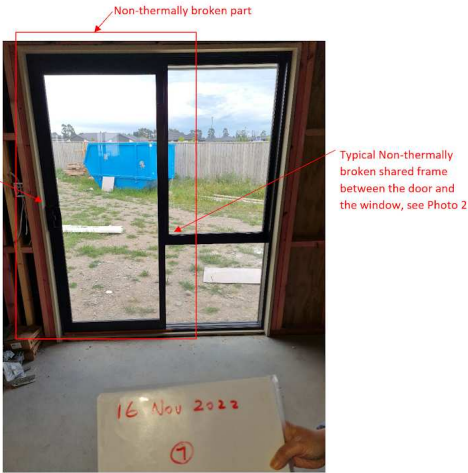
- g) Photo 7 – Indicating the non-thermally broken parts of the Sliding Door “Bedroom 2 D4” (Door number referred to the attached quote no. 27363) (Trim Size: 2130 x 1800; Area: 3.834 m sq.)

Photo 7 – Indicating the non-thermally broken parts of the Sliding Door “Bedroom 2 D4” (Door number referred to the attached quote no. 27363) (Trim Size: 2130 x 1800; Area: 3.834 m sq.)

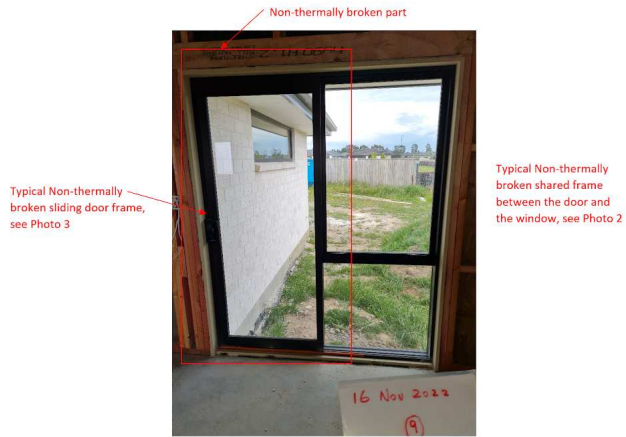
- h) Photo 9 – Indicating the non-thermally broken parts of the Sliding Door “Master Bedroom D3” (Door number referred to the attached quote no. 27363) (Trim Size: 2130 x 1800; Area: 3.834 m sq.)

Photo 9 – Indicating the non-thermally broken parts of the Sliding Door “Master Bedroom D3” (Door number referred to the attached quote no. 27363) (Trim Size: 2130 x 1800; Area: 3.834 m sq.)

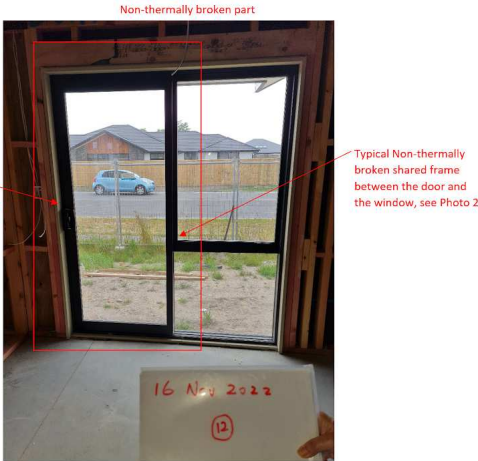
- i) Photo 12 – Indicating the non-thermally broken parts of the Sliding Door “Bedroom 4 D4” (Door number referred to the attached quote no. 27363) (Trim Size: 2130 x 1800; Area: 3.834 m sq.)

Photo 12 – Indicating the non-thermally broken parts of the Sliding Door “Bedroom 4 D4” (Door number referred to the attached quote no. 27363) (Trim Size: 2130 x 1800; Area: 3.834 m sq.)

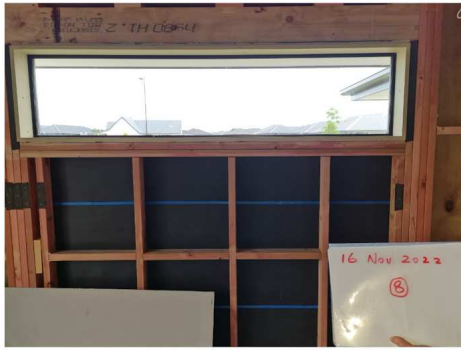
- a) Photo 8 – Indicating uncertain thermally broken window “Bedroom 2 W5” (Door number referred to the attached quote no. 27363) (Trim Size: 600 x 2400; Area: 1.37 m sq)

Photo 8 – Indicating uncertain thermally broken window “Bedroom 2 W5” (Door number referred to the attached quote no. 27363) (Trim Size: 600 x 2400; Area: 1.37 m sq.)

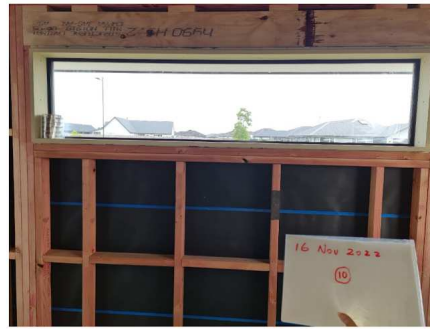
- b) Photo 10 – Indicating uncertain thermally broken window “Master Bedroom W4” (Door number referred to the attached quote no. 27363) (Trim Size: 600 x 2400; Area: 1.37 m sq)

Photo 10 – Indicating uncertain thermally broken window “Master Bedroom W4” (Door number referred to the attached quote no. 27363) (Trim Size: 600 x 2400; Area: 1.37 m sq.)

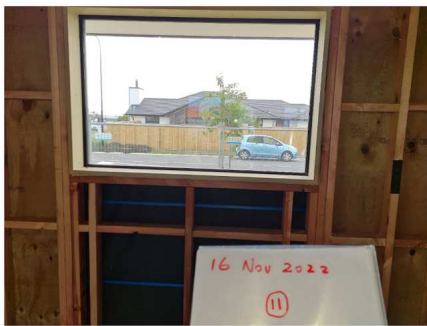
- c) Photo 11 – Indicating uncertain thermally broken window “Master Bedroom W3” (Door number referred to the attached quote no. 27363) (Trim Size: 101500; Area: 1.5 m sq)

Photo 11 – Indicating uncertain thermally broken window “Master Bedroom W3” (Door number referred to the attached quote no. 27363) (Trim Size: 1000 x 1500; Area: 1.5 m sq.)
