Re: Incorrect Thermal broken Aluminum Joinery: 2 Rapare St. Job No.27363 - JSR Construction.

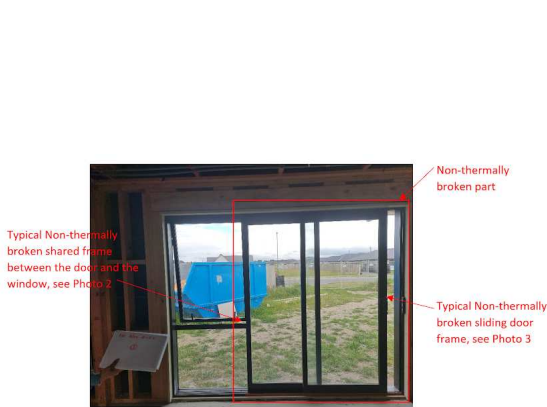
- a) Photo 1 – Indicating the non-thermally broken parts of the Sliding Door “Lounge D6” (Door number referred to the attached quote no. 27363) (Trim Size: 2130 x 2700; Area: 5.751 m sq.)

Photo 1 – Indicating the non-thermally broken parts of the Sliding Door “Lounge D6” (Door number referred to the attached quote no. 27363) (Trim Size: 2130 x 2700; Area: 5.751 m sq.)

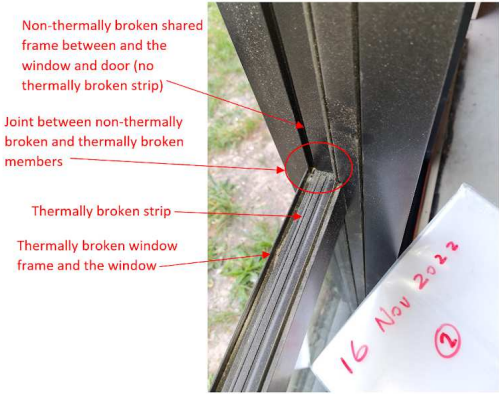
- b) Photo 2 – Typical joint between the vertical frame of the sliding door and the horizontal frame of the window shows that the shared frame door and the window do not have the thermally broken strip.

Photo 2 – Typical joint between the vertical frame of the sliding door and the horizontal frame of the window shows that the shared frame between the door and the window do not have the thermally broken strip.

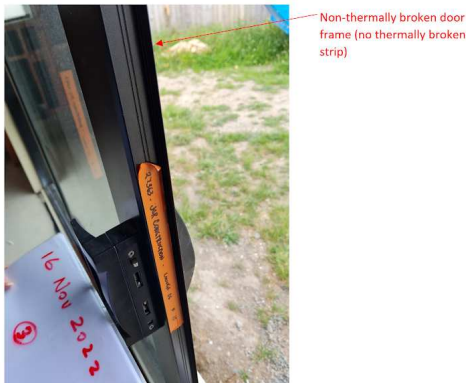
1. All the stiles of the sliding doors are not thermally broken (referring to the photo 3 in my email on Nov 20, 2022 at 10:06 PM)
2. All the fixed interlockers of the sliding doors are missed a thermally-broken strip (referring to the photo 2 in my email on Nov 20, 2022 at 10:06 PM). Note that these fixed interlockers are also a part of the adjacent windows.

- c) Photo 3 – Typical slide door frame shows that the slide door does not have thermally broken strip
 - d) Photo 4 – Indicating the non-thermally broken parts of the Sliding Door “Living D6” (Door number referred to the attached quote no. 27363) (Trim Size: 2130 x 2700; Area: 5.751 m sq.)

Photo 3 – Typical slide door frame shows that the slide door does not have thermally broken

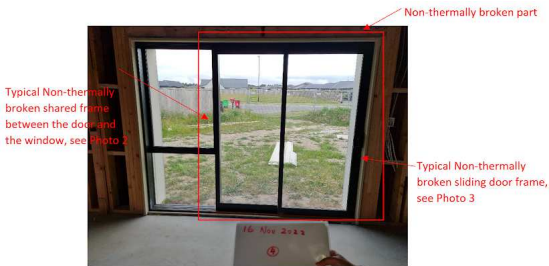
Photo 4 – Indicating the non-thermally broken parts of the Sliding Door “Living D6” (Door number referred to the attached quote no. 27363) (Trim Size: 2130 x 2700; Area: 5.751 m sq.)

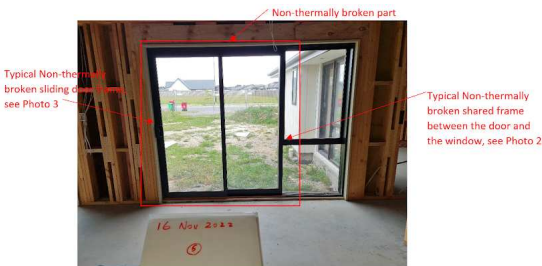
- e) Photo 5 – Indicating the non-thermally broken parts of the Sliding Door “Dining D6” (Door number referred to the attached quote no. 27363) (Trim Size: 2130 x 2700; Area: 5.751 m sq.)

Photo 5 – Indicating the non-thermally broken parts of the Sliding Door “Dining D6” (Door number referred to the attached quote no. 27363) (Trim Size: 2130 x 2700; Area: 5.751 m sq.)

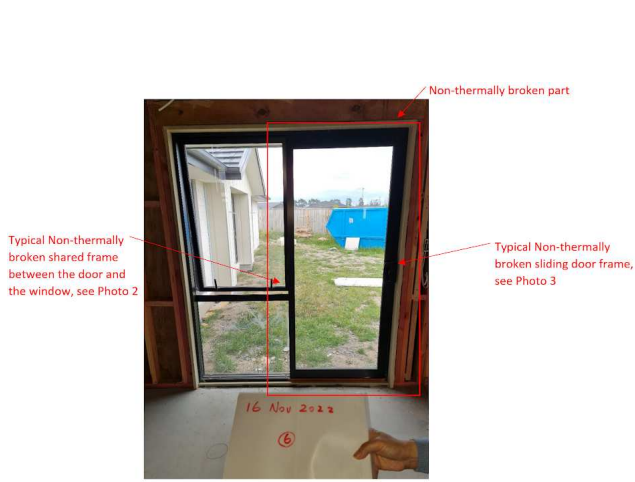
- f) Photo 6 – Indicating the non-thermally broken parts of the Sliding Door “Bedroom 3 D5” (Door number referred to the attached quote no. 27363) (Trim Size: 2130 x 1800; Area: 3.834 m sq.)

Photo 6 – Indicating the non-thermally broken parts of the Sliding Door “Bedroom 3 D5” (Door

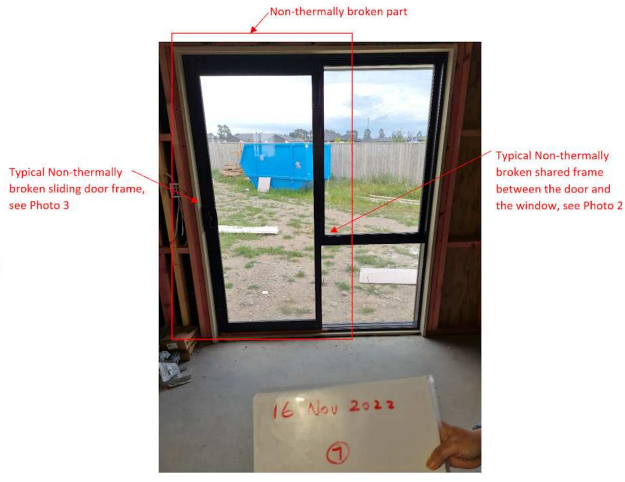
- g) Photo 7 – Indicating the non-thermally broken parts of the Sliding Door “Bedroom 2 D4” (Door number referred to the attached quote no. 27363) (Trim Size: 2130 x 1800; Area: 3.834 m sq.)

Photo 7 – Indicating the non-thermally broken parts of the Sliding Door “Bedroom 2 D4” (Door number referred to the attached quote no. 27363) (Trim Size: 2130 x 1800; Area: 3.834 m sq.)

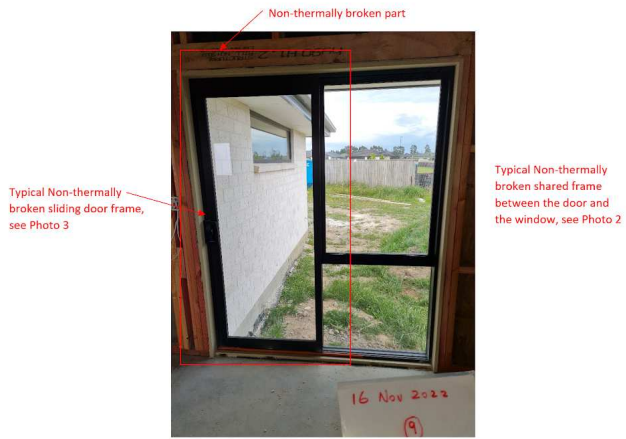
- h) Photo 9 – Indicating the non-thermally broken parts of the Sliding Door “Master Bedroom D3” (Door number referred to the attached quote no. 27363) (Trim Size: 2130 x 1800; Area: 3.834 m sq.)

Photo 9 – Indicating the non-thermally broken parts of the Sliding Door “Master Bedroom D3” (Door number referred to the attached quote no. 27363) (Trim Size: 2130 x 1800; Area: 3.834 m sq.)

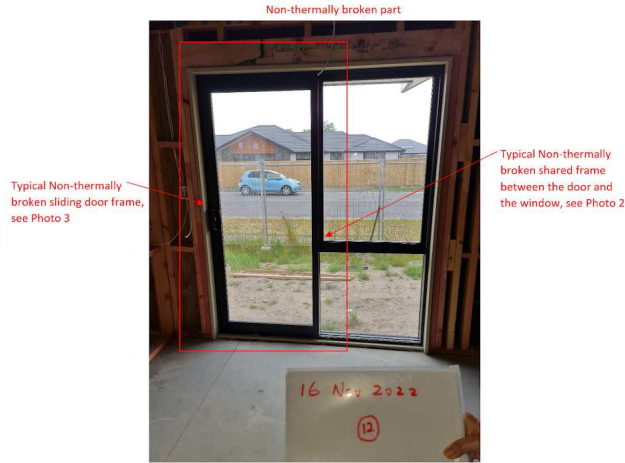
- i) Photo 12 – Indicating the non-thermally broken parts of the Sliding Door “Bedroom 4 D4” (Door number referred to the attached quote no. 27363) (Trim Size: 2130 x 1800; Area: 3.834 m sq.)

Photo 12 – Indicating the non-thermally broken parts of the Sliding Door “Bedroom 4 D4” (Door number referred to the attached quote no. 27363) (Trim Size: 2130 x 1800; Area: 3.834 m sq.)

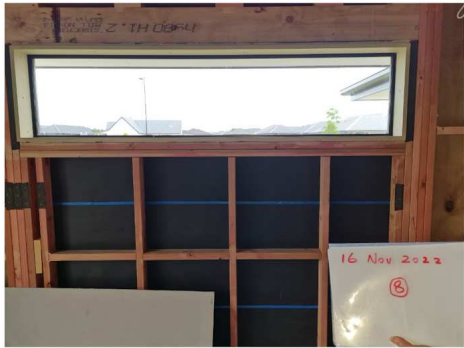
- a) Photo 8 – Indicating uncertain thermally broken window “Bedroom 2 W5” (Door number referred to the attached quote no. 27363) (Trim Size: 600 x 2400; Area: 1.37 m sq)

Photo 8 – Indicating uncertain thermally broken window “Bedroom 2 W5” (Door number referred to the attached quote no. 27363) (Trim Size: 600 x 2400; Area: 1.37 m sq.)

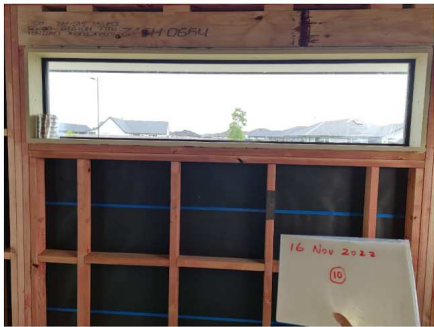
- b) Photo 10 – Indicating uncertain thermally broken window “Master Bedroom W4” (Door number referred to the attached quote no. 27363) (Trim Size: 2400; Area: 1.37 m sq)

Photo 10 – Indicating uncertain thermally broken window “Master Bedroom W4” (Door number referred to the attached quote no. 27363) (Trim Size: 600 x 2400; Area: 1.37 m sq.)

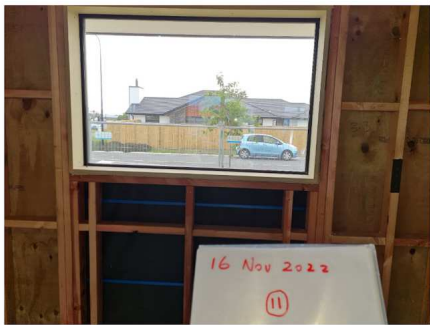
- c) Photo 11 – Indicating uncertain thermally broken window “Master Bedroom W3” (Door number referred to the attached quote no. 27363) (Trim Size: 1500; Area: 1.5 m sq)

Photo 11 – Indicating uncertain thermally broken window “Master Bedroom W3” (Door number referred to the attached quote no. 27363) (Trim Size: 1000 x 1500; Area: 1.5 m sq.)
