**INVESTIGATION REPORT
ON
TAIL STRIKE INCIDENT TO
M/S INDIGO A-321 AIRCRAFT VT-ILR
WHILE LANDING AT
NETAJI SUBHASH INTERNATIONAL AIRPORT, KOLKATA
ON
02.01.2023**

INVESTIGATION REPORT ON TAIL STRIKE INCIDENT TO
M/S INDIGO AIRLINE A-321 AIRCRAFT VT-ILR AT KOLKATA AIRPORT
ON 02.01.2023

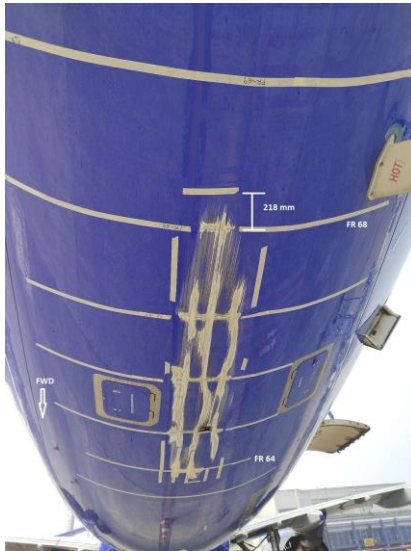
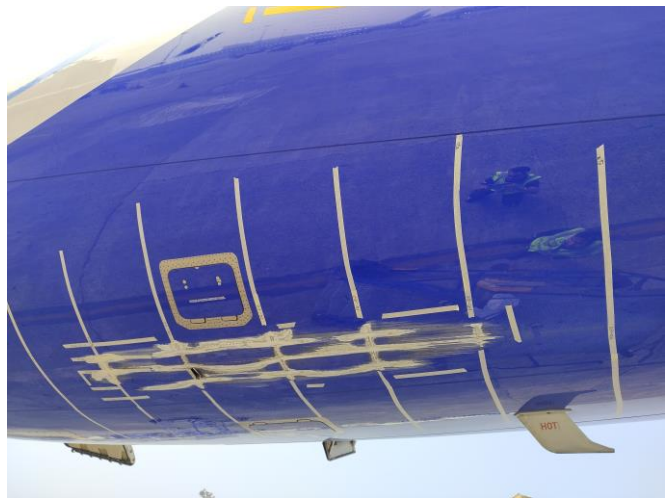
During the walk around inspection, damages observed on aft fuselage. During detailed inspection of the aircraft various internal and external structural damages, cracks, scratches, deformations were observed including the damage to the skin.

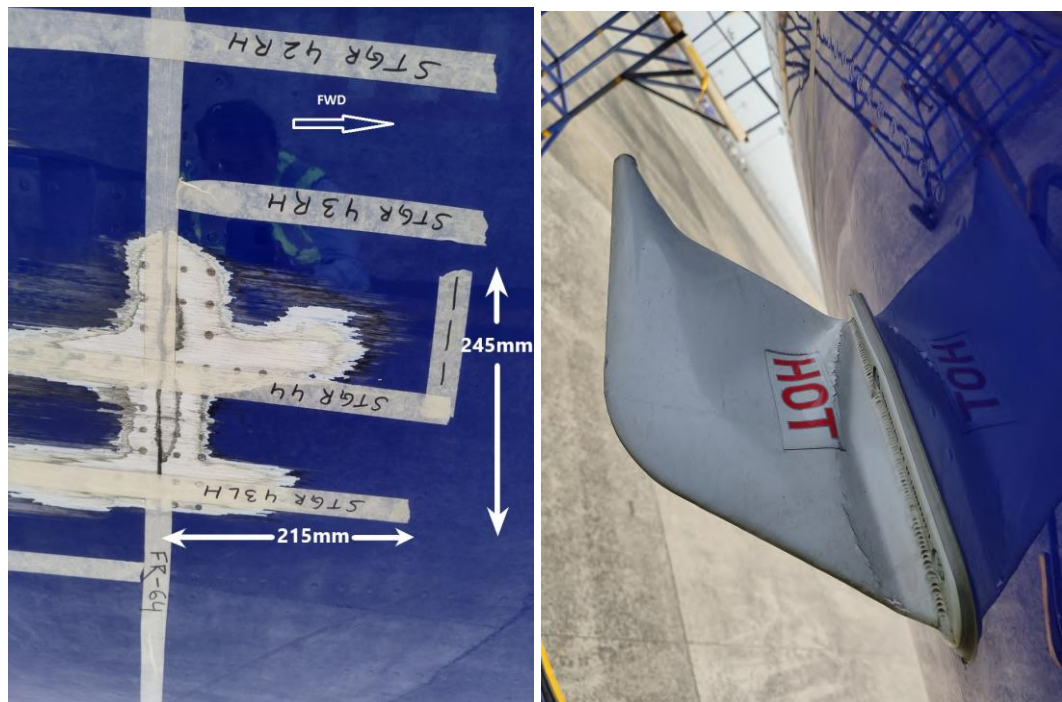
- Aft fuselage skin damage in between Frame 63 to 69 and between Stringer 42LH and Stringer 42RH.

- Frame # 64, 65, 66, & 67, bottom chord at 6 O' clock location, have deep rubbing/ gouge marks.

- Frame # 65 depressed, torn and bottom attachment lug found missing in an area of 4 inches length between stringer 44 to stringer 43RH.
- Overall lower skin damage was observed of dimensions: max length 2540 mm and max width 390mm.
- Damage started from 350mm aft of Frame 63 upto 165mm forward of Frame 69.
- Skin teared at 06 locations below Frame 65, 66 & 67 with maximum dimension: length 95mm and width 85mm at frame 65.
- -Drain mast damaged (bent and cracked). No further damage observed on drain mast support structure.

- S18 Lower equipped shell replacement done as per repair references
- S17 between FR63-64 flush skin repairs done as per repair references
- Embodiment deviations repaired as per repair references

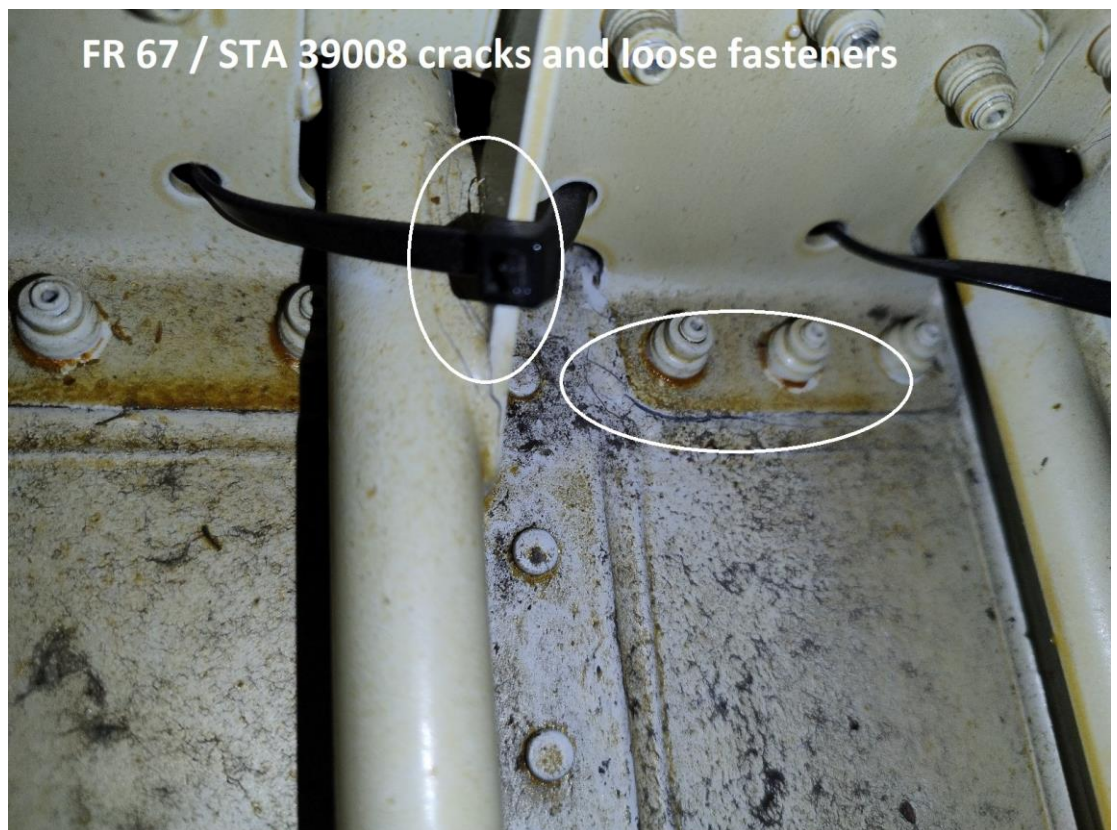
- Frame 65 damage and distorted between stringer 43RH to stringer 42LH.
- Rivets pulled off on frame 65 to stringer 43LH, stringer 44 and stringer 43 RH attachment clip.
- Rivets loose on frame 66 and frame 67 attachment between stringer 43LH and stringer 43RH.

All the damaged structural fittings, systems components, waste lines, hoses, drain mast, toilet system etc, were replaced/repared as per Airbus approved procedures. Sections S17 and S18 lower shells and internal structure suffered several damages due to Tail Strike.

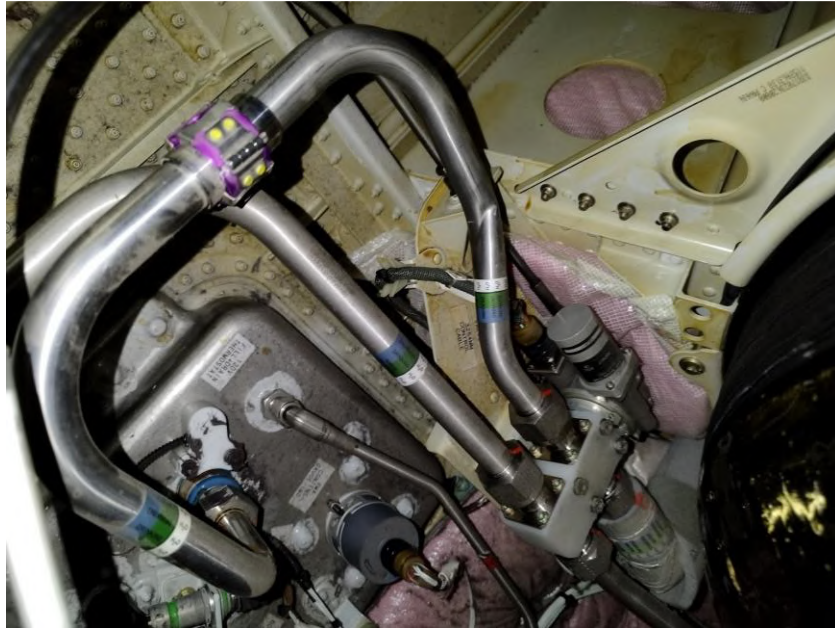
- Sharp bend observed on water tank filling line (p/n: D3817021101600). No further damage observed on water and waste tank mounting/attachment structure.

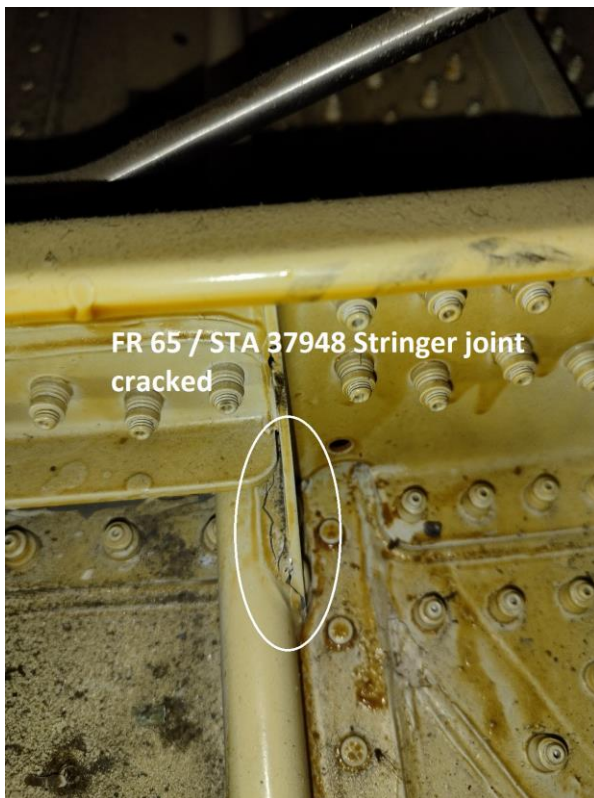
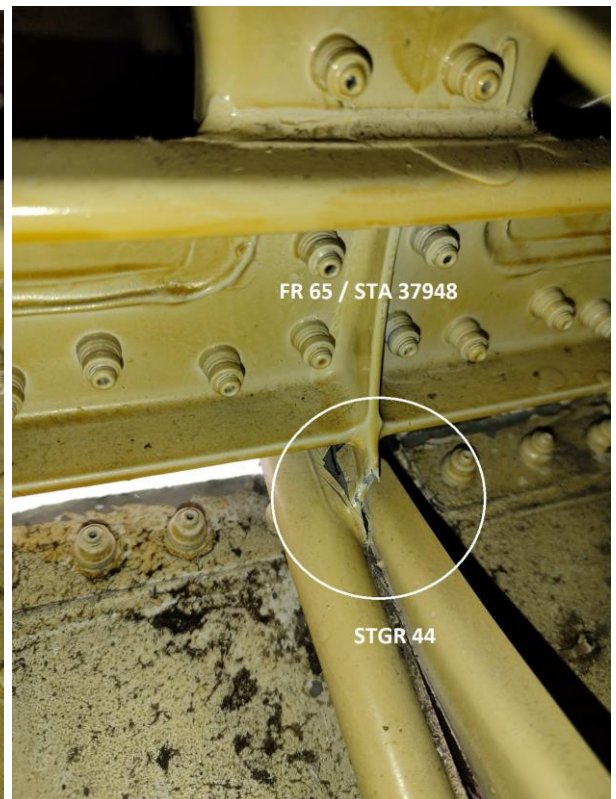
- Slight depression observed in skin panel between stringer 44 and stringer 43LH from frame 65 to 67.

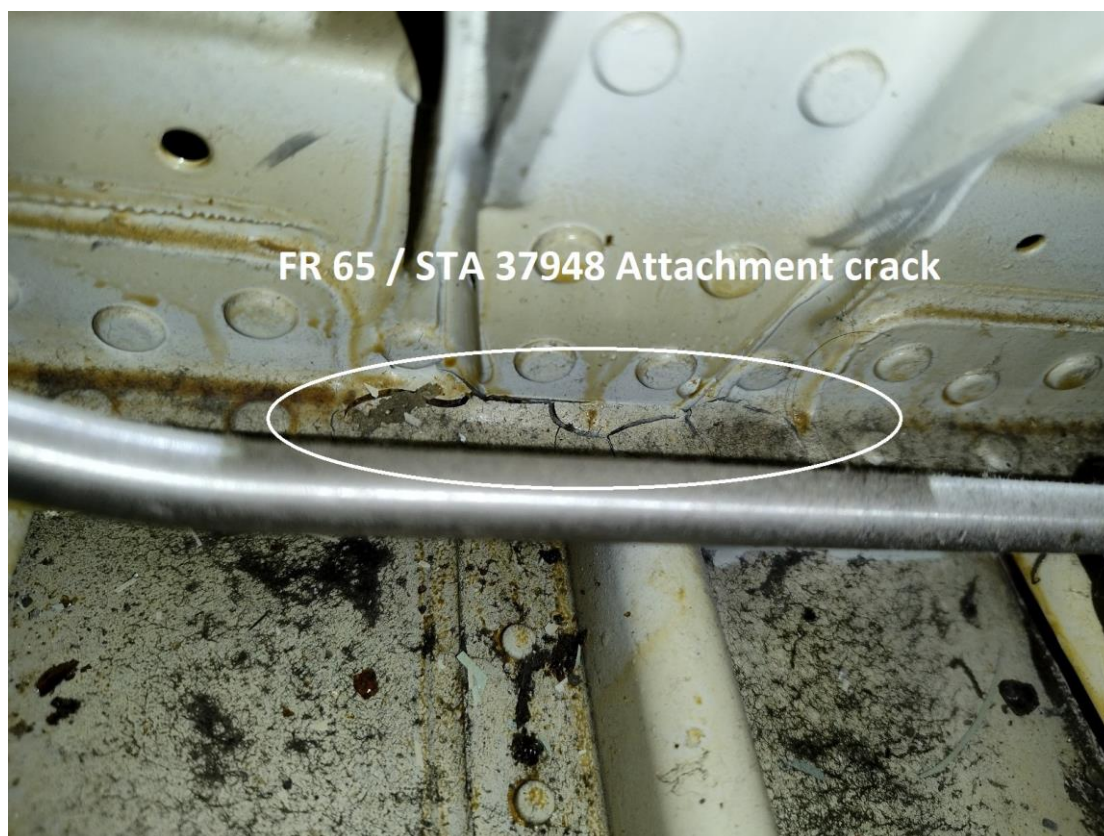
All the damages/cracks/deformations observed during the inspection were caused by the impact of aircraft due tail strike. No abnormality in the movement or unbalancing of flight controls was reported before the incident that can cause

On completion of required maintenance and repair work, all the service panels and internal panels of aft cargo compartment were installed.
