The failure of Carsington Dam

A. W. SKEMPTON* and P. R. VAUGHAN*

The upstream slope of Carsington Dam failed just before its completion in 1984. The slip started on the right abutment and spread across the valley to a length of nearly 500 m. Extensive investigations were conducted, and further information was obtained when the dam was reconstructed. The initial slip sheared through the core, which contained shear surfaces due to rutting, and along a layer of Yellow Clay which contained solifluction shears. Both materials were brittle, with low residual strengths. The factor of safety based on measured peak strengths was about 1.4; with reductions to allow for shears it was 1.2. It had been reduced to 1.0 by progressive failure. Finite element (FE) analyses in which strain-softening was reproduced confirmed this. It was concluded that the slide spread by lateral load transfer, through sections of the dam with a safety factor greater than 1. In the valley centre, the slide passed through the base of the mudstone fill. A combination of FE and limit equilibrium analysis indicated that the factor of safety just before collapse was about 1.1. The factor of safety was 1.6 with intact st

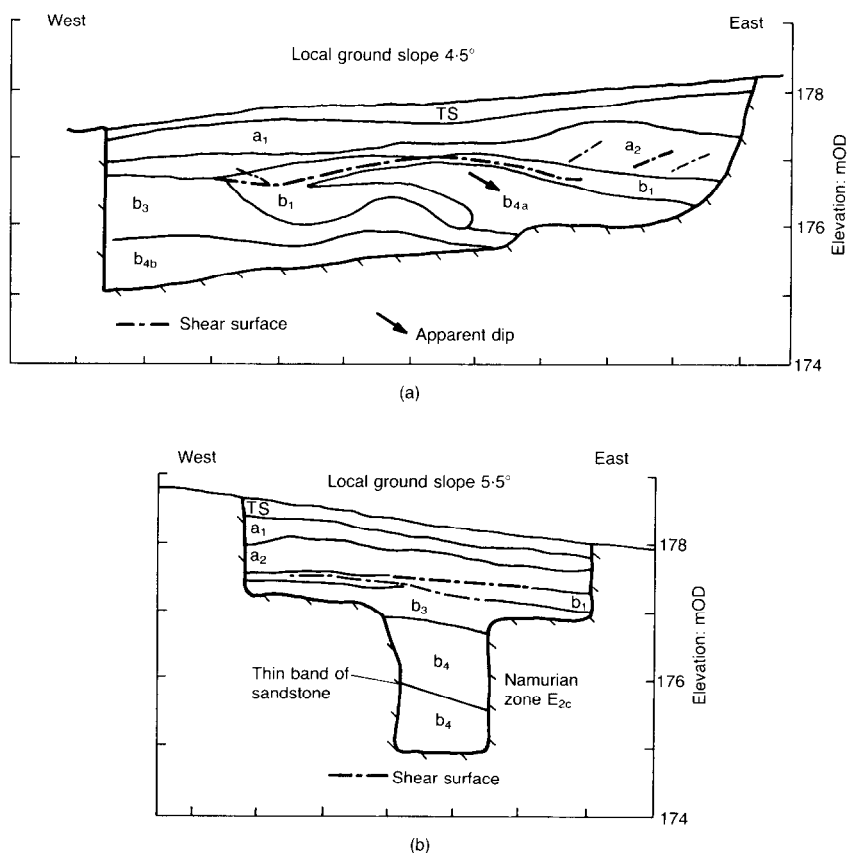
Fig. 6. Sections of pits showing solifluction shears: (a) trial pit 620VP, north face; (b) trial pit NBA1

Solifluction shears occurred over 40% of the total length (56 m) examined in pits on the north side of the valley where the slope is around 5° . Two examples are shown in Fig. 6. The undulations in the shear surfaces in this area can be quantified approximately by an angle $i = 3^\circ$ as sketched (to an exaggerated vertical scale) in Fig. 7. On the south side of the valley, with a ground slope of 8° , the shears were flatter and more extensive. Details of the exploratory pits, and an illustration of the soil fabric in thin section, which shows substantial alignment of particles along a shear surface, are given by Skempton *et al.* (1988).

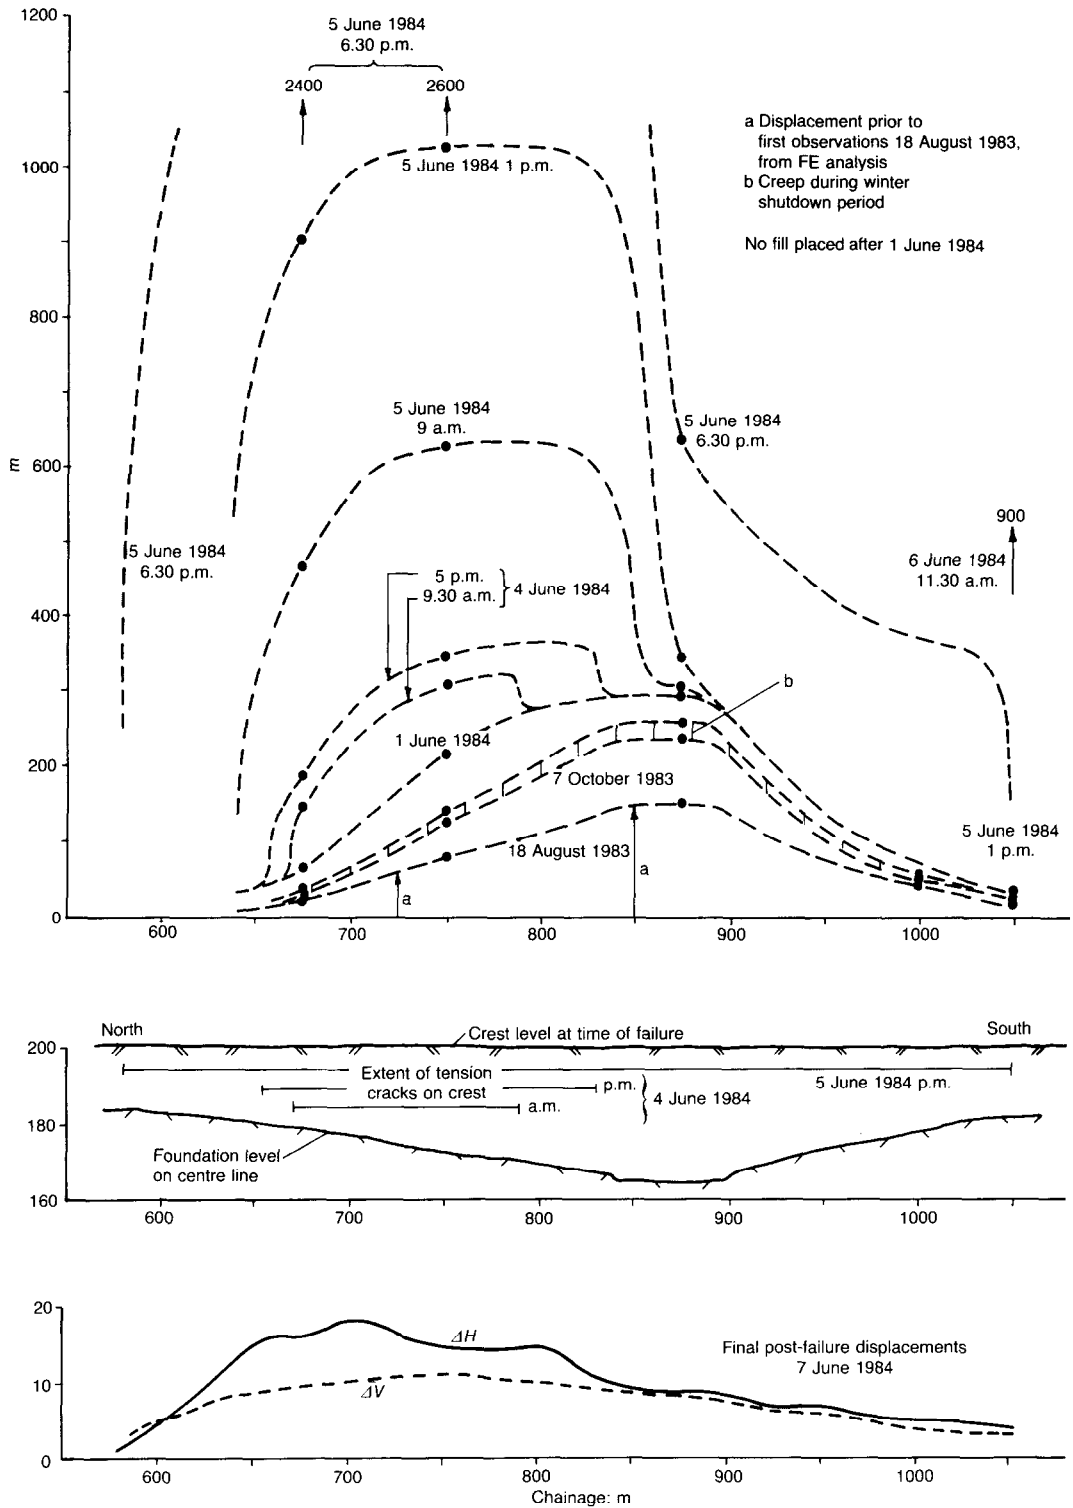
Fig. 12. Horizontal displacement before, during and after the slip

The development of movement during the failure is shown in Fig. 12. By 2.00 p.m. the crack extended from ch. 655 to ch. 830, and had a maximum width of about 50 mm. By 5.00 p.m. the pegs at ch. 675 and ch. 750 had moved a further 40 mm at an average rate of 6 mm/h, and were moving at about 10 mm/h. Meanwhile no movement was measurable at the peg at ch. 875.

Large movements occurred overnight, and by the morning of Wednesday 6 June maximum horizontal movement was 13 m, with crest settlement approaching 10 m. The slip had extended to its final length from ch. 580 to ch. 1075. Movement ceased by Thursday 7 June. The final horizontal movement of the upstream face and the crest settlement are shown in Fig. 12. Propagation of the failure along the embankment was associated with average longitudinal shear strains between pegs of the order of 1%.

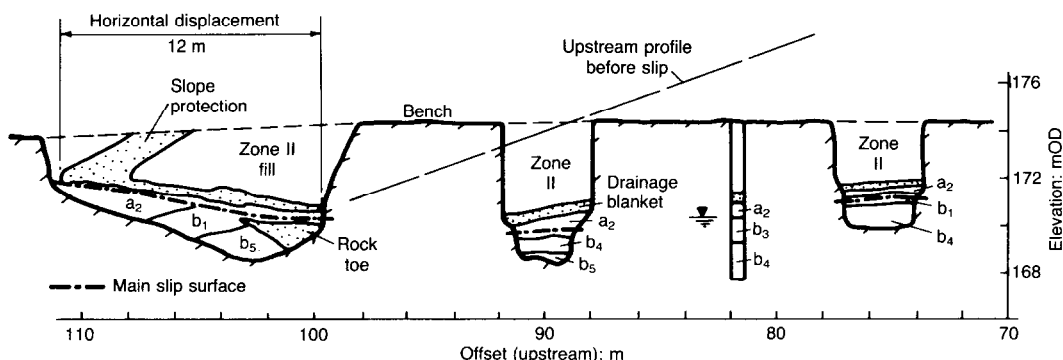
Fig. 13. Sections of trial pits showing slip surface at ch. 720

shears observed outside the slip. Through the core the location of the slip surface was indicated approximately by the breakage of tubes to piezometers within the slip at the instrumented section at ch. 705, and the survival of those outside. Various points within the slip and on the slope could be identified before and after movement, enabling displacement vectors to be constructed, as in Fig. 14(a). A reasonably accurate picture of the total slip movement was thus constructed.

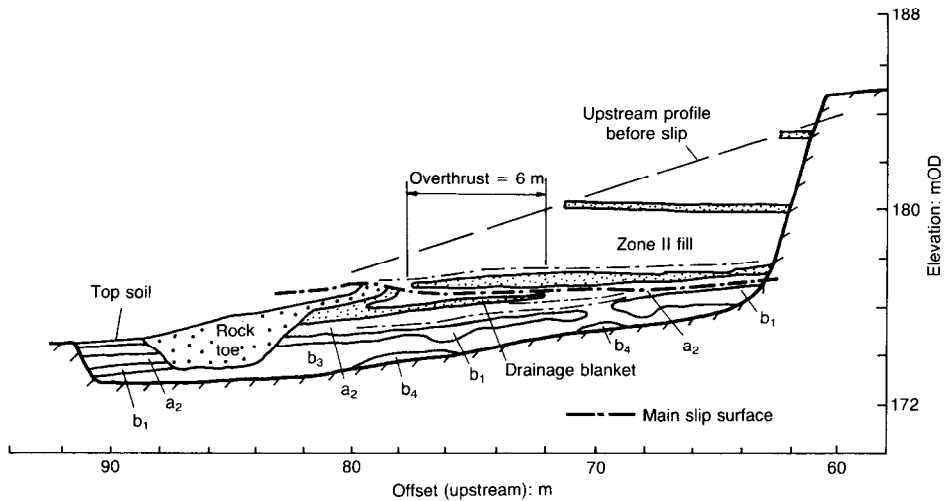
Fig. 16. Section of trial pit showing slip surface at ch. 620

In the pit at ch. 620 the main slip surface passed through Yellow Clay (a_2) below the basal drain layer, cutting through the blanket to pass over the stone toe, with an overthrust of 6 m as shown in Fig. 16. Like the other main shears, this was polished and striated in the direction of the slip, and was associated with shear zones and secondary shears. One of the latter continued below the basal drain layer where this remained in place near the toe, but the polish and striations died away towards the rock toe, consistent with a small and decreasing displacement. Another slip surface was observed in the zone II fill. This was consistently 300 mm above the disrupted drain-

age layer, as if following the surface of the bottom layer of fill. It joined the main slip surface at the overthrust, and had clearly moved during the slip, although by an unknown amount. The FE analyses indicate that this part of the slip would have formed quickly after collapse had started as the slip 'ran away'. Failure in the Yellow Clay

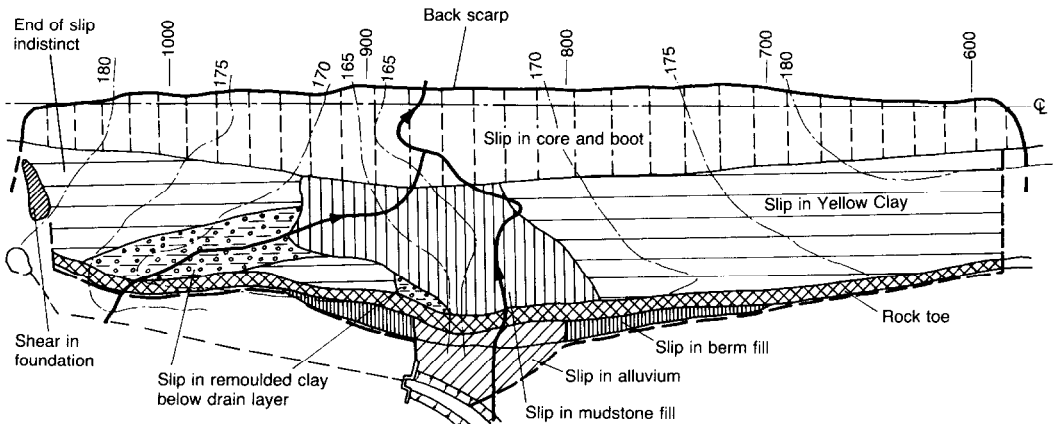
Fig. 17. Location of slip surface as surveyed during excavation of embankment

The location of the slip surface as observed during removal of the dam in 1989 is shown in Fig. 17. Its location in the Yellow Clay on both flanks of the valley, and in the zone I and zone II fill in the valley centre was confirmed. The 1984 trial pit at ch. 820 was found to be close to the boundary between the two types of movement, which may have influenced the formation of the sliding surface at this point. In the bottom of the valley where no Yellow Clay was present between ch. 970 and ch. 1040 and at ch. 880, part of the surface passed through a layer of remoulded clay

During the removal of the dam, solifluction shear surfaces were observed in the Yellow Clay outside the slide area. In one very local area downstream, and in one area at the south end of the slide (Fig. 17) shear surfaces were seen on bedding planes in the foundation. The second surface was about 10 m by 20 m, in planar bedding dipping into the dam abutment. It crossed grout holes used for consolidation around the tunnel, and dislocation of these showed that movement had not exceeded 70 mm. The cryoturbation of the mudstone in the top of the foundation had disrupted the bedding elsewhere, which prevented any general failure along bedding planes which might otherwise have occurred.
