## TABLE OF CONTENTS

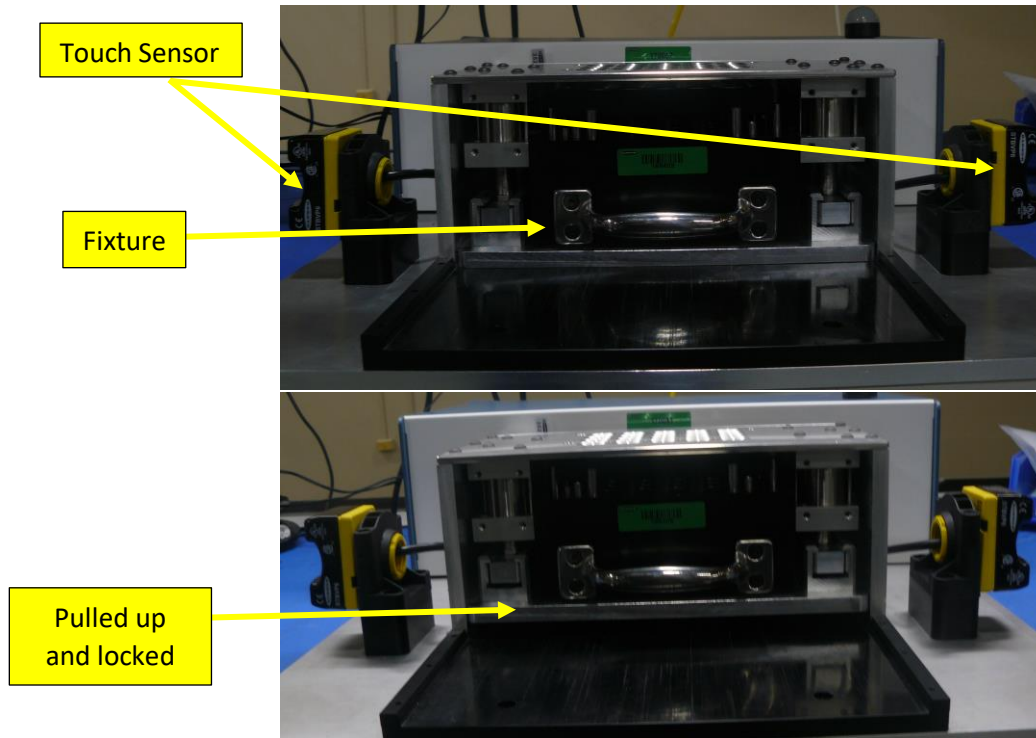
Upon inspecting the PCB fixture, numerous problems were detected. First was, violation of safety conditions by the production line employees. Employees must touch the sensor for at least  $134 \text{ ms} \pm 8 \text{ ms}$ . The fiber optic sensor and touch sensor has a response time of 10 ms, and they are debounced for 50 ms using a safety controller that has a response time of 6 ms, with PLC having a scan time of 4 ms (PLC takes 2 scans to display the output). Hence, total delay becomes 134 ms.

Total delay = (Sensor response time + debounce time) \* 2 + safety controller response time + PLC scan time + PLC scan time =  $(50\text{ms} + 10\text{ms}) * 2 + 6\text{ms} + 4 \text{ ms} + 4 \text{ ms} = 134 \text{ ms}$ .

However, employees don't touch the sensors long enough, hence, the safety controller sees it as a violation of safety condition and locks the systems. Second problem was with fiber optic sensors, three fiber optics sensors are used and for some reason sometimes they don't work. Conducted few tests on these sensors, will conduct more tomorrow.

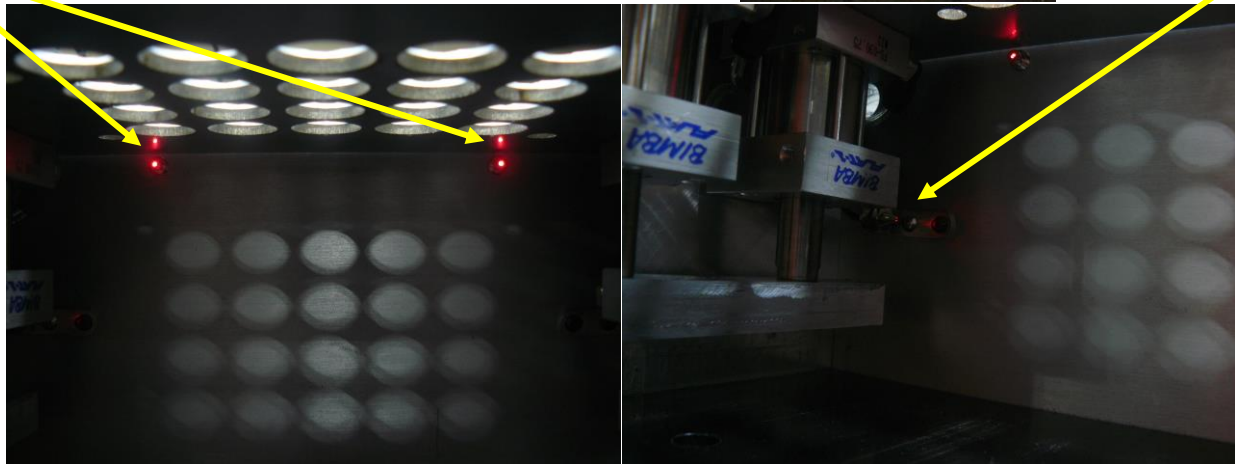
After thorough testing, it was concluded that all three fiber optics sensors are working. They were reinstalled in the fixture and were tested again. It was noticed that after prolonged use of the fixture, signal strength received by the sensor decreases. This is seen as the violation of safety conditions by the safety controller and hence it locks the fixture. I investigated sensor's data sheet, sensor's performance changes with respect to the distance and is affected by dust. It was noticed that with the change in distance the excess gain of the sensor must be changed, shown in the figure below. For example, at 0.1 inches, the gain should 20 times the original signal for correct performance. Fiber optics cable attached to the emitter and receiver of the sensor were cleaned and sensors were re-installed. They were tested again but still they are failing. Will investigate other problems tomorrow.

Rear sensor to see if the fixture is pulled up

Strength of signal is displayed here

Side sensor to see if the fixture is all the way in

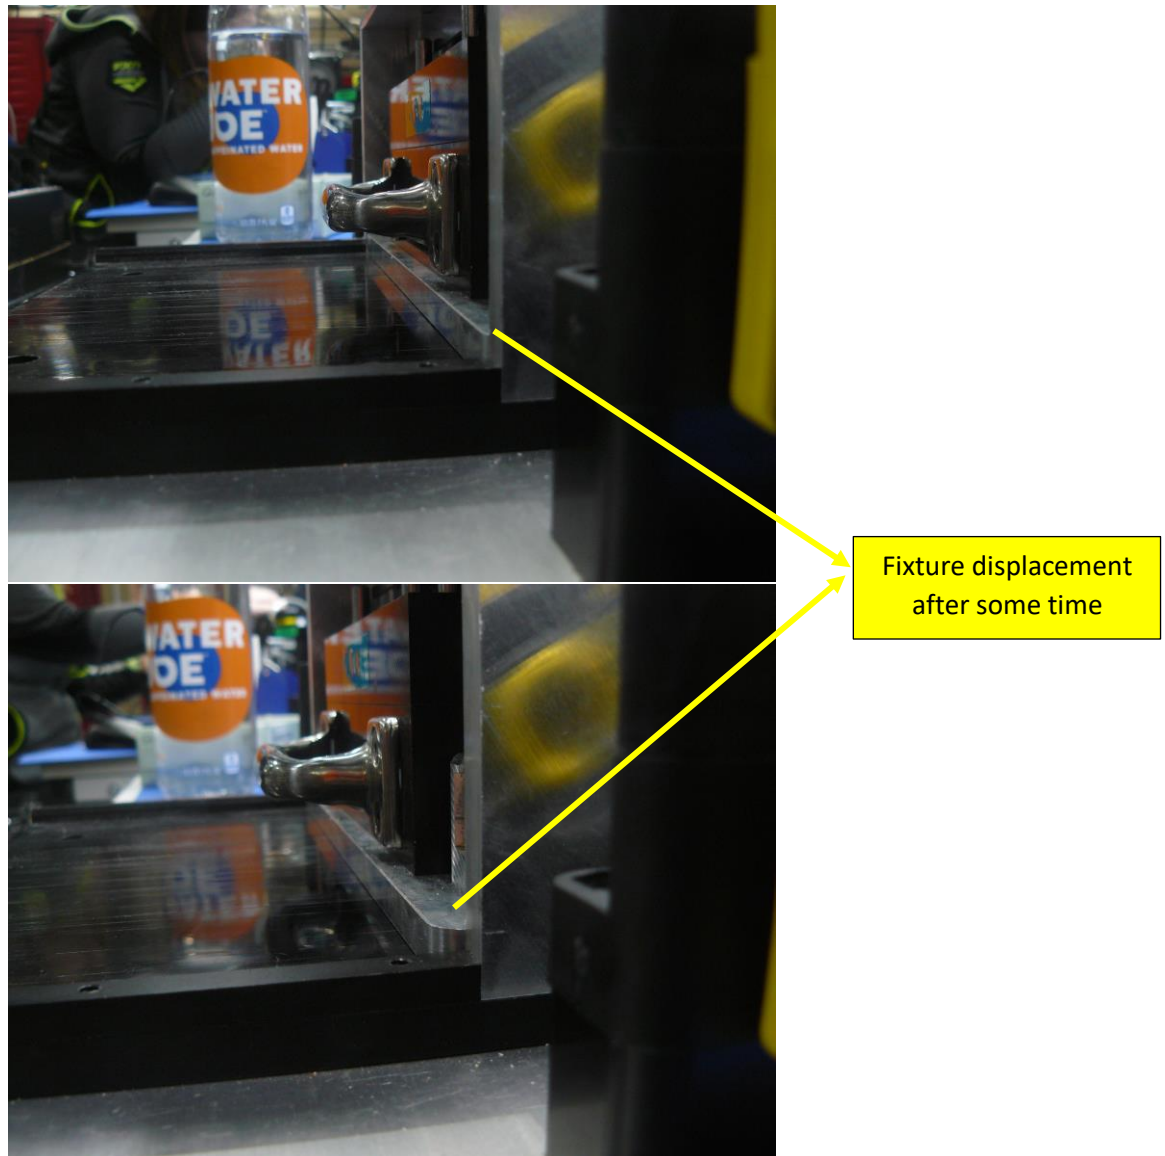
I probed all the connections inside the fixture, everything is connected correctly. I tested the PLC, relay and the power controller too and everything is working as expected. However, after more testing it was noticed that the fixture gets displaced from its position by a fraction of an inch. This happens after the fixture is used for few cycles, shown in figure. This displacement in fixtures position changes the between the sensor and the fixture, and the sensors are calibrated for fixed gain/distance ratio. Since, the sensor is very sensitive to the distance, seen in the sensor's performance graph, hence with the increase in slightest of distance the gain also must increase. And in this case, if the fixture is pulled up then this causes sensor fault, and the safety controller locks the fixture. Only way to fix this would be to open the fixture and readjust the gain. Will work on the possible solutions tomorrow.

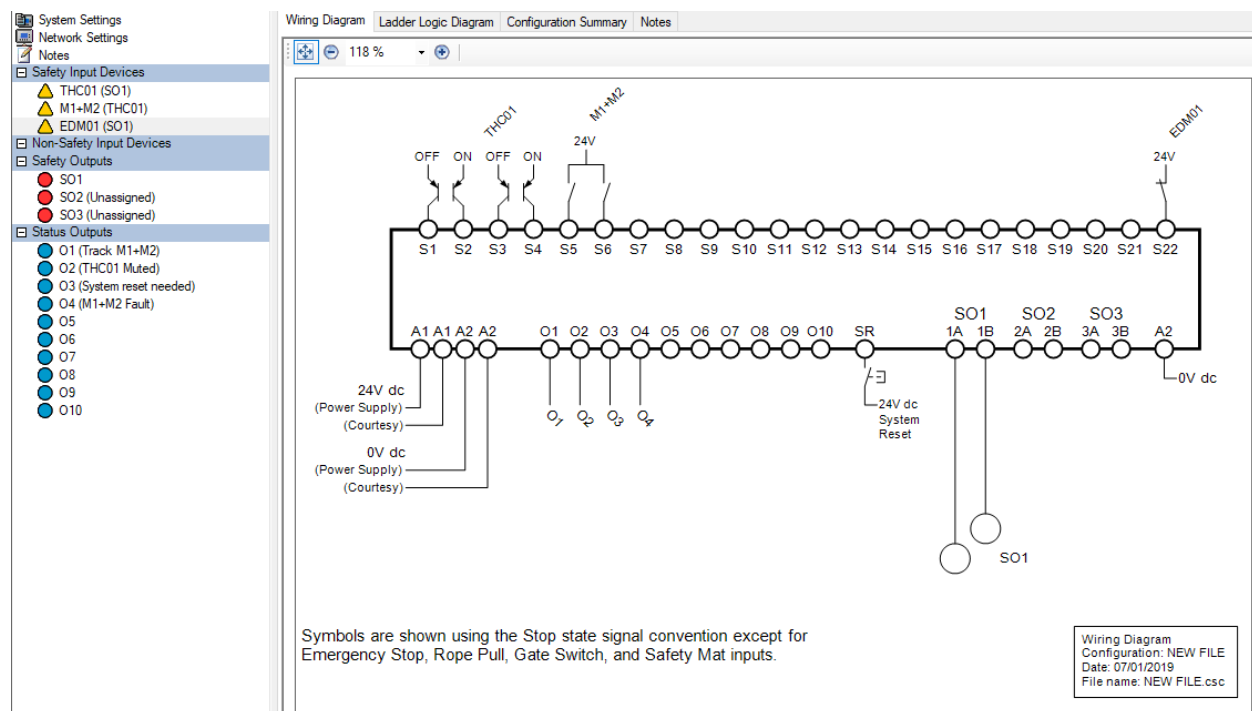
Safety Controller:

This morning the fixture got stuck again, upon inspection it was noticed that the safety controller needs a system reset after every 24 hours. The safety controller can be resetted by recycling the power. Safety controller was reprogrammed to monitor the side sensor faults, rear sensor fault and systems reset separately, shown in figure. The output of the safety controller is fed to the PLC and previous

connections were removed. Now, the safety controller will inform the PLC about the status of side sensor, top rear sensor and system reset separately. And if any fault occurs the PLC would turn on the respective light.

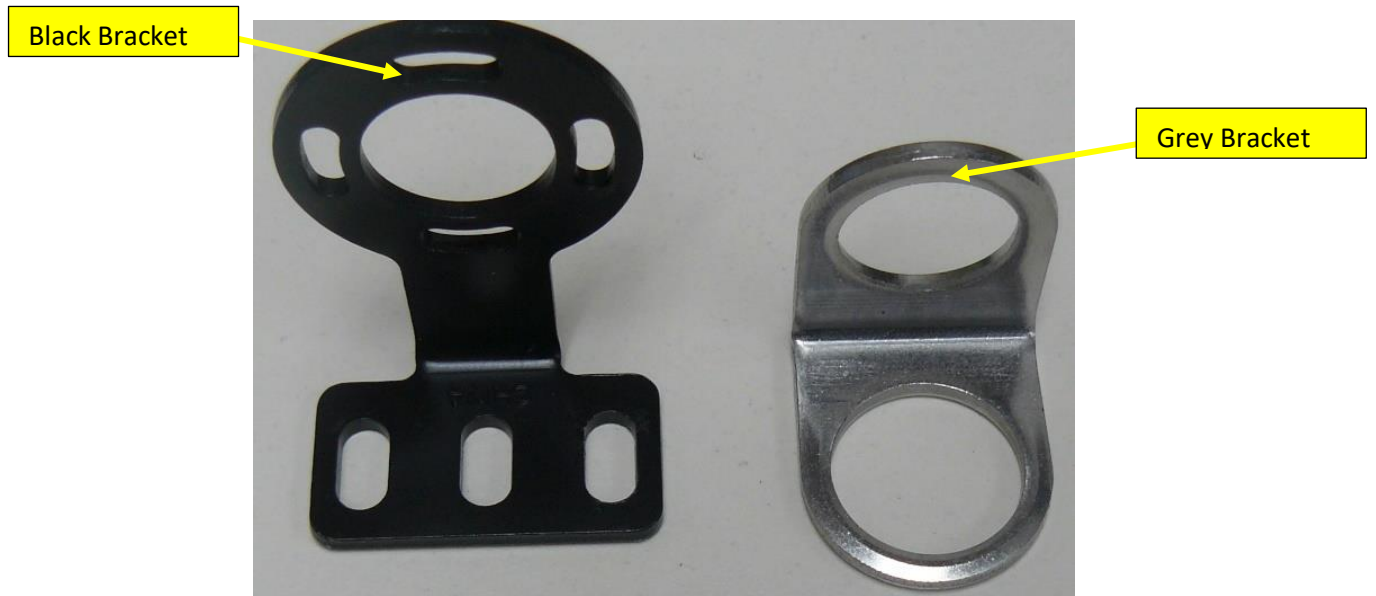
Drilled a hole on top of oven 1, installed the sealing grommet on the oven. Wired the sensors beside the racks, however, the black standing brackets that were used to keep the sensors still are not stable and can be knocked out easily if an employee inserts a tray wrong. Hence, grey brackets are used, which are more stable. However, the sensors are seeing the racks. To avoid this, sensors were mounted higher, however, some sensors are still seeing the racks, and when can only increase the height so much. Will investigate the source of error tomorrow.

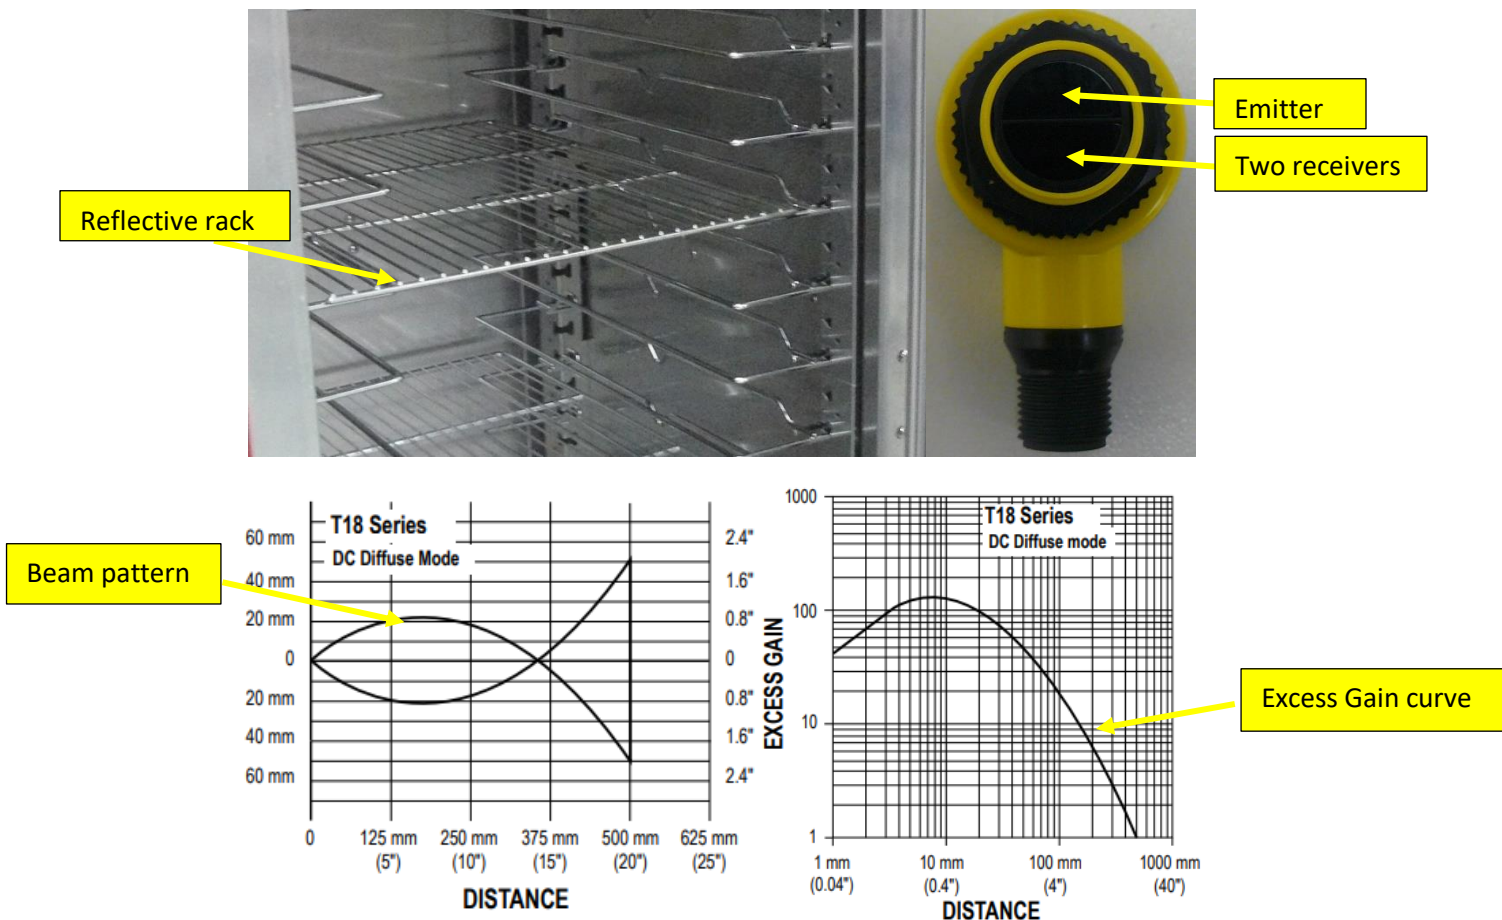
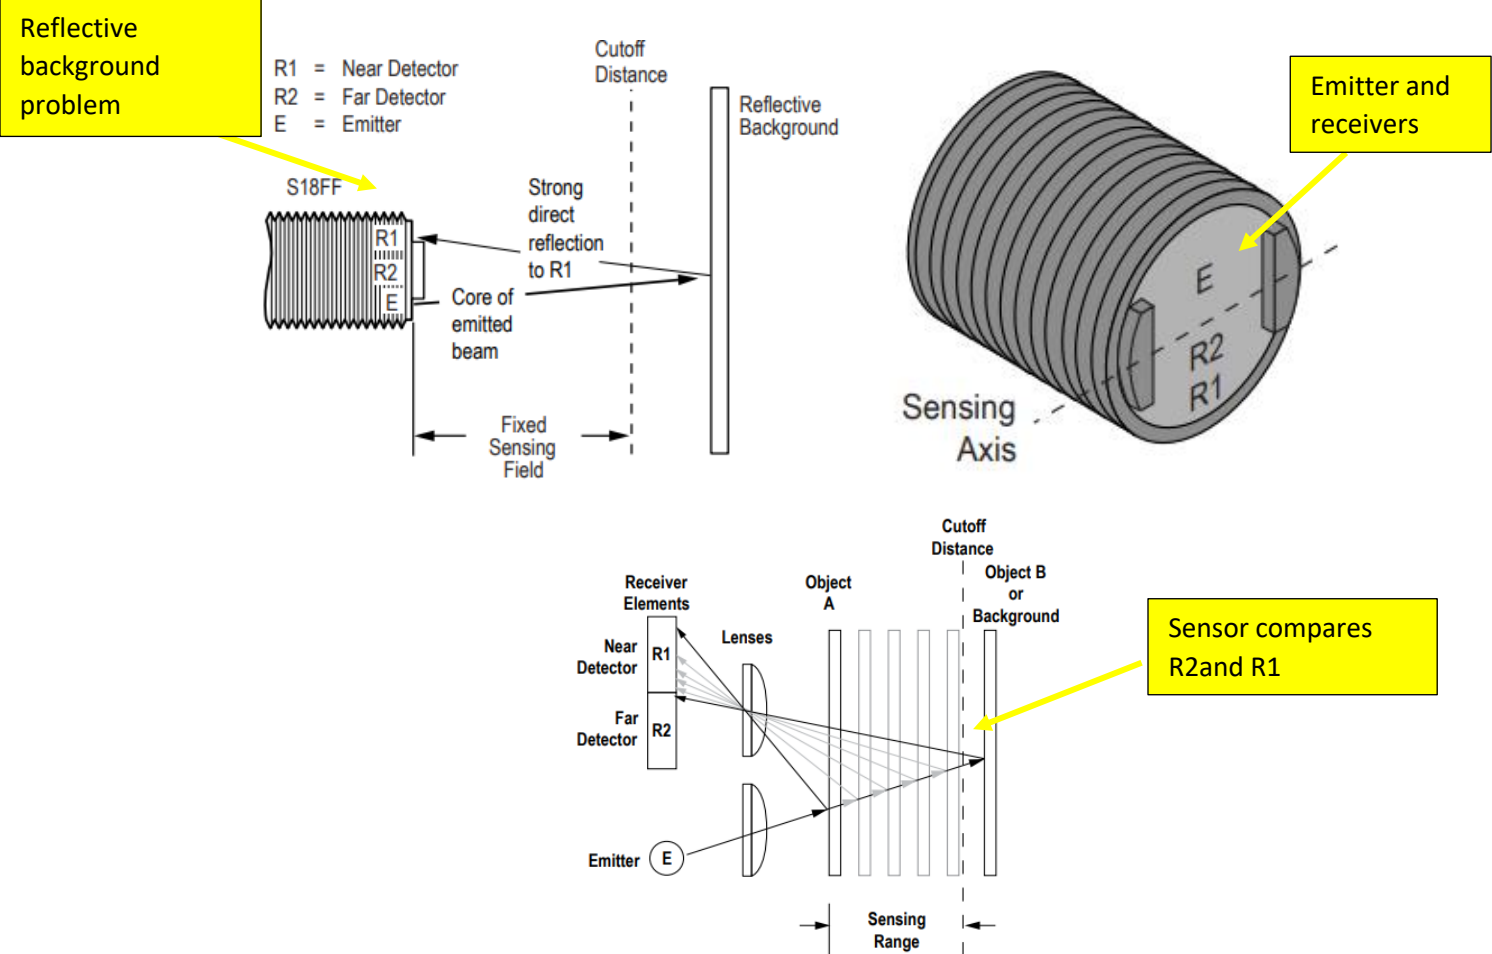
It was noticed that the racks were highly reflective, hence it was reflecting off the beam that the emitter was shooting from the sensor. Sensors were mounted higher than the racks but still they were seeing the racks, this was happening due to the beam pattern the sensor has, shown in figure. Also, the sensing axis was perpendicular to the rack, hence, the sensor was seeing the objects that are below its line of sight. Hence to fix this, brackets were welded on top of the rack stand, and sensors were mounted on top of it. However, now sensors were seeing the reflective background. The sensor compares the R2 and R1, and if R2 i.e. far detector signal strength is more than R1 i.e. close detector signal strength then the sensor is always turned on. Hence, to fix this, layers of black tape were taped on the reflective surface to reduce the far detector signal strength. Also, the gain was reduced so that the overall signal strength reduces, and the sensor will see the object in the range of 8 inches and won't see the background. Then each sensor was the tested, the gain of each sensor and the angles of the brackets were calibrated accordingly. Will work on the other ovens tomorrow.
