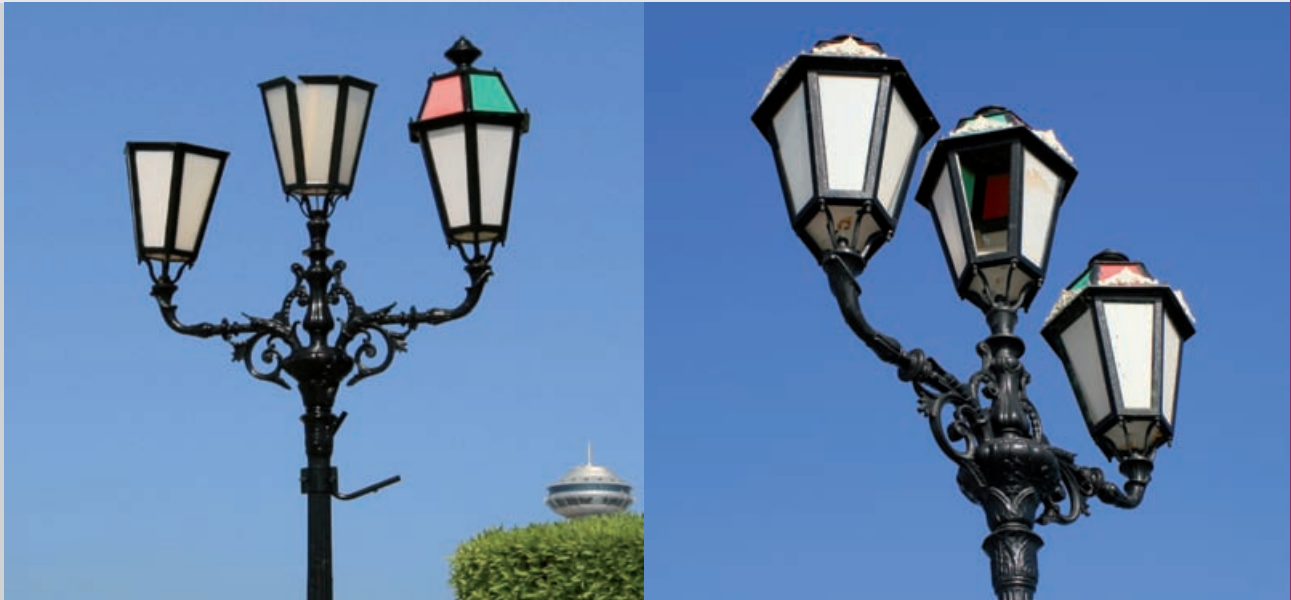
Figures 146, 147

Post top lanterns which are damaged by wind may cause danger for nearby pedestrians, loose elements could fall down.

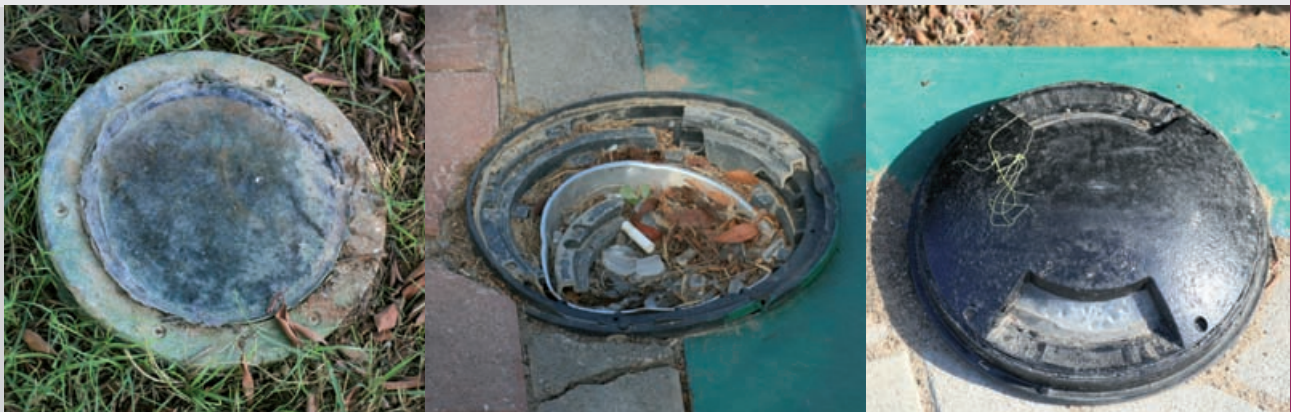
Figures 148, 149, 150

Figure 148: The in-ground light is not performing as it was designed, replacement would be required.

Figure 149: The electrical circuit looks like still in use and may cause fatalities in case someone may touch it.

Figure 150: In fact of poor quality or maintenance humidity is shown inside this path luminaire.
