MARINE STRUCTURES CONDITION ASSESSMENT AND REPAIR RECOMMENDATIONS REPORT, HERRON ISLAND, WA

Prepared for HMC Management

KPFF Project No. 109086
September 24, 2010

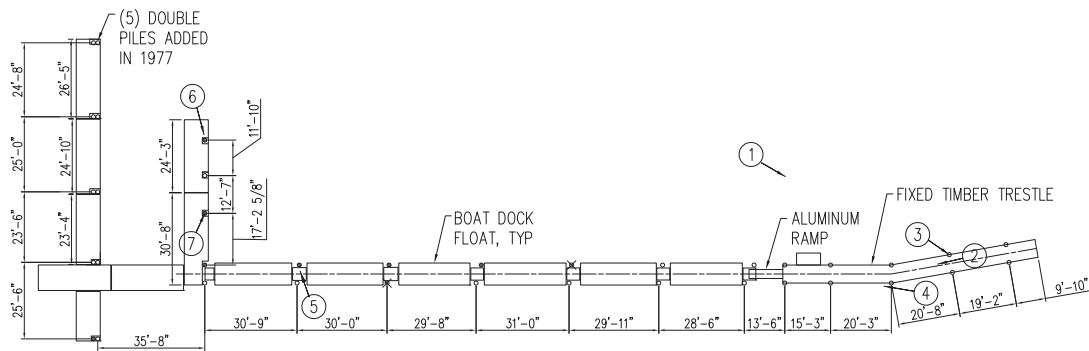
FIG. A

Observed Conditions: A summary of observed conditions is provided below by location. Observed areas of distress are also noted on **Figure A**.

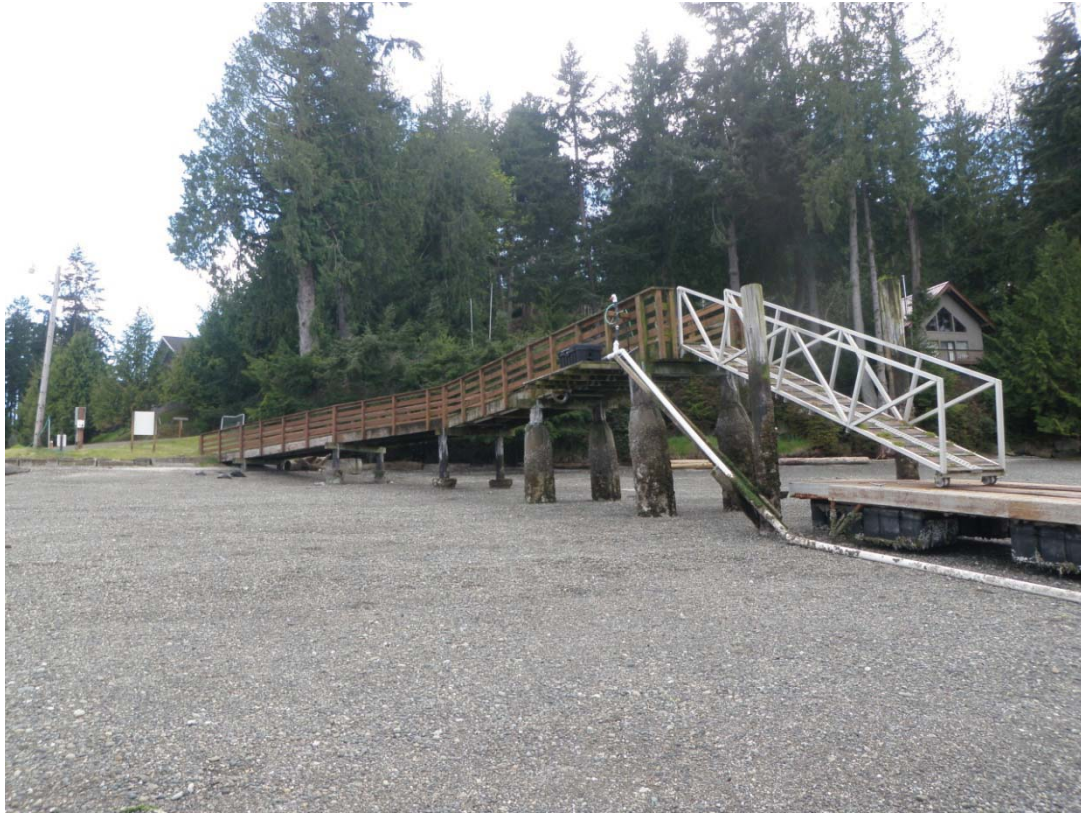
- **North Beach Marina Timber Trestle:** The timber framing of the fixed trestle is generally in good condition. See **Photo #1 and #2**. Wood members were observed to be sound from probing and hammer sounding. All of the timber piles supporting the trestle were also observed to be sound. Two of the four concrete pipes that the trestle piles are cast in are deteriorated and breaking apart. See **Photo #3**. The other two concrete pipes are covered with marine growth. See **Photo #4**.

Photo 1 Timber Trestle at North Beach Marina at low tide

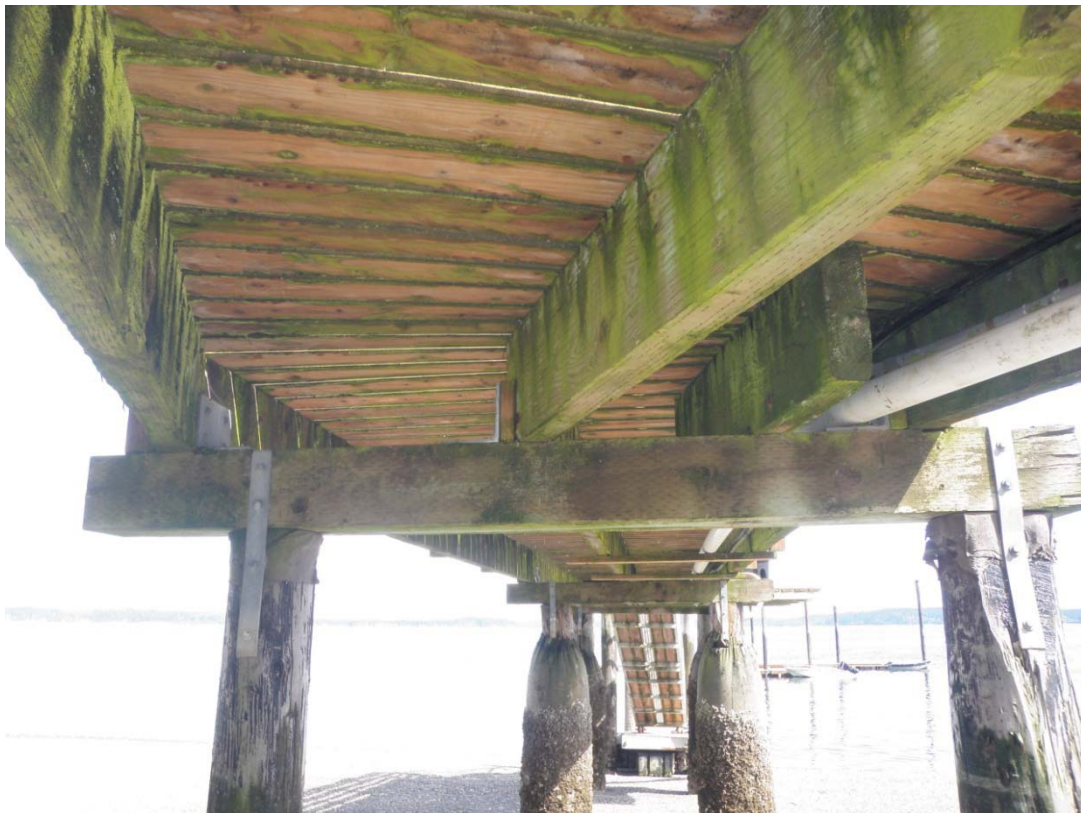
Photo 2 Underside view of Timber Trestle

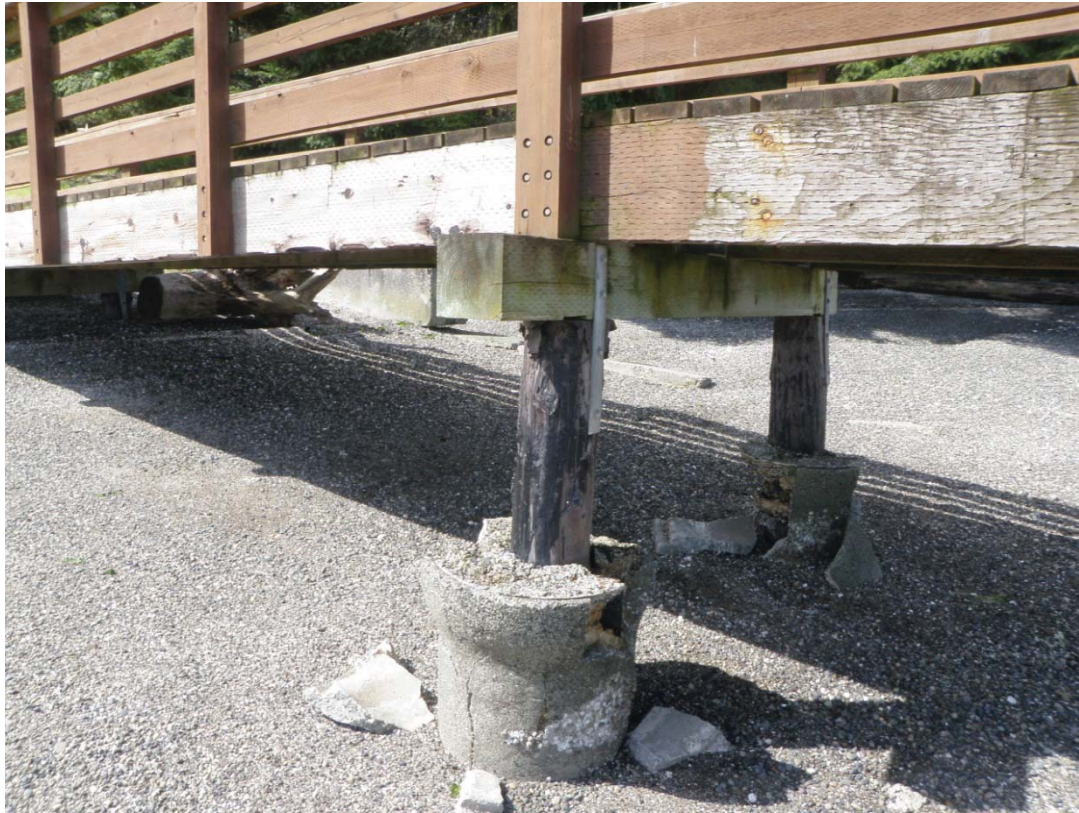
Photo 3 Broken concrete trestle piles set in broken concrete pipe

Recommendation:		Repair the damaged pile concrete encasements at the timber trestle (NB-3). Plan for repair of deteriorated dock guide piles (NB-1B) as soon as possible and attach floating dock to the best piles available in the mean time. Continue to remove the dock floats from the water during the storm season. See "FIG A"

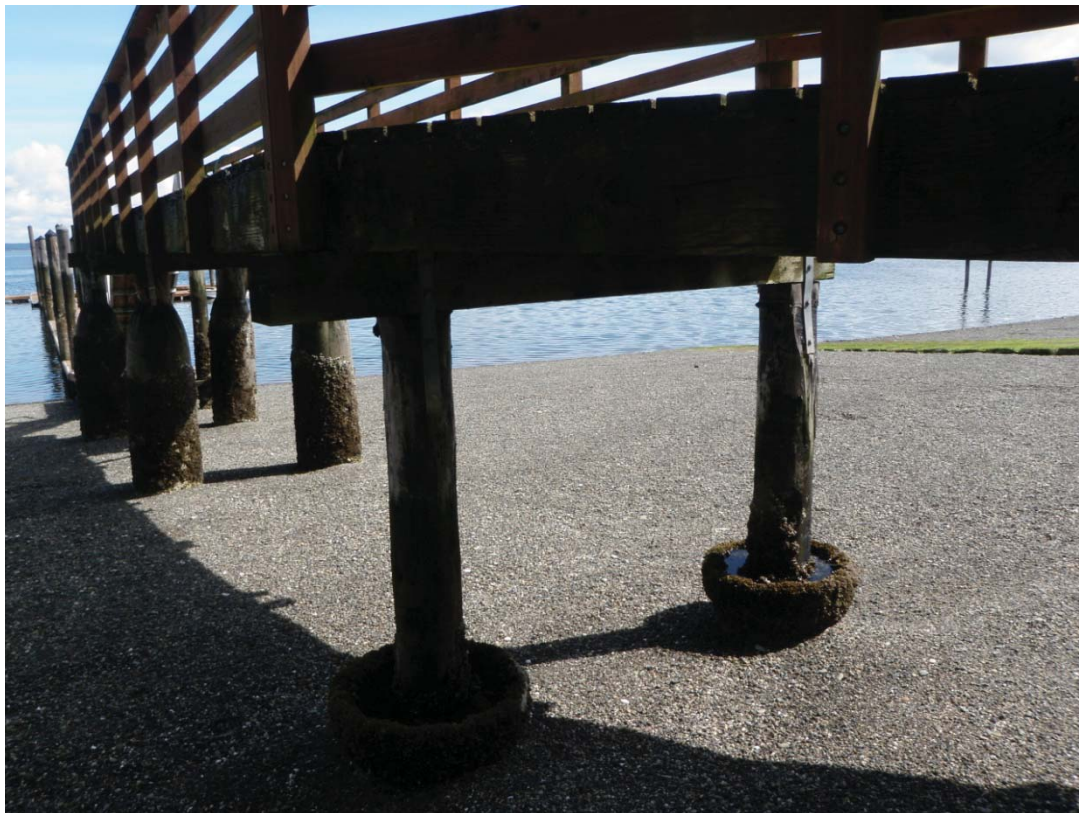
Photo 4 Timber Trestle

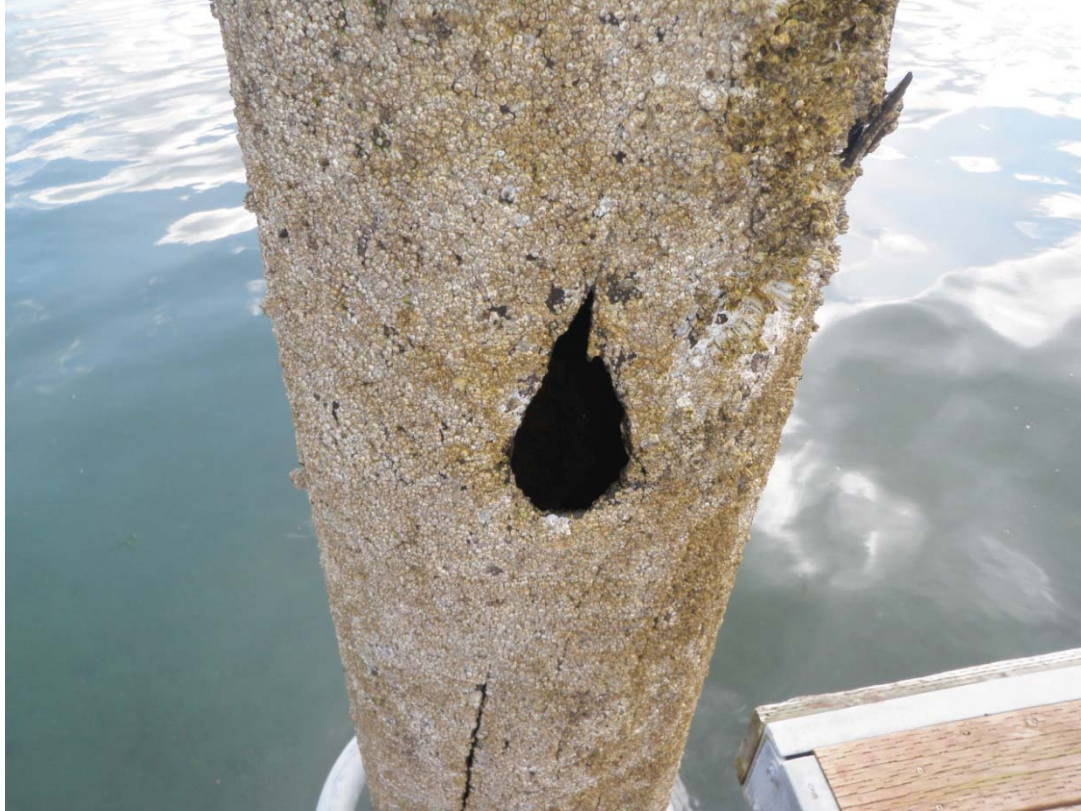
- **North Beach Marina Timber piles:** Of the 29 piles, six piles were visually observed to have significant deterioration. See **Photos #5, #6, and #7** for examples of such conditions. An additional five piles were observed by hammer sounding to have some interior deterioration. At these five piles core samples were taken to observe the interior condition of the timber. In some of the core samples, the timber was observed to show signs of decay. In some instances, clear water flowed freely from the hole created from taking the core sample indicating that a void exists at the interior. Similar conditions were observed at the two piles to the East of the boat dock. Due to tide conditions at the time of the field work, KPFF

was not able to observe the entire exposed length of all piles. The observed conditions are considered typical. If further investigation was performed, it is likely that more examples of deterioration would be identified. Overall, the North Beach Marina piles are in poor to very poor condition.

In our opinion, some of the piles and the North Beach Marina are at risk of failure at any time due to the severity of section loss. However, it was observed that not all of the piles were attached to the dock floats. Piles noted to be in the most severe condition, and therefore at the greatest risk of failure, should not be relied upon. Immediate remediation may be accomplished by attaching the floating dock to the most sound piles available. Additionally, it is our understanding that the dock floats are removed during the stormy winter months. The period of time that floats are not attached to the piles, the risk to the structure is negligible.

Photo 5 North Beach Marina Boat Dock example of deteriorated Pile

Repair Recommendations: Using the benefits and disadvantages listed above together with our understanding of the financial constraints of HMC Management, we recommend that HMC Management begin planning for option NB-2B. We are recommending the use of steel piles as the lower cost option with a proven system. When properly detailed and installed, this option should provide a service life of around 50 years, with a minimal amount of maintenance.

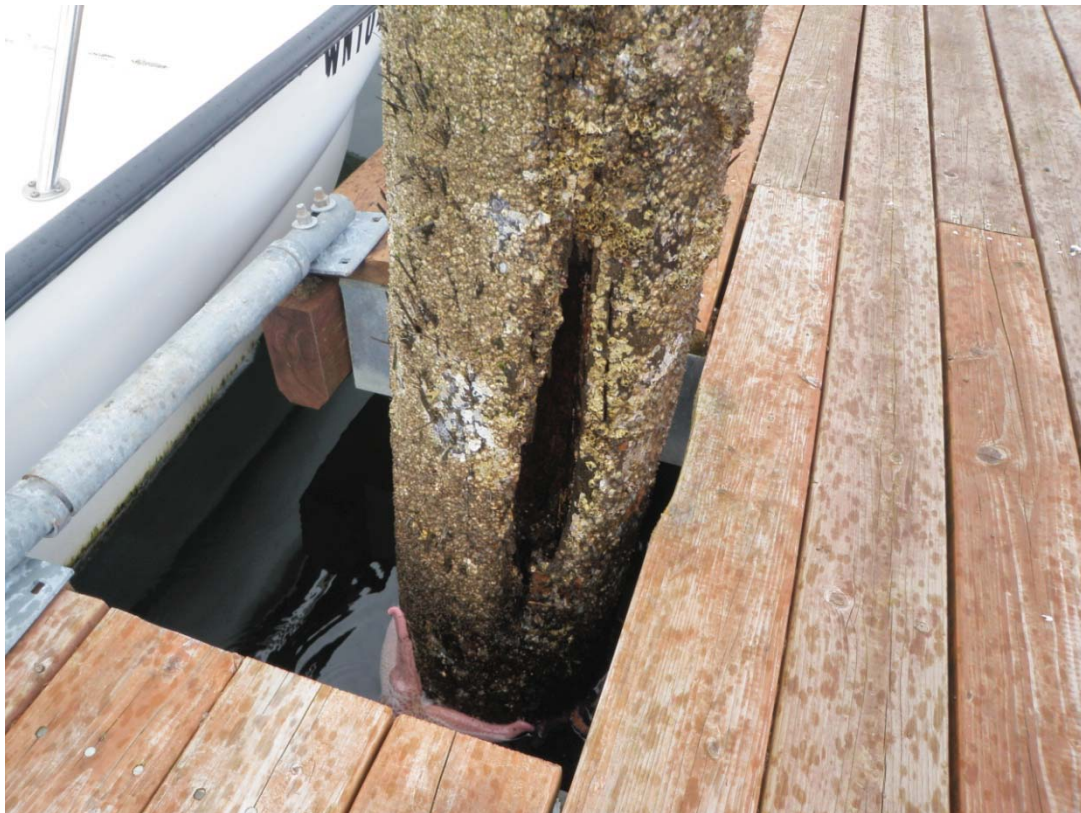
Photo 6 North Beach Marina Boat Dock example of deteriorated Pile

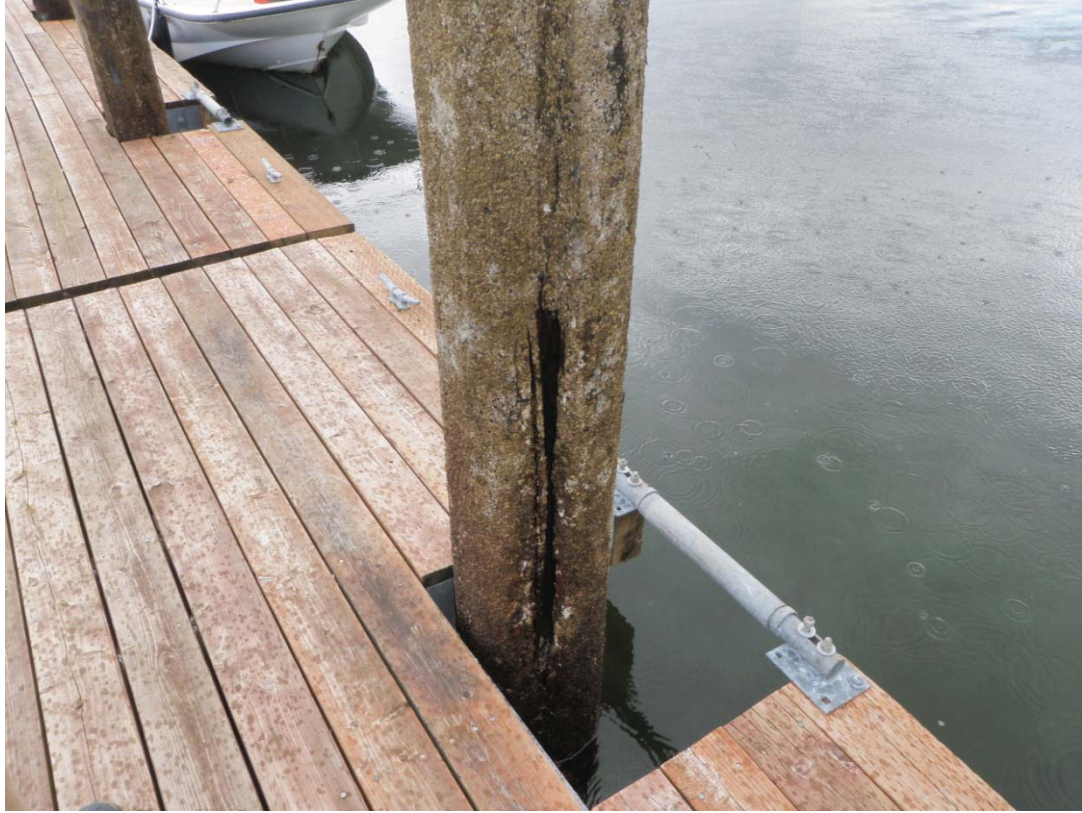
Photo 7 North Beach Marina Boat Dock example of deteriorated Pile

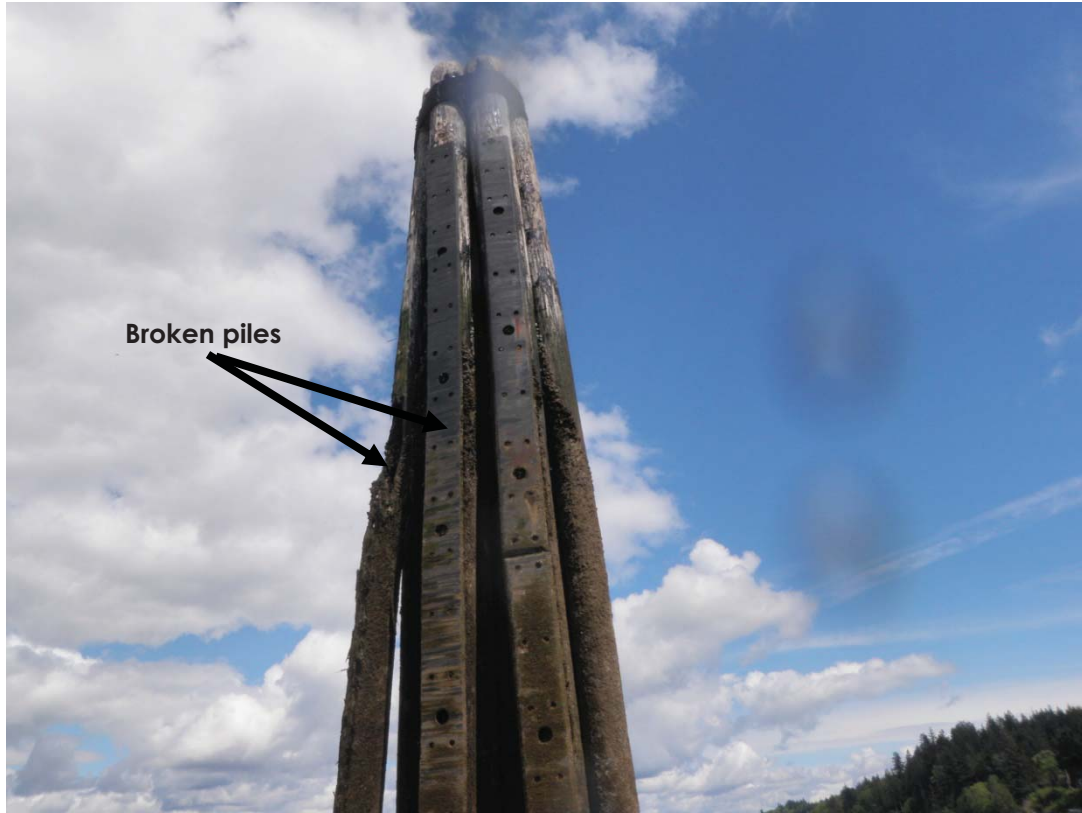
- **Mainland Ferry Terminal Dolphins:** Observations indicate that the outermost piles that were added in 1999 are mostly in good condition, with exception of two of the piles in the Northwest dolphin. It is our understanding that the Northwest dolphin receives the most impact from the ferry and from observation the two piles in question are the first to come in contact with the incoming ferry. These two piles were observed to deflect due to impact from the incoming ferry to such

an extent that they are considered to have little remaining strength. See **Photo #8**. However, the dolphin as a whole was observed to be solid.

Photo 8 North-West timber dolphin at the Mainland Ferry Terminal

Using the benefits and disadvantage listed above together with our understanding of the financial constraints of the HMC Management, we recommend that the HMC Management plan to replace the existing timber cluster pile dolphins with steel mono pile dolphins within the next 10 years. FT-2 is recommended as the option with the lowest cost and shortest construction time with a proven system.

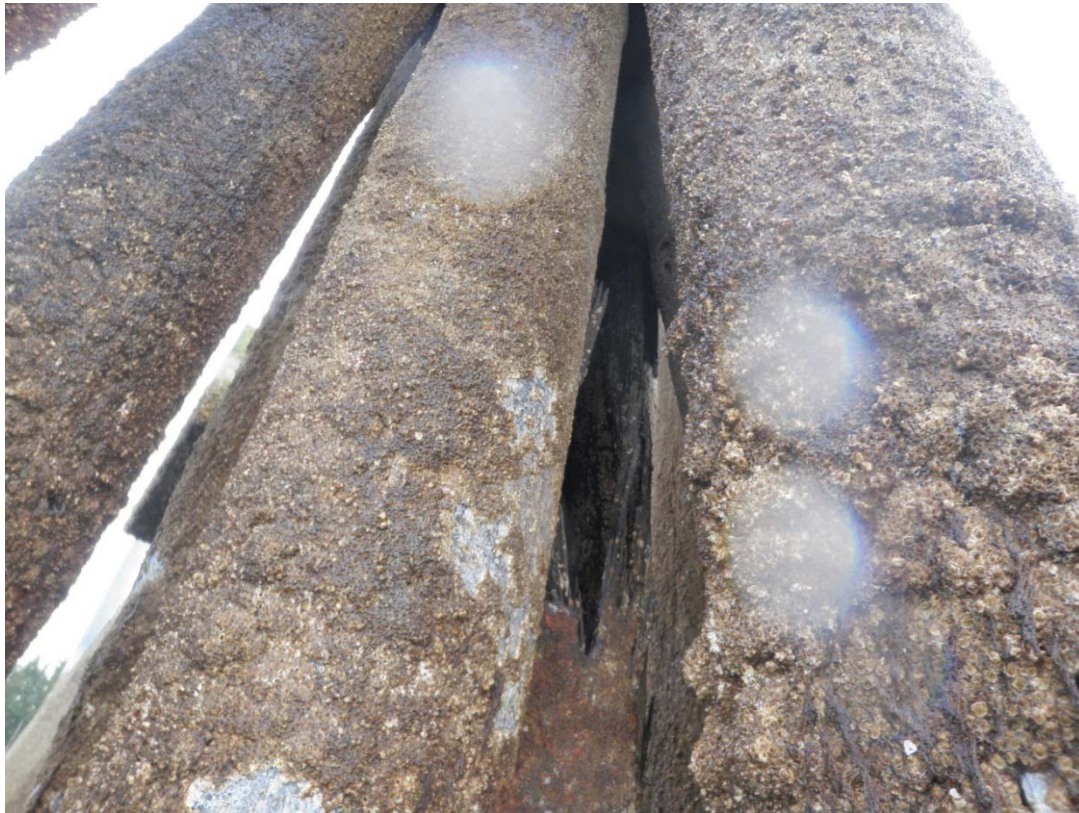
In all of the dolphins, deteriorated piles were observed. In most instances the deteriorated piles were at the interior of the cluster. See **Photos #9 and #10**. With the exception stated previously, the perimeter piles were observed to be in good condition by means of hammer sounding and probing.

Photo 9 Typical example of timber dolphins with deteriorated interior pile

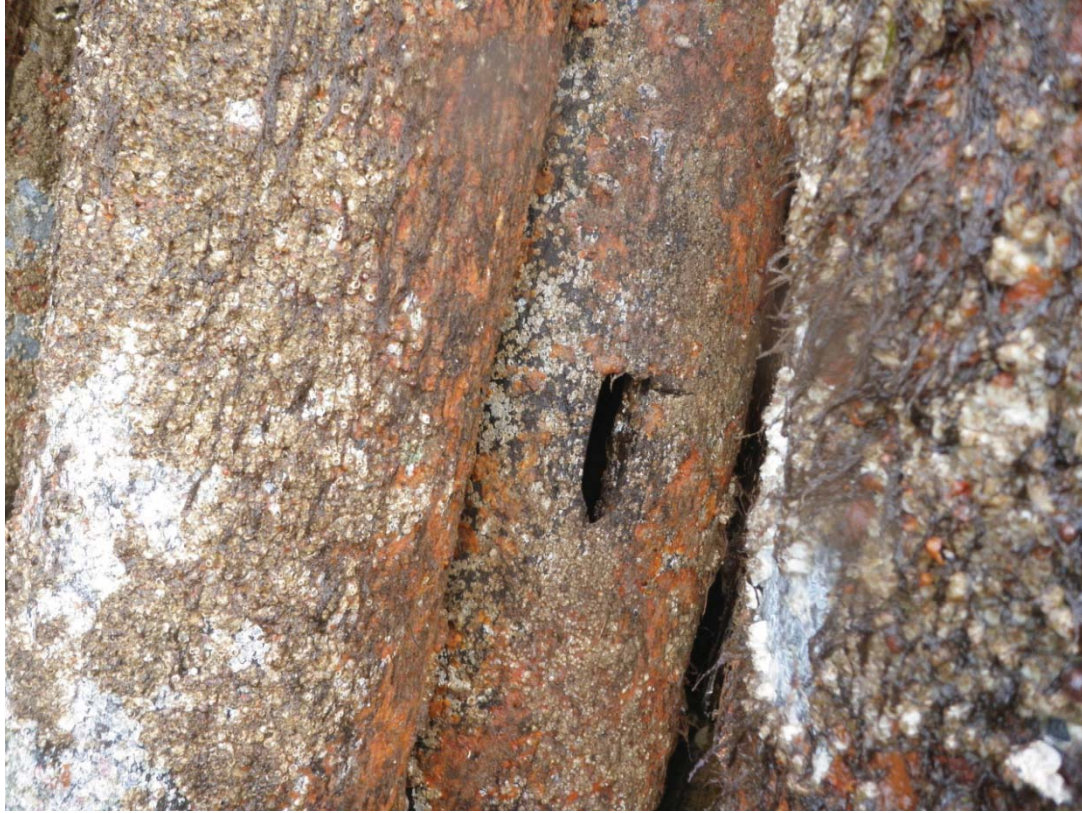
Photo 10 Typical example of timber dolphins with deteriorated interior pile

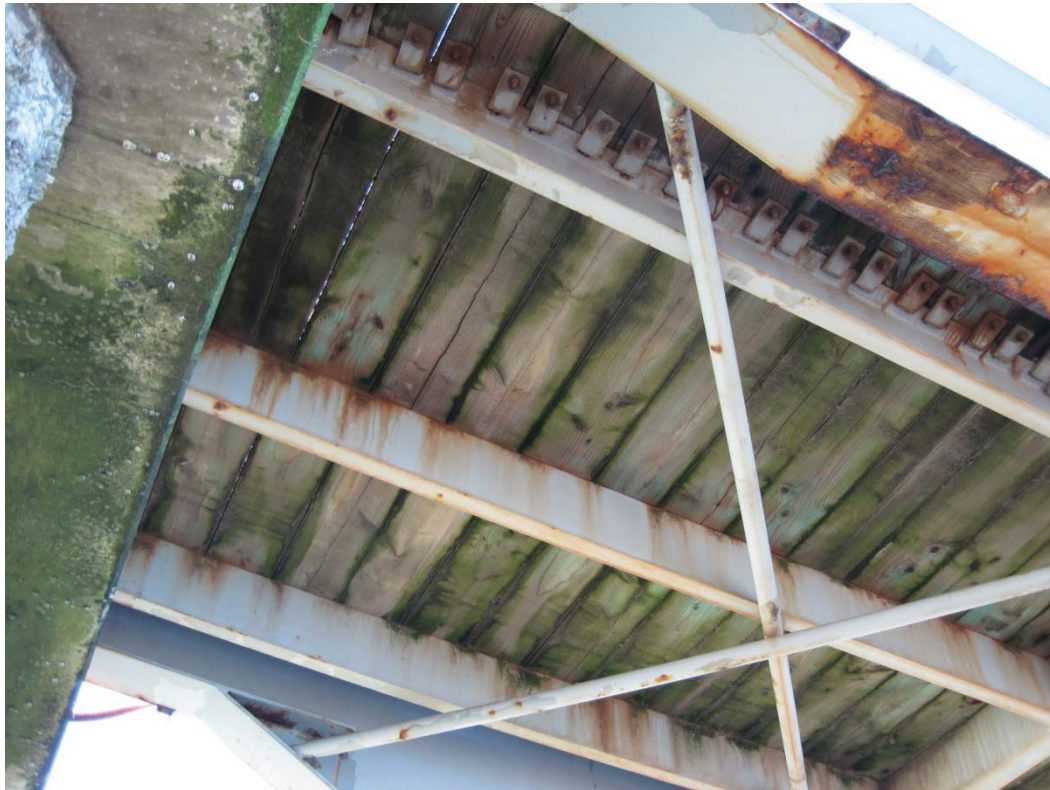
"The painted steel stringer has rust stains washing down from the seam between stringers and the deck. Vehicle traffic is most likely causing the deck planks to wear the paint from the tops of the stringers. Several stringers have dark rust stains along their weld connections to the floor beams. No significant corrosion was observed in these joints or on the stringers. There are many local paint failures throughout the stringers, allowing surface corrosion. There are two main girders in this span. These girders are considered fracture critical because they are steel and there is no load path redundancy. I.E., if one girder were to fail, the entire span would fail. The girders appear to receive more salt spray than the stringers and girders, as a result there are several areas of blistering paint and surface corrosion. Most blistering is along the bottom flange of the girders." (pg. 3), (See **Photo #11**)

Comparing the condition description from the KPFF report to the Sargent report, it may be extrapolated that the paint has been deteriorating for more than 5 years. See the report by KPFF For a complete review of all conditions observed by KPFF in 2005.

Photo 11 Underside view of steel draw span

- FT-4:** The scope of option FT-4 includes spot cleaning the deteriorated areas of paint on the steel draw span and repainting the entire draw span (does not include stripping of paint is good condition). This would require the removal of the timber decking and the galvanized guardrail. In order to minimize the impact to island residence, the work for this option would be scheduled to coincide with the ferry maintenance schedule. Therefore, the contractor would be required to deliver all materials to the island before the ferry is taken out of service. The contractor would then have to access the island by use of a small boat. This access restriction will increase the cost. Therefore, the cost estimate for this work is separated by the Mainland terminal and the Island terminal. The estimated cost for this option at the Mainland side terminal is \$91,000. The estimated cost for this option at the island side terminal is \$121,000. The cost estimates include overtime costs to limit the work period to two weeks.

Repair Recommendations: We recommend that the HMC Management begin planning for option FT-4. As discussed in the Sargent Engineers report, the paint system is intended to protect the steel material from deterioration. There are sections of the paint system that have failed, leaving the steel at risk of corrosion and section loss. We believe that this is a critical repair that should be scheduled as soon as is practical.
